09021 OLD BALLOCH SCHOOLHOUSE, GLENBUCHAT.

At the request of your client, Mr Duncan, our Messer's McKenzie & Willis visited the above property on the 25th August 2009. The purpose of the inspection was to assess the condition of the existing building structure and determine its suitability for refurbishment/conversion. The weather at the time of the inspection was warm and dry.

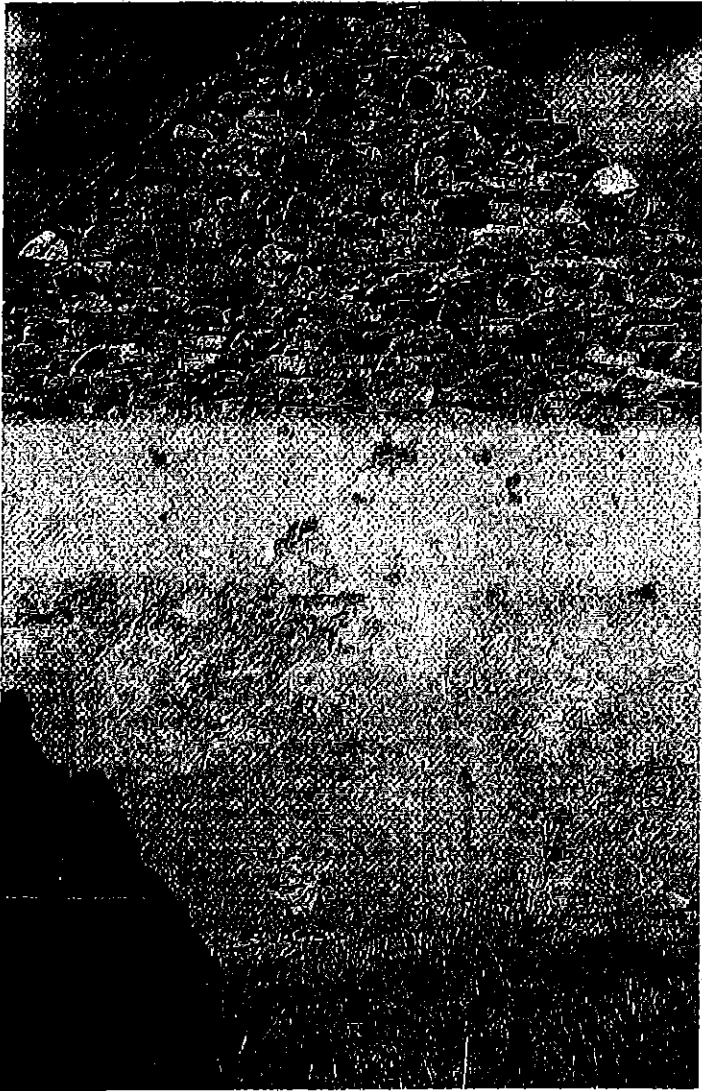
Figure 7 shows the south east of the building.

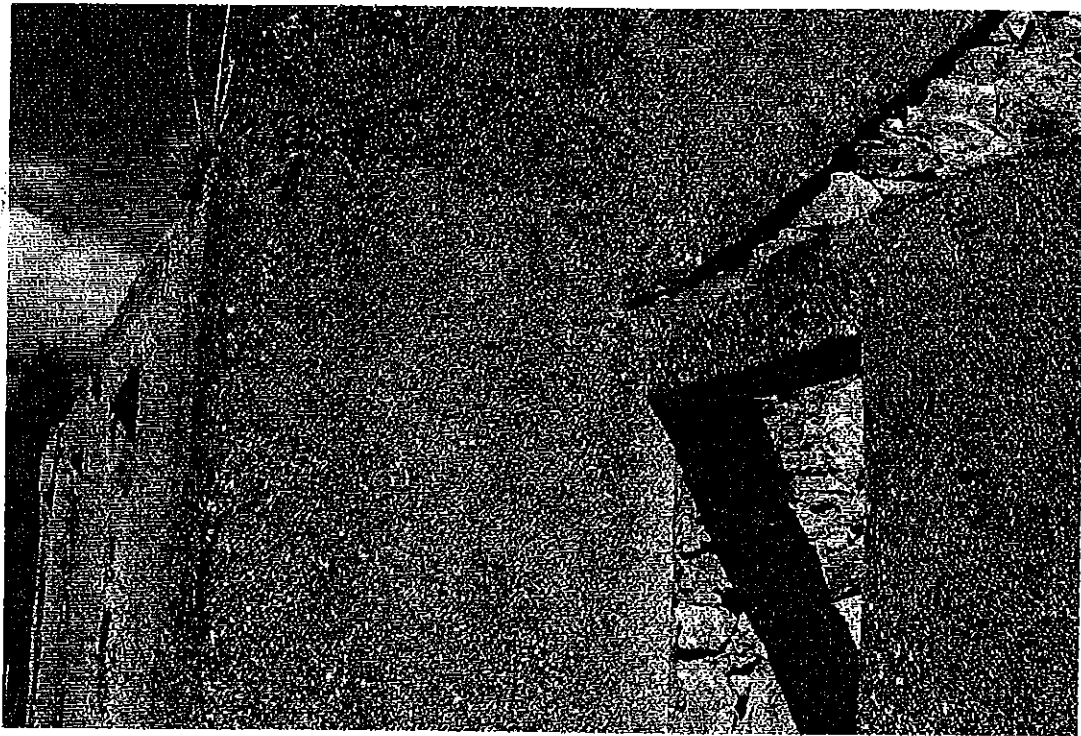
FIGURE 4

The walls are generally fairly straight & plumb. The lintels in the west elevation above the windows have started dislodging, probably caused by historical movement in the now removed roof structure. Where the internal walls are exposed the mortar in the walls has generally decayed to no more than a grey sand that can be freely raked out. In the east wall in parts, around half the internal thickness of the wall has collapsed, refer fig 2. While the other internal walls are still currently intact, from random samples, generally the mortar can be freely removed and in effect has structurally failed. All the lintels in the building should be considered unsuitable and be replaced as part of any future renovation works.

Figure 4 shows the south west external face with signs of cracking @ the head of the wall & local to the window lintels.

All lintels in the building should be replaced.

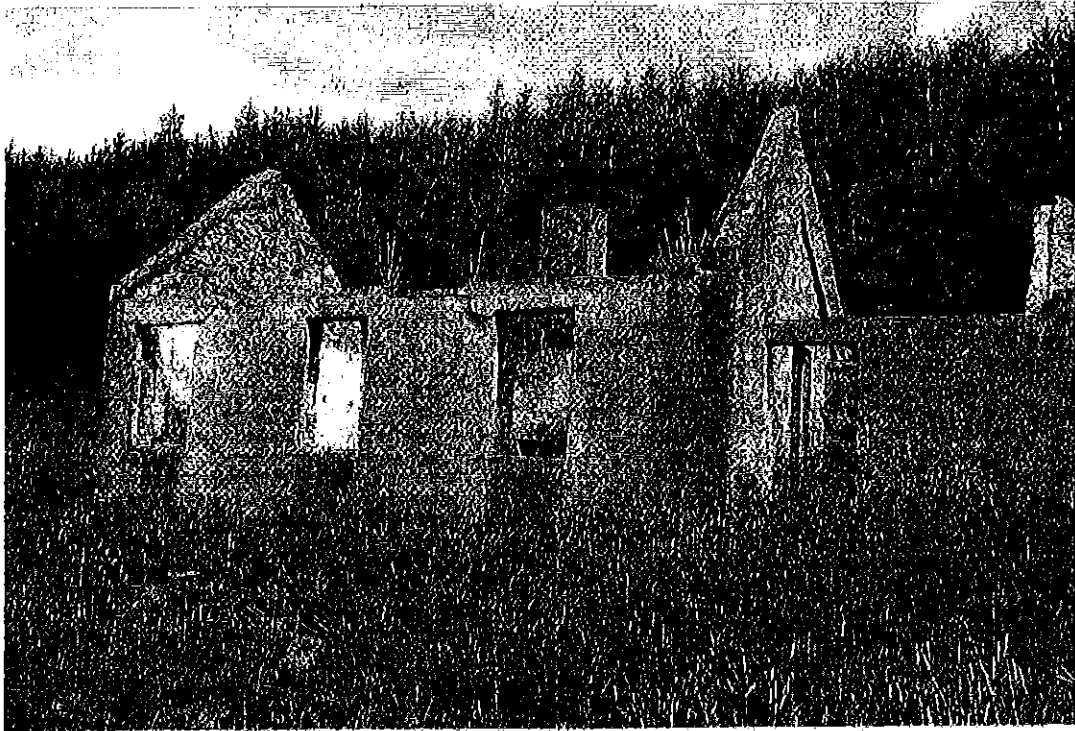
Figure 1

The old Balloch School House consists of two adjoining rectangular blocks with a corrugated steel sheet outhouse on the northern gable, refer figure 1, the outhouse is proposed to be removed so is not discussed further under this report.
