**Report on Structural Survey of
Masonry Walls of Steading at
Balnagowan, Balnagowan Brae, Nethybridge**

Ref: 1736/KGC
Date: March 2009

1.00 Project Brief

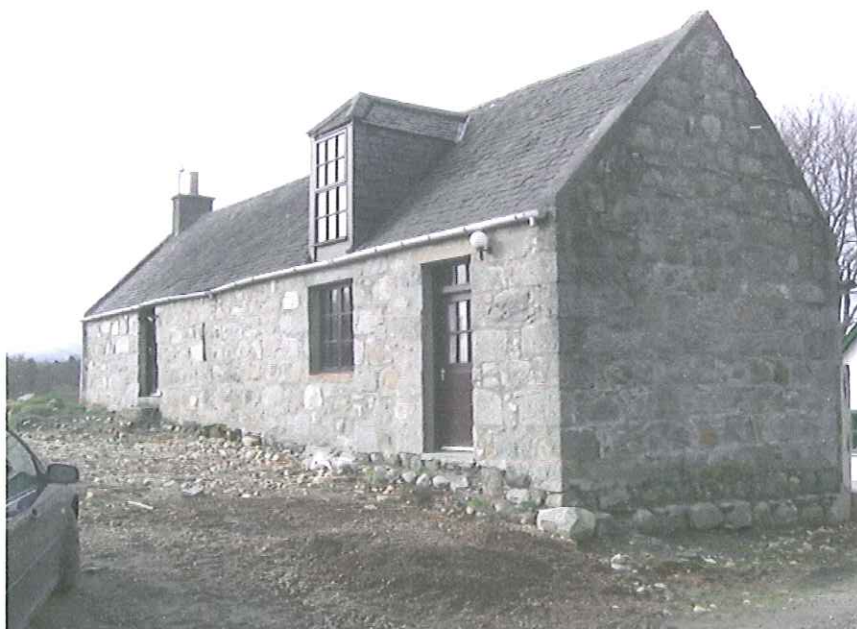
- 2.02 The building is of traditional construction with masonry walls and timber rafters and sarking with slate covering. It is rectangular in plan and orientated with the gables at north and south, the side walls east and west. The photograph on the front cover shows the north gable and east wall. There appears to be two distinct stages of construction. The northern section, approximately one third of its length, has been built with masonry to eaves level, and ties forming an attic floor at eaves level. The southern section is of one and three quarter storey construction and at a lower level, with first floor joists resting on slots in the masonry and a raised tie roof structure giving headroom to the first floor. There is a retaining wall approximately 1.8m high
