### BEAULY-DENNY TRANSMISSION LINE PROJECT

# **Beauly-Denny Replacement Transmission Line Restoration Monitoring Year 3 (2018)**

**March 2019**

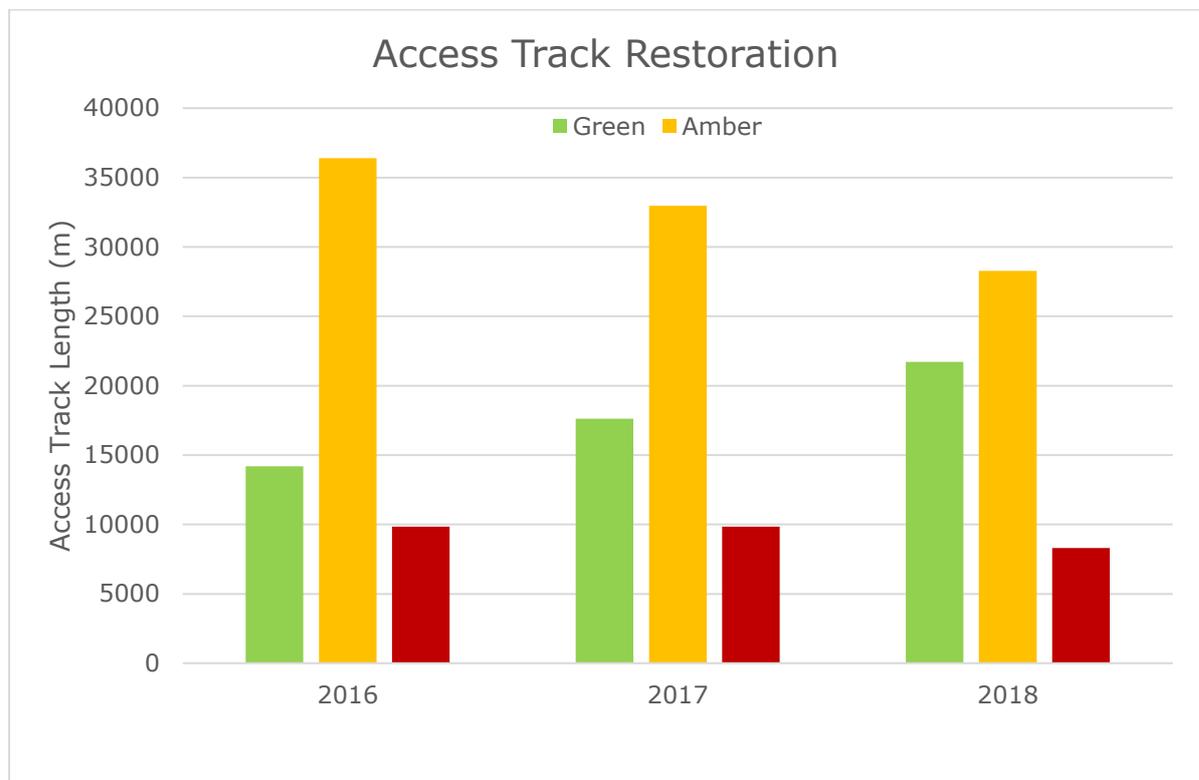
Figure 1. Length of reinstated access track classed as red, amber and green in 2016, 2017 and 2018

Status	Length (km)	Percentage
Red	8.5	18.4
Amber	31.7	68.5
Green	6.1	13.1
Total	46.3	100

The level of restoration on sections of reinstated access track varies considerably across the project. This is discussed in Section 4. Appendix 2 summarises the current state of restoration of reinstated access tracks, and this is displayed visually using red, amber or green colours on the associated maps in Appendix 4. Red symbolises sections of track that have sparse (0-25%) vegetative cover with no discernible improvement since the previous year of monitoring; amber symbolises sections of track that are partially restored (25-85% vegetative cover) and green symbolises sections of track assessed as being fully restored, with 85-100% vegetative cover.

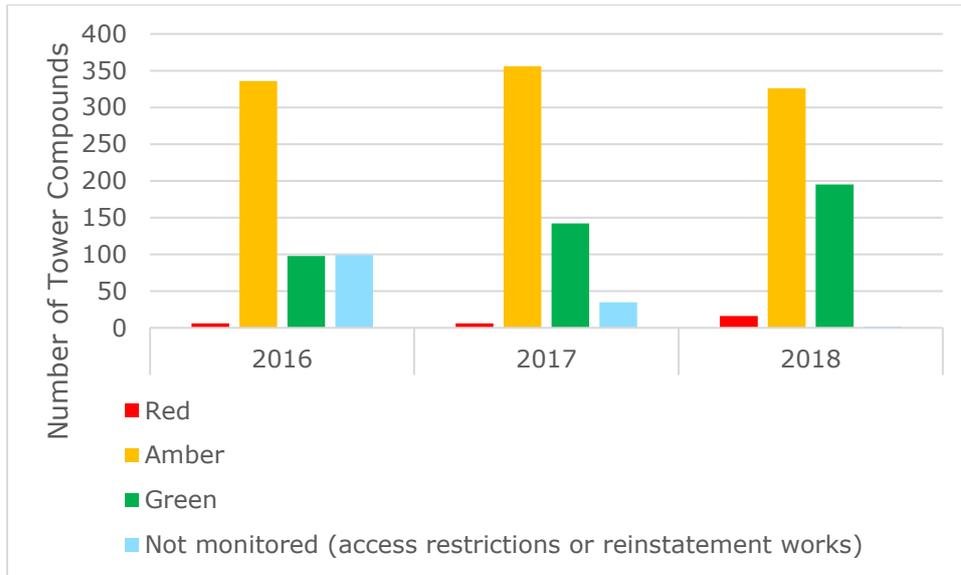
Figure 2. Number of tower compounds classed as red, amber and green in 2016, 2017, 2018

16 compounds were flagged red, meaning that vegetative cover is sparse and has not discernibly increased since the 2017 monitoring. The likely reasons for the lack of restoration at these locations are discussed in section 6 and details for all locations are provided in Appendix 3.

Works at Melgarve Substation required works to be undertaken at 4 towers with an additional tower added. Two towers were completely soil stripped for the works and reinstated with bare soil. This accounts for the increase in compound flagged red in the 2018 results.

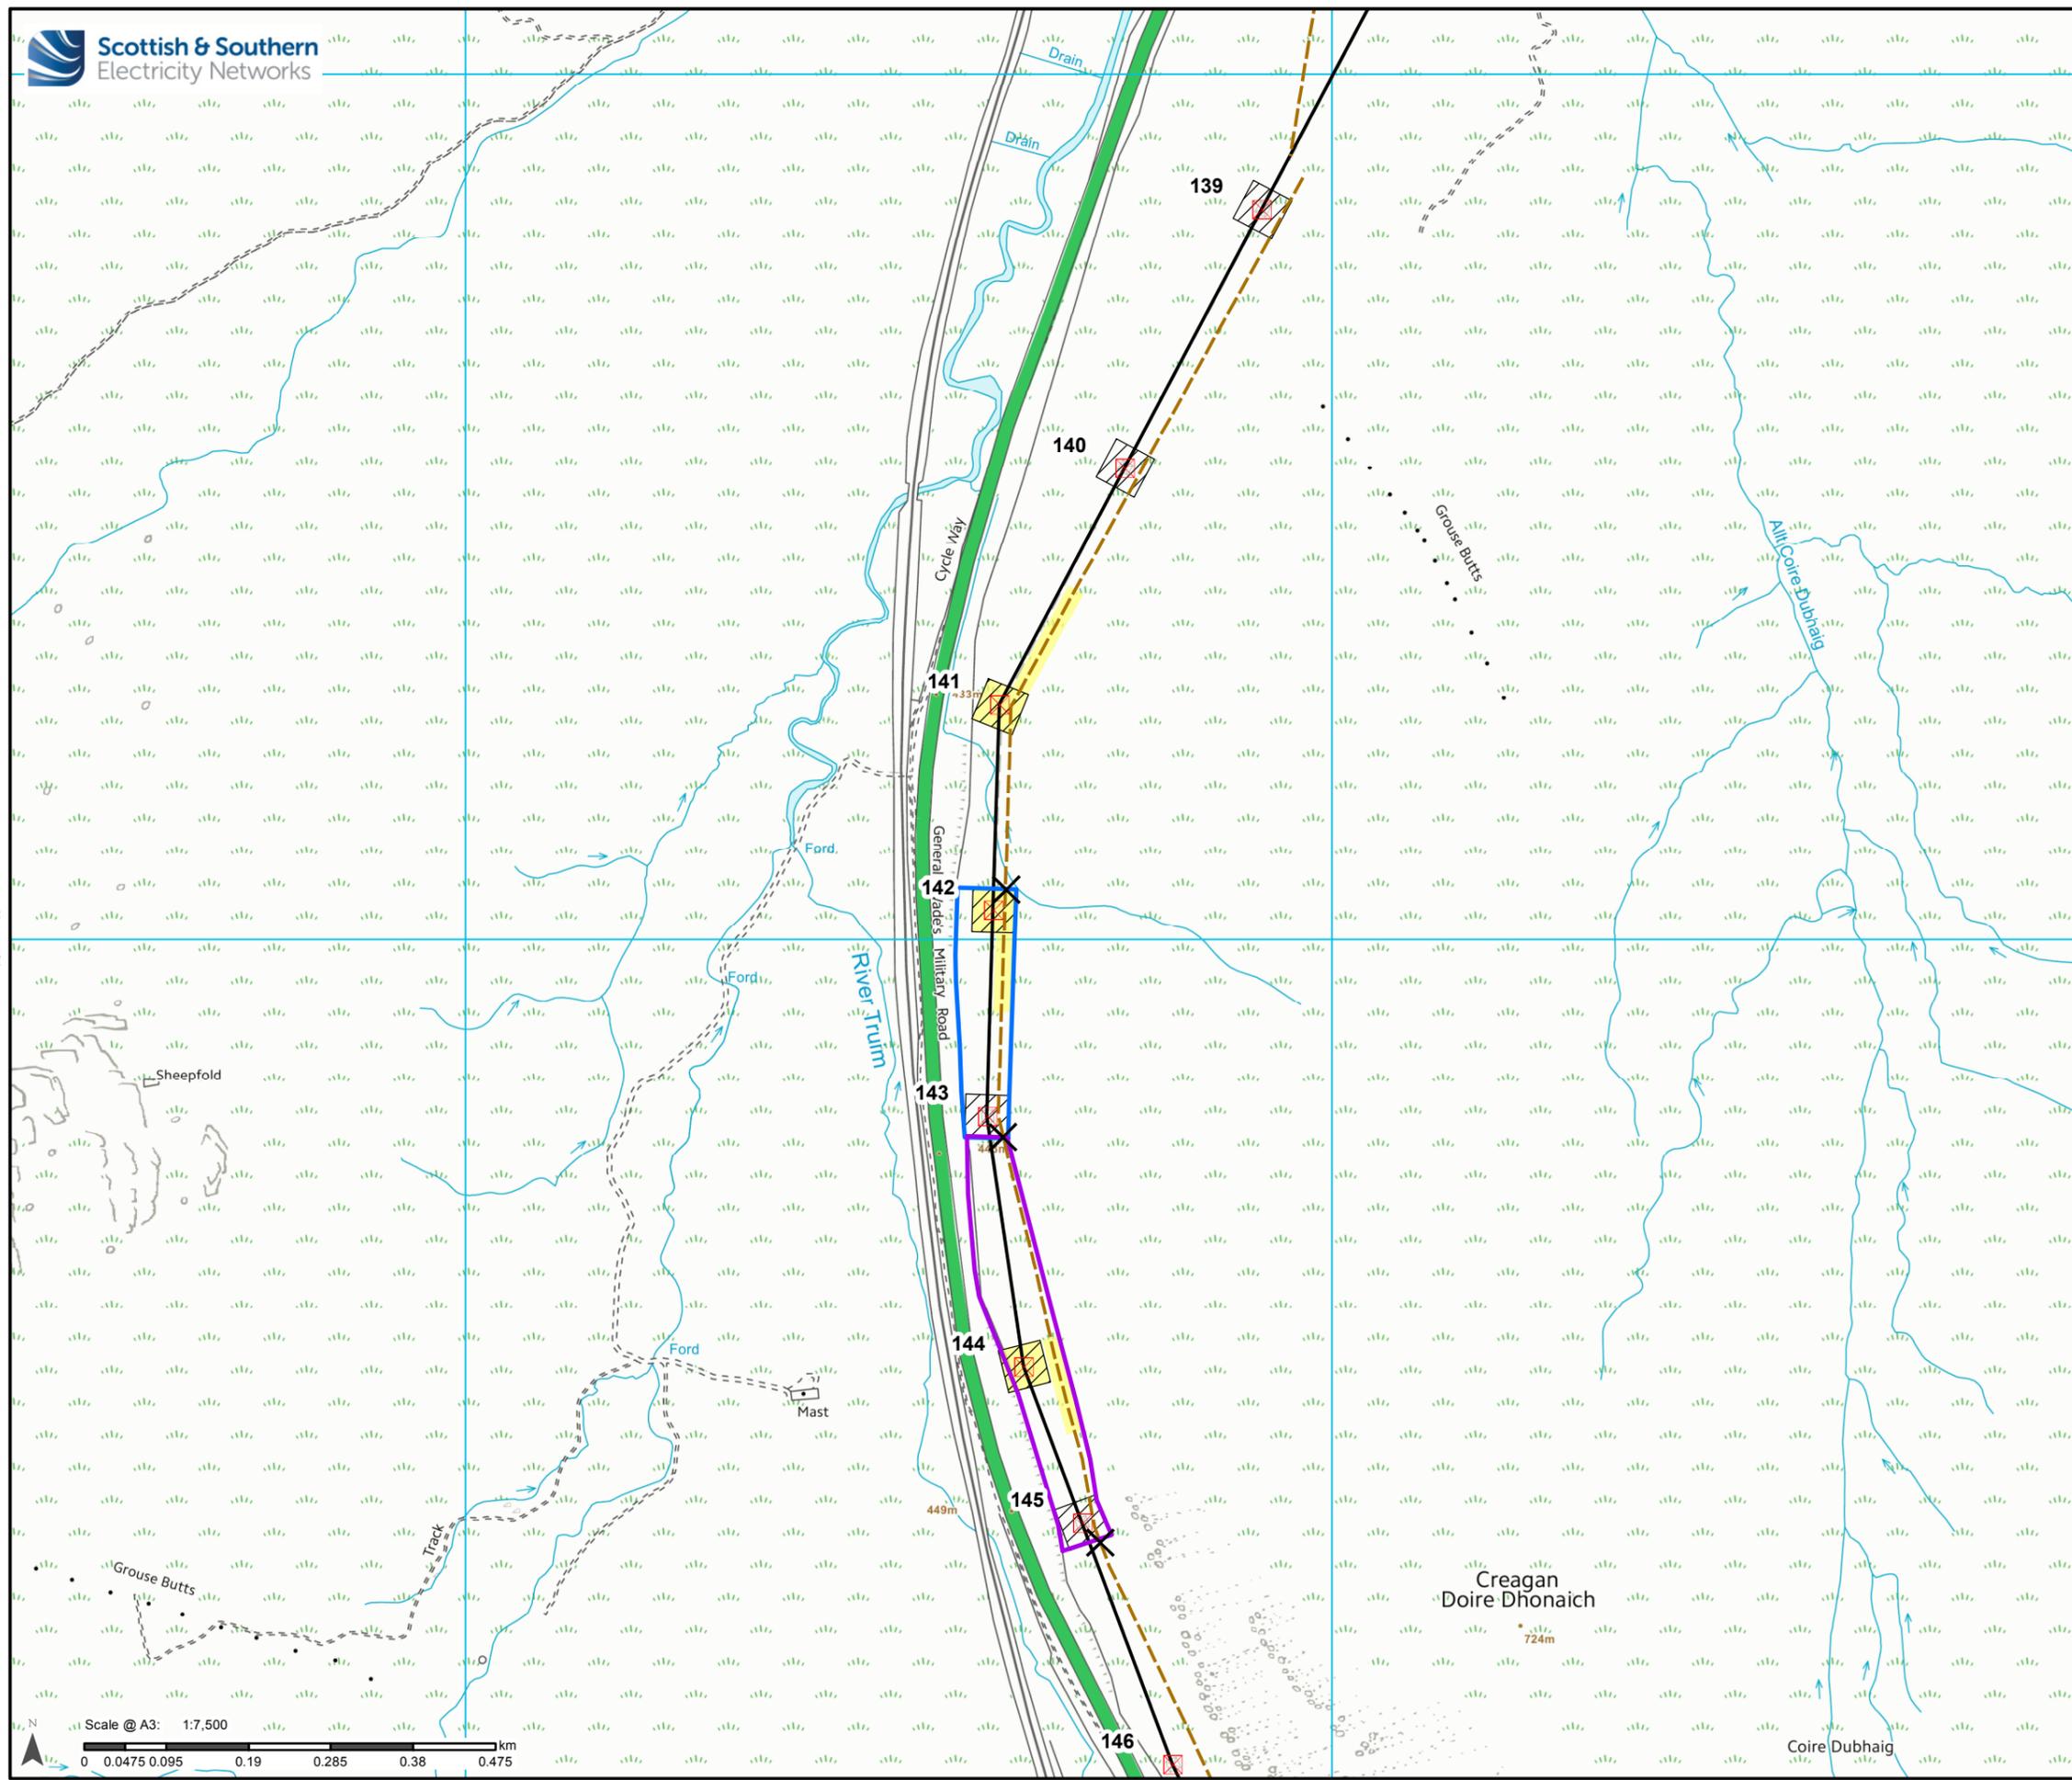
Title:  
CNPA - Restoration of Temporary Tracks

Compound FT141 (GY1 138) was seeded with a highland seed mix and FT140 (GY1 137) was left unseeded as a comparison. No fencing was erected around the tower bases. Compounds FT142 (GY1 139) and FT143 (GY1 140) and the reinstated access track between them were enclosed within a deer fence in spring 2018, to prevent grazing by both sheep and deer. Compounds FT144 (GY1 141) and FT145 (GY1 142) were enclosed within a stock fence in spring 2018, to exclude sheep but not exclude deer. This area included the access track between FT143 AND FT143. Compound Due to the timing of initiating these trials, the effectiveness of these interventions will be assessed as part of the year 4 restoration monitoring in 2019.

- Trial sites: a site visit in May 2019 to ensure gates to enclosed areas are closed and to assess any early impact of this intervention. At present it is recommended at these locations not to intervene and to monitor progress, as accessing these sites may set back this initial natural regeneration.
