# Upper Spey Embankment Condition Assessment

Final Report

Cairngorms National Park Authority

cbec eco-engineering UK Ltd

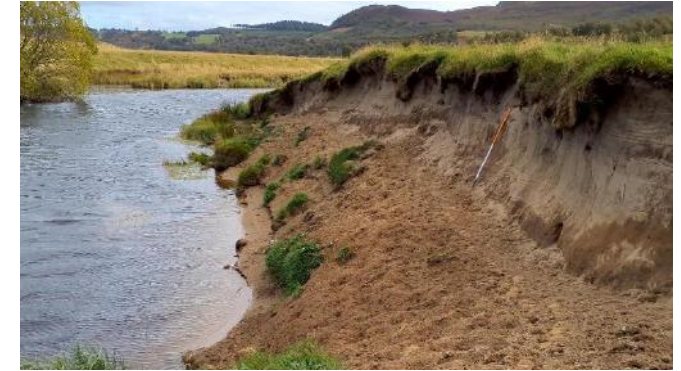
Figure 3.3. High-severity riverbank erosion.

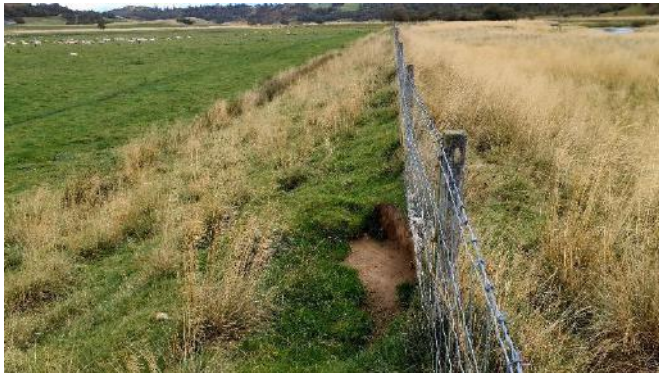
Figure 3.4 Low risk of embankment breach. Slumping of the embankment crest appears to have been caused by livestock trampling. The embankment is set back from the riverbank and signs of slumping observed are localised.

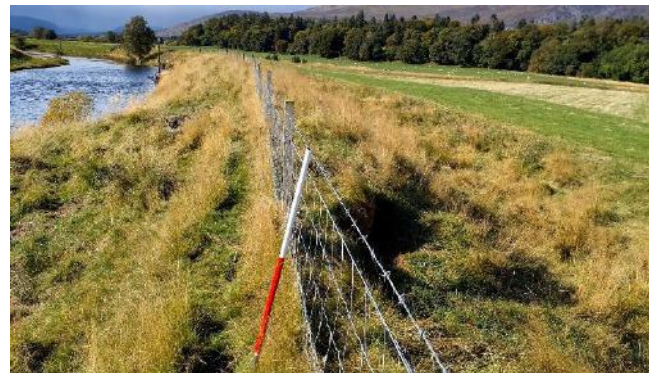
Figure 3.5 Moderate risk of embankment breach. Situated within 5 m of the riverbank, with slumping and bare ground exposed on the dry side of the embankment.

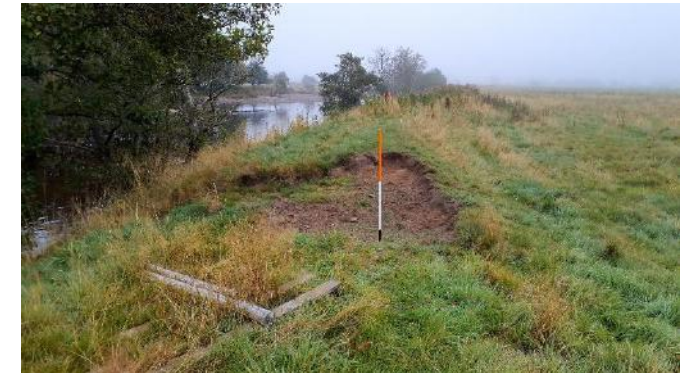
Figure 3.6 High risk of embankment breach. Embankment positioned along the top of the riverbank. Bare ground and slumping evident across over half of the embankment crest width.

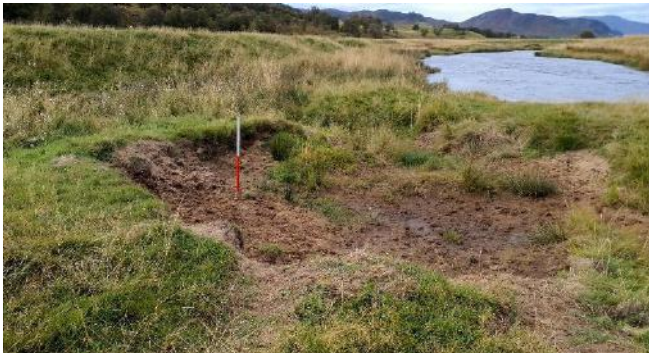
**Figure 3.7. Livestock trampling across the riverbank, leading to soil erosion and loss of surface vegetation.**

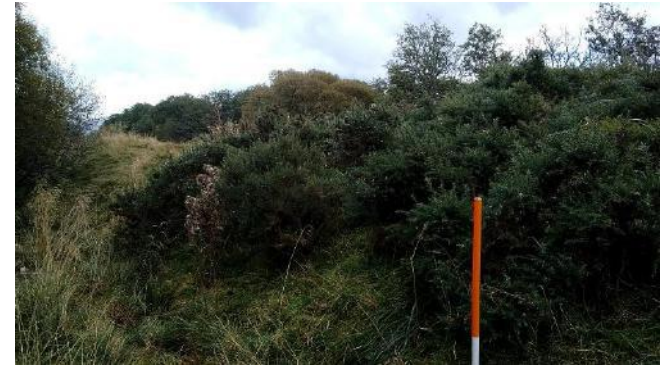
**Figure 3.9. Scrub growth on the crest and face of an embankment.**

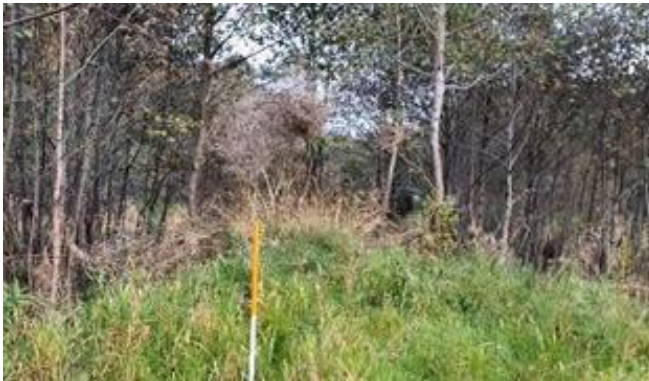
**Figure 3.10 Young tree growth and regeneration across the crest and face of an embankment.**

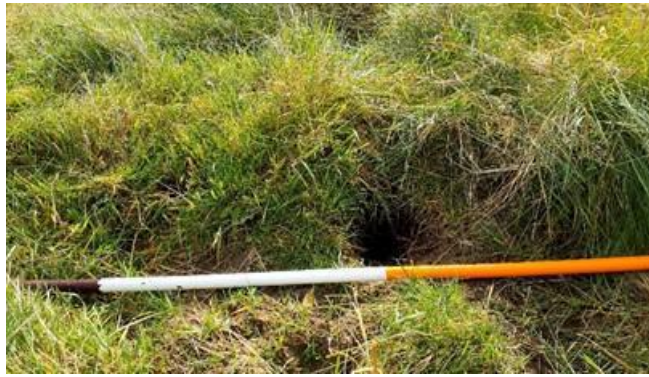
**Figure 3.11 Burrow within the crest of an embankment. Mole hills and burrows were occasionally noted in Areas 1 and 2, but their position and density were insufficient to cause concern at the time of survey.**

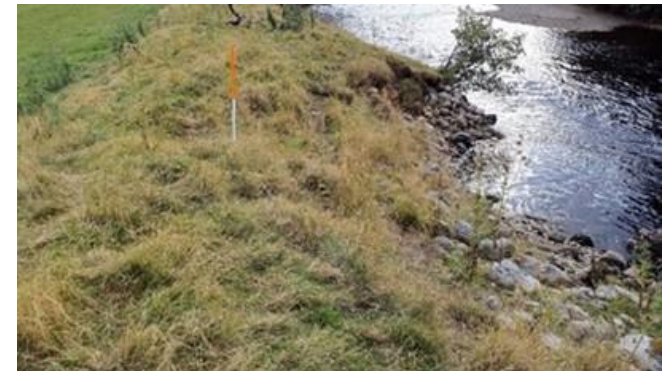
**Figure 3.12 Riverbank erosion undermining an embankment positioned at the top of the bank. High risk of embankment breach.**

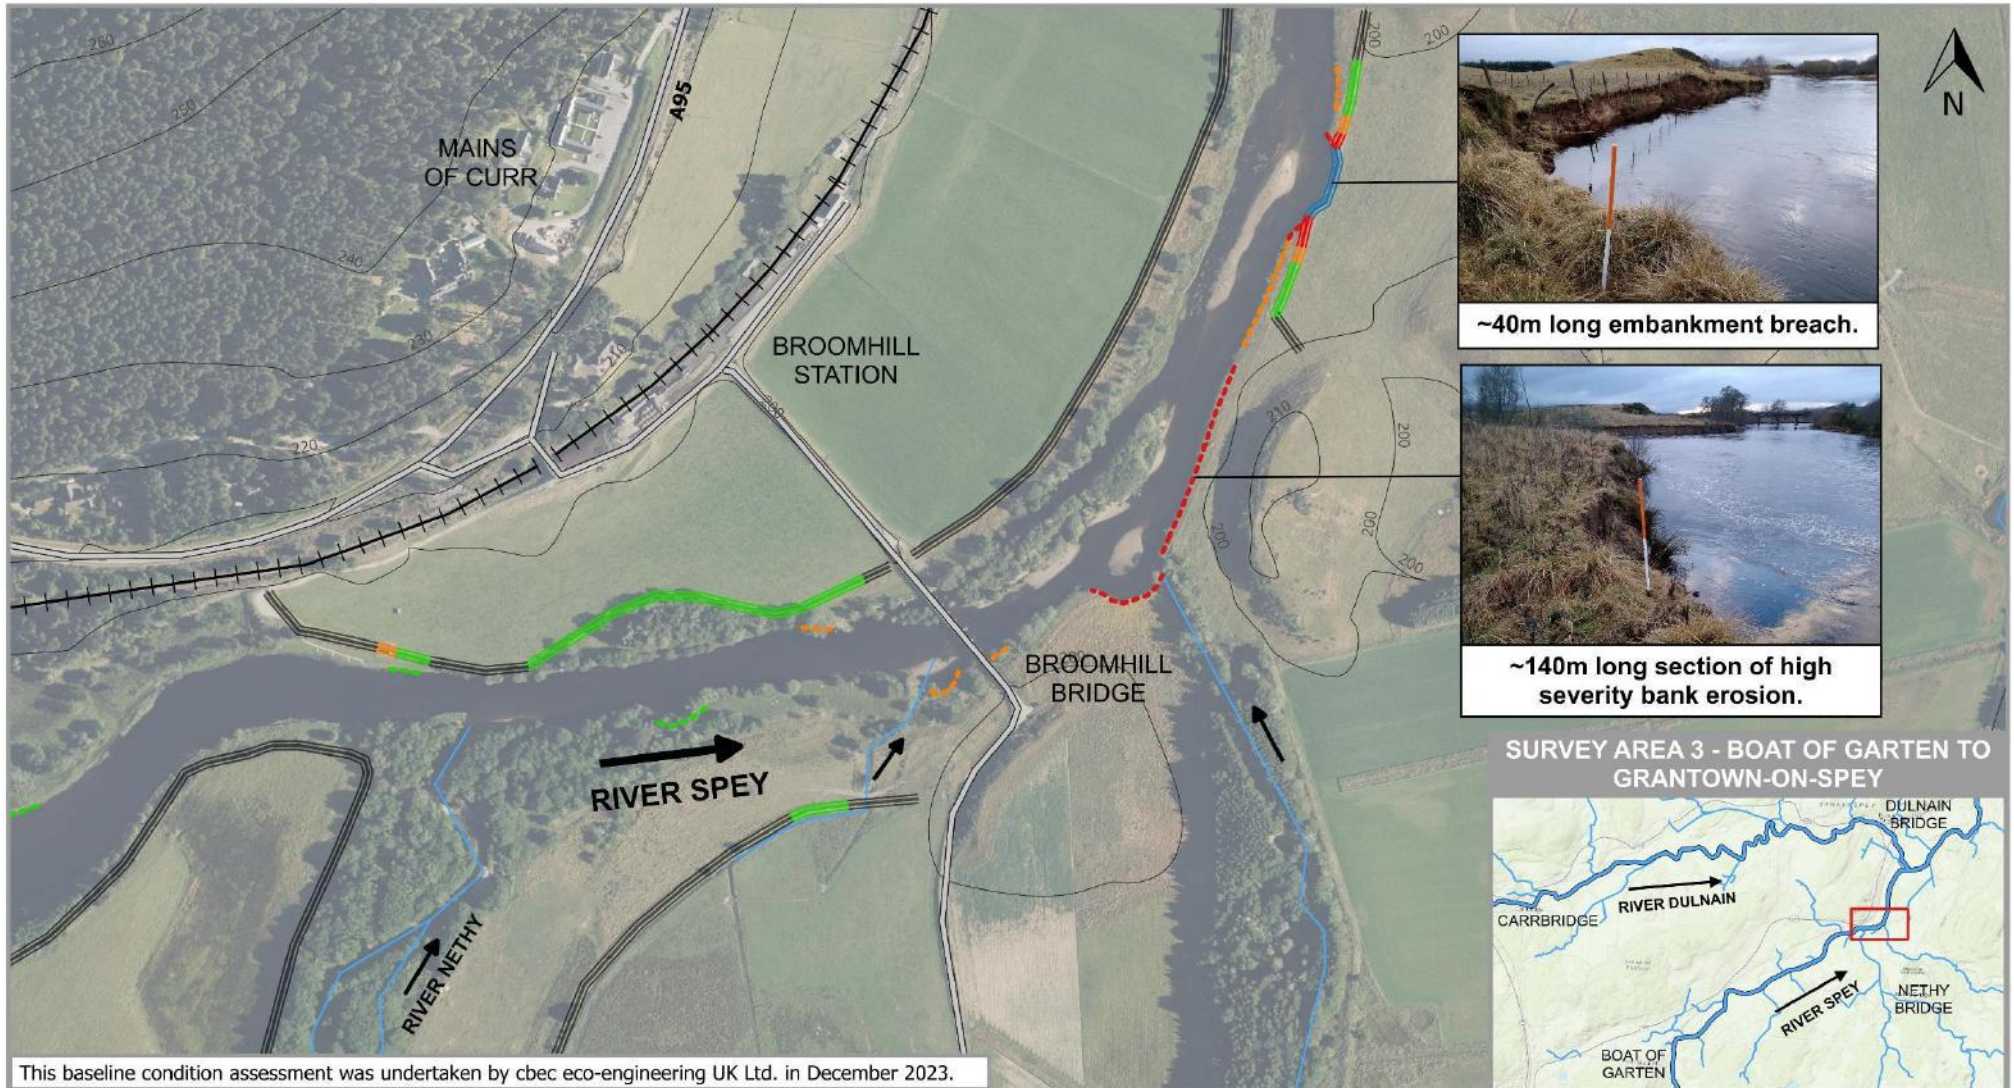
~40m long embankment breach.

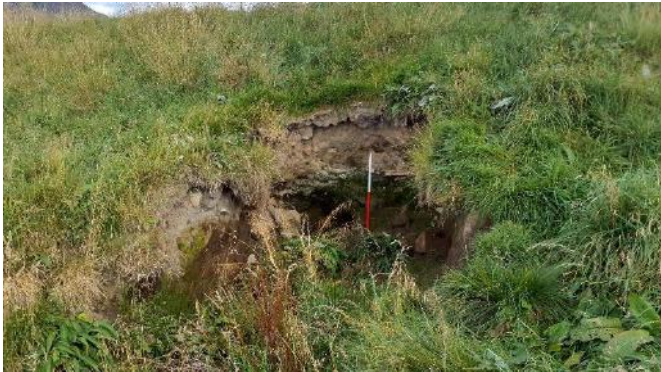
**Figure 3.63 Culvert through the embankment with erosion around the inlet at Drumgask Farm (OS NGR NN 61927 94037).**

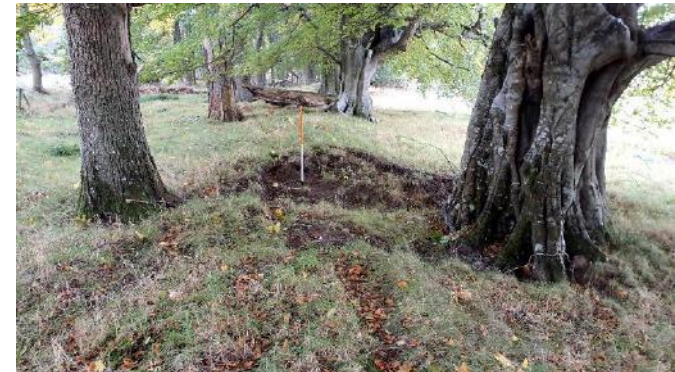
**Figure 3.65 Example of mature trees growing on the embankment and erosion caused by sheltering livestock.**
