# Upper Spey Embankment Condition Assessment

Final Report

Cairngorms National Park Authority

cbec eco-engineering UK Ltd

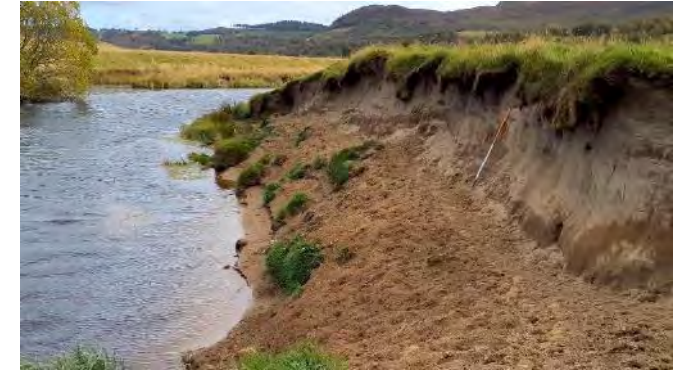
Figure 3.3. High-severity riverbank erosion.

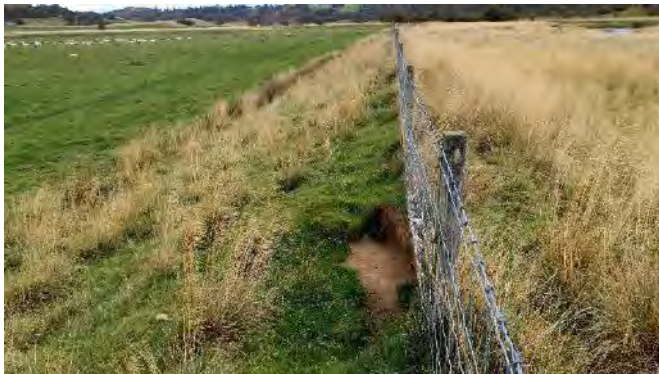
Figure 3.4 Low risk of embankment breach. Slumping of the embankment crest appears to have been caused by livestock trampling. The embankment is set back from the riverbank and signs of slumping observed are localised.

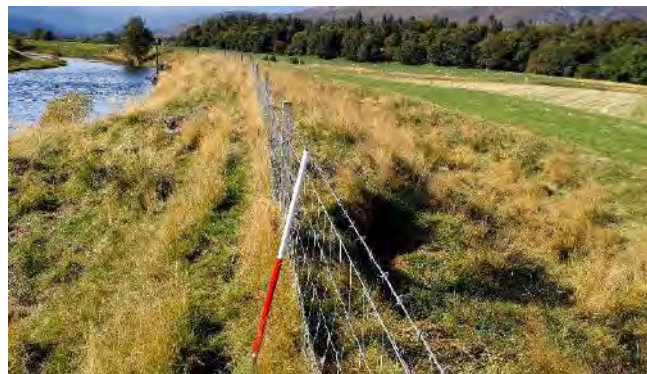
Figure 3.5 Moderate risk of embankment breach. Situated within 5 m of the riverbank, with slumping and bare ground exposed on the dry side of the embankment.

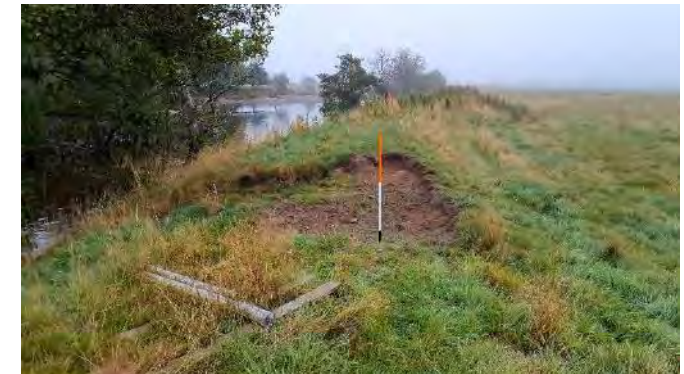
Figure 3.6 High risk of embankment breach. Embankment positioned along the top of the riverbank. Bare ground and slumping evident across over half of the embankment crest width.

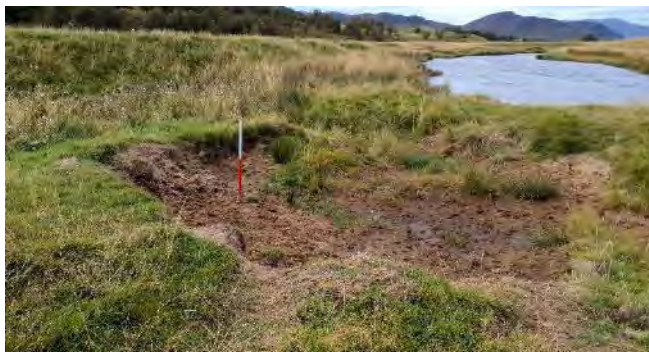
**Figure 3.7.** Livestock trampling across the riverbank, leading to soil erosion and loss of surface vegetation.

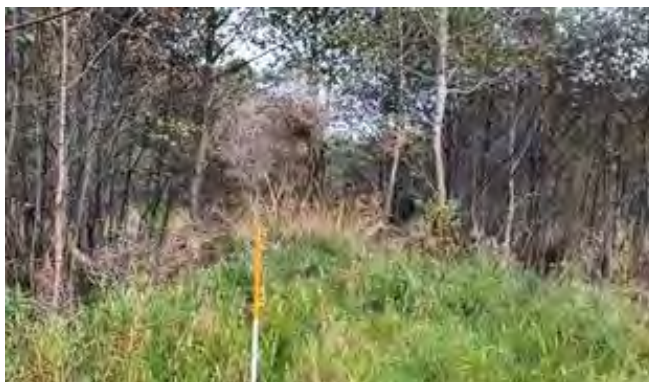
**Figure 3.10** Young tree growth and regeneration across the crest and face of an embankment.

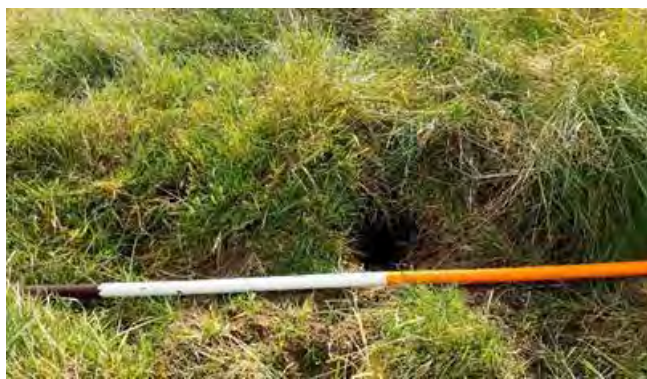
**Figure 3.11** Burrow within the crest of an embankment. Mole hills and burrows were occasionally noted in Areas 1 and 2, but their position and density were insufficient to cause concern at the time of survey.

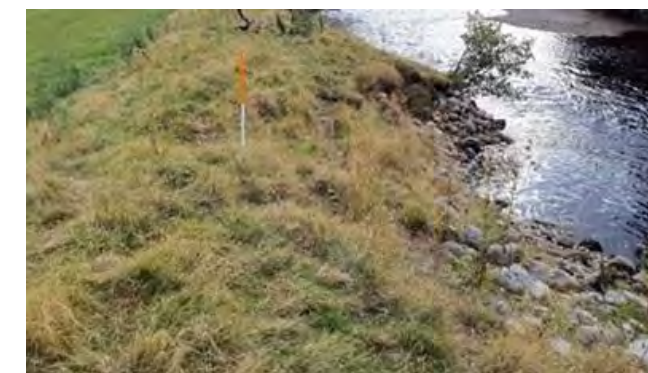
**Figure 3.12** Riverbank erosion undermining an embankment positioned at the top of the bank. High risk of embankment breach.

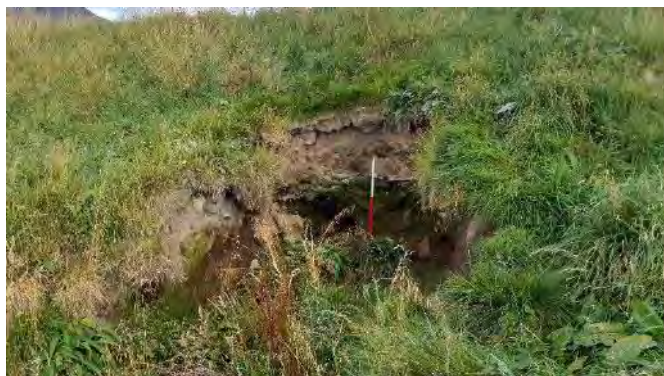
Figure 3.63 Culvert through the embankment with erosion around the inlet at Drumgask Farm (OS NGR NN 61927 94037).

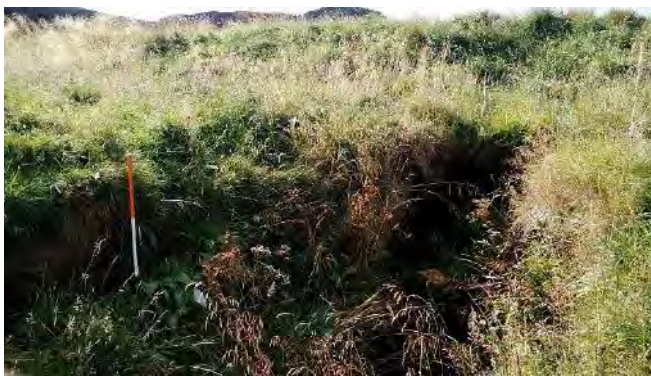
Figure 3.64 Culvert with erosion around the outlet at Drumgask Farm (OS NGR NN 61927 94037).

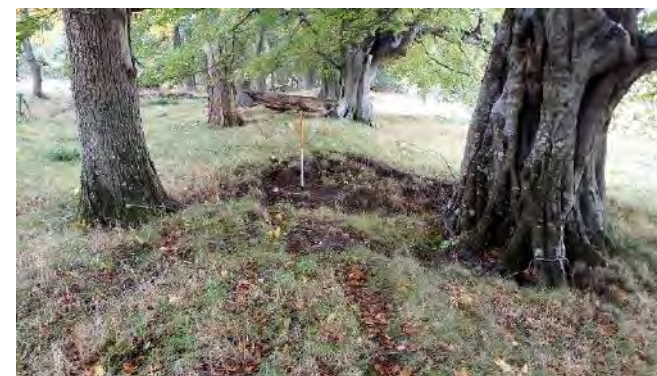
Figure 3.65 Example of mature trees growing on the embankment and erosion caused by sheltering livestock.
