AGENDA ITEM 8

2021/0262/DET

Glen Clova Estate

The Saddles
 Location Plan & Site
 Ownership
 (1:1250)

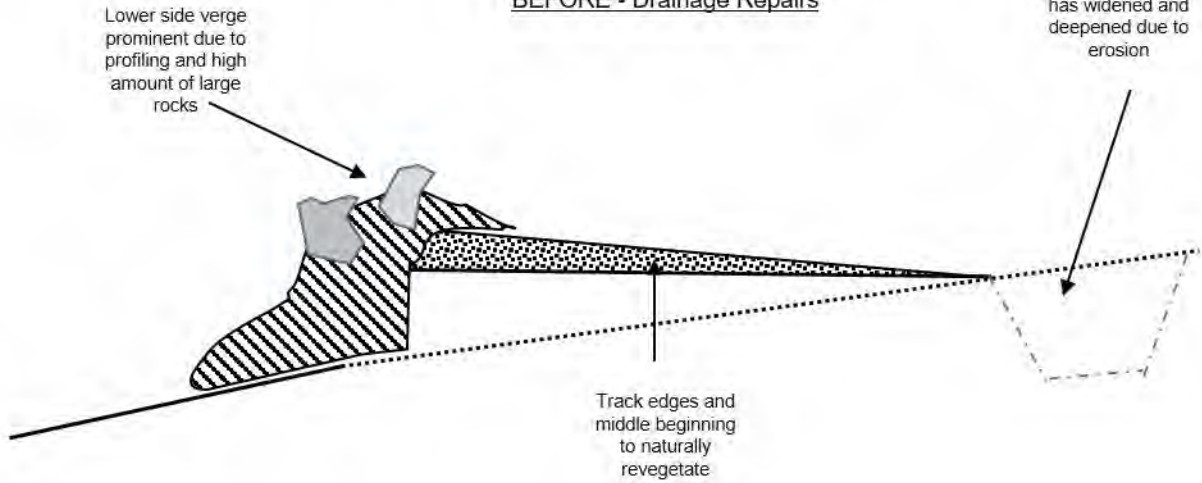
Forestry Track Construction –
BEFORE - Drainage Repairs

Track drainage has insufficient culverting causing scouring.

Mitigation - Insert additional, 300-450mm culverts to divert track water. Use excess spoil to reprofile the drains, insert blocks to assist with culverting. Seed batters and profile where necessary
