Upper Spey Embankment Condition Assessment

Final Report Cairngorms National Park Authority cbec eco-engineering UK Ltd January 2025

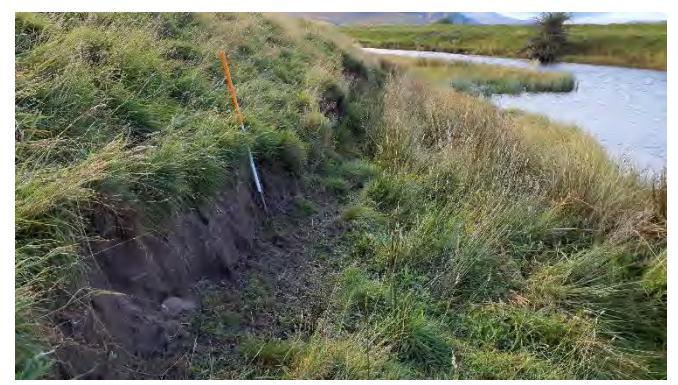
Figure 3.2 Moderate-severity riverbank erosion.

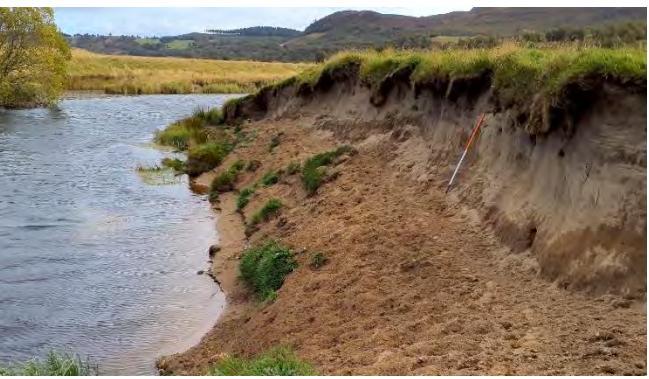
Figure 3.3. High-severity riverbank erosion.

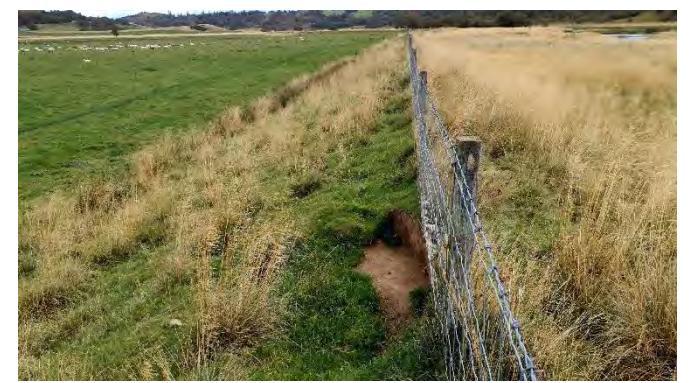
Figure 3.4 Low risk of embankment breach. Slumping of the embankment crest appears to have been caused by livestock trampling. The embankment is set back from the riverbank and signs of slumping observed are localised.

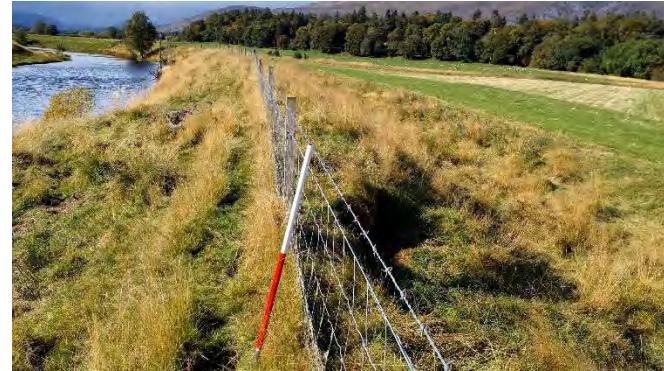
Figure 3.5 Moderate risk of embankment breach. Situated within 5 m of the riverbank, with slumping and bare ground exposed on the dry side of the embankment.

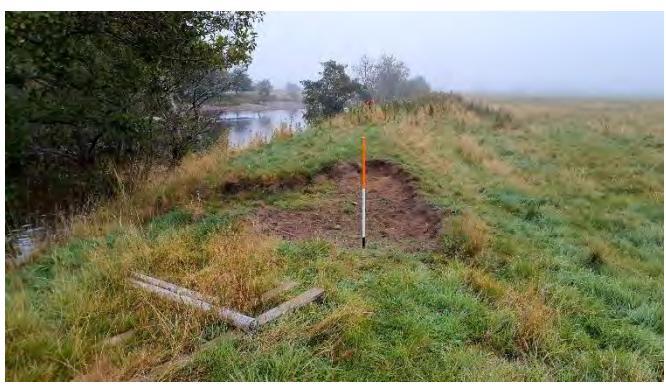
Figure 3.6 High risk of embankment breach. Embankment positioned along the top of the riverbank. Bare ground and slumping evident across over half of the embankment crest width.

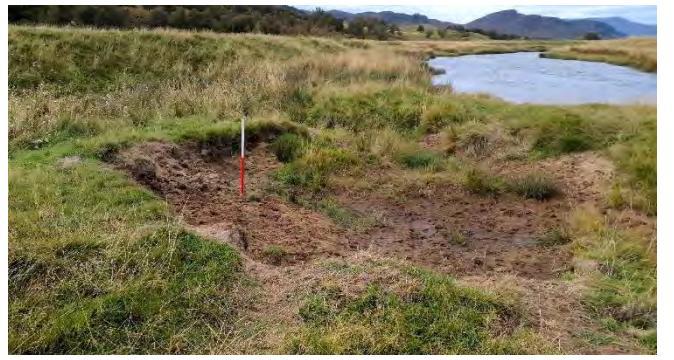
Figure 3.7. Livestock trampling across the riverbank, leading to soil erosion and loss of surface vegetation.

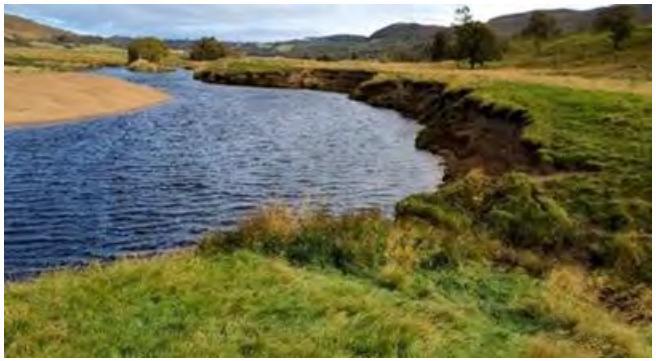
Figure 3.8 Bank erosion on the outer bank of a meander is a natural process in meandering channels. Native riparian planting and set-back fencing could promote increased stability in such areas over time.

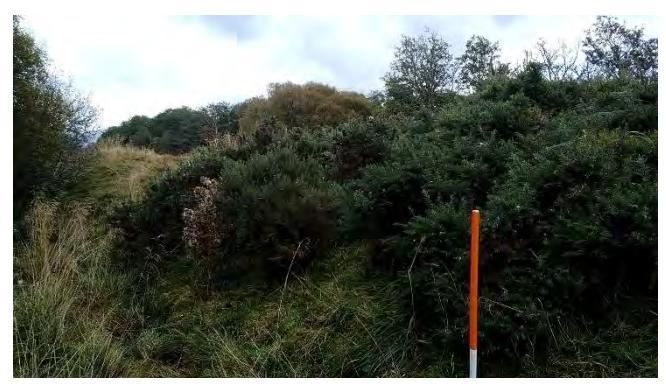
Figure 3.9. Scrub growth on the crest and face of an embankment.

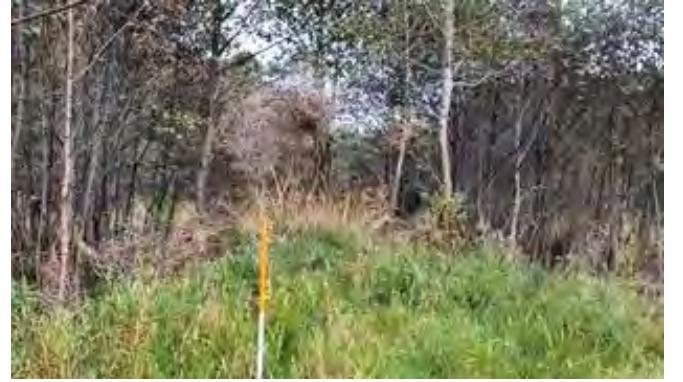
Figure 3.10 Young tree growth and regeneration across the crest and face of an embankment.

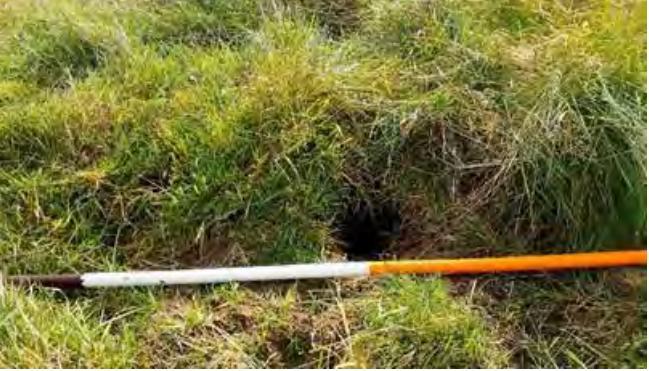
Figure 3.11 Burrow within the crest of an embankment. Mole hills and burrows were occasionally noted in Areas 1 and 2, but their position and density were insufficient to cause concern at the time of survey.

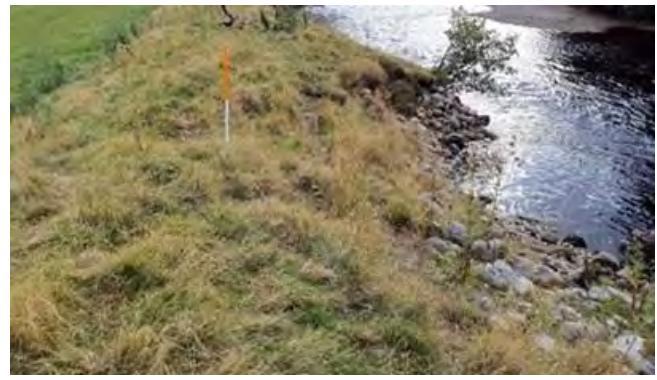
Figure 3.12 Riverbank erosion undermining an embankment positioned at the top of the bank. High risk of embankment breach.
