HYDROLOGY AND HYDROGEOLOGY PEAT ASSESSMENT

Dalwhinnie Quarry, Dalwhinnie
Hydrology, hydrogeology and peat
assessments

MNV Consulting Ltd

Client:	Leiths (Scotland) Ltd	
Contract Start Date:	December 2017	
Report Reference:	MNV/LSL001/2238	
Contributors:	Dr Richard Johnson Marcus Sturrock Fraser Cassels	
Checked by:	Rita Day	
Document revisions:		
Status:	Version:	Date:
Final	v1	13/02/2018

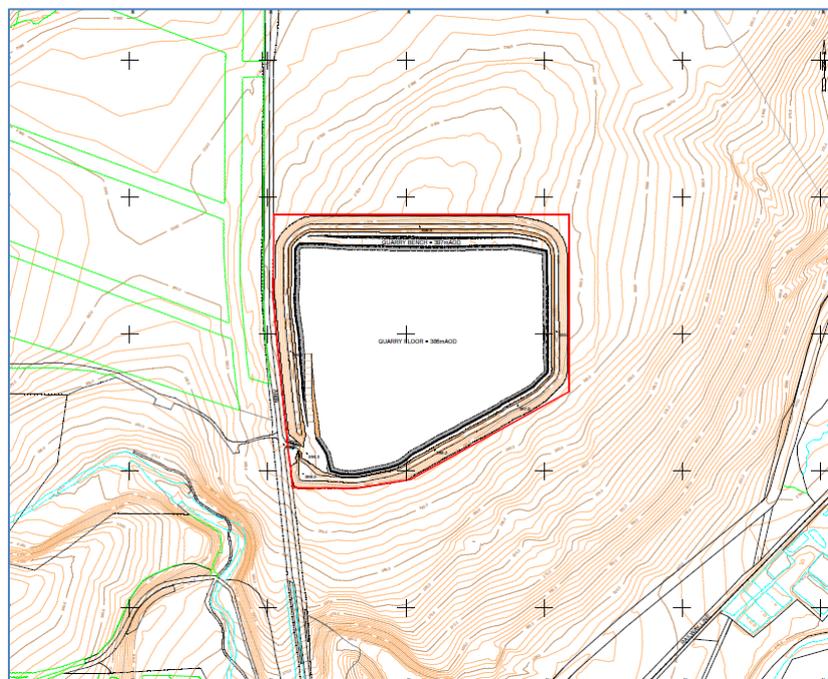
Figure 2 Proposed development site

The current proposal is to extend the existing quarry in a northerly and easterly direction (Figure 2) with the total development area being 15.1ha and the average annual extraction rate will be 70,000 tonnes/year. Extraction will be undertaken on a phased basis with overburden and soils stored around the perimeter of the site and all crushing, processing, stockpiling and loading of HGVs will take place on the quarry floor. Restoration will be undertaken by re-grading the quarry floor and by using the material stored around the periphery of the site creating shallow slopes into the water body and providing a variety of habitats within the site.

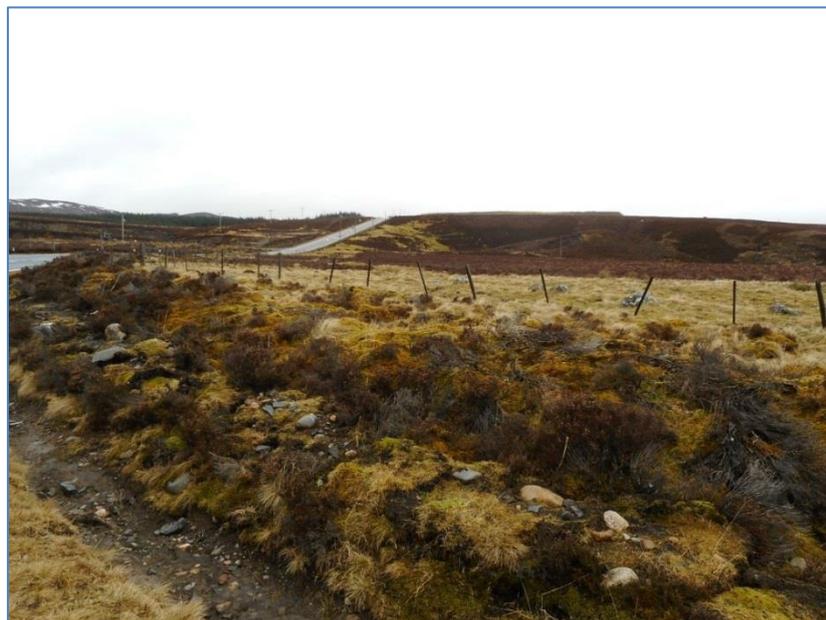
Figure 4 General view of the area from the A889, south of the quarry

The site is situated on a low dome shaped feature between two rivers (Figure 4). The River Truim, 680m to the east has developed a glacial valley into a relatively wide feature with a floodplain formed from alluvial deposits with steeper side slopes supporting extensive glacial deposition material. The Allt an t-Sluic, 230m to the west, flows off the hills to the west to join the River Truim just north of Dalwhinnie. This is a typical mountain river with a large volume of coarse sediments transported downstream by the energetic river flows.

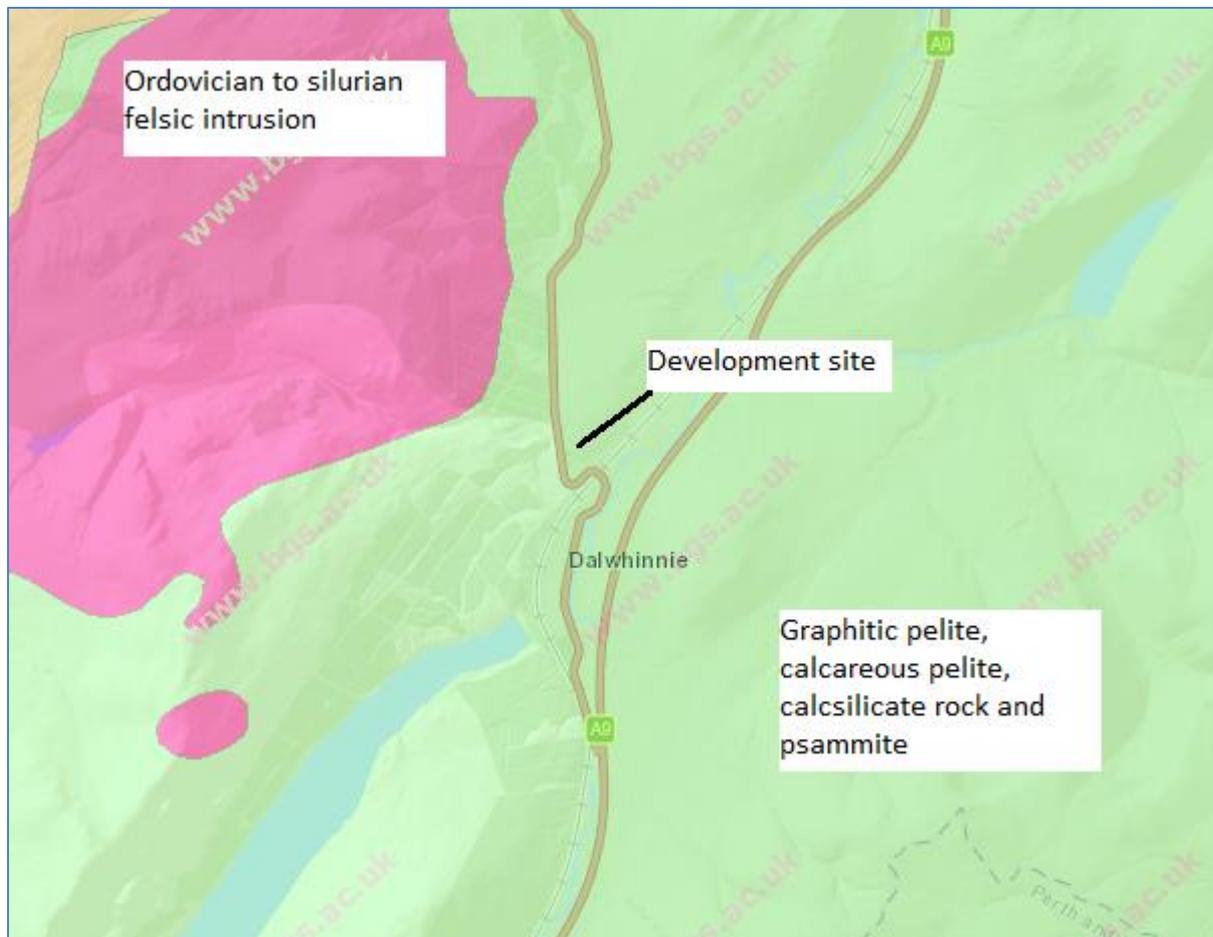
Figure 5 Solid geology of the area

The structural geology of the area is part of the Gaick Psammite formation within a regional structure which includes several major Felsic intrusions and fault lines to the north of the site (Figure 5). Psammite is a medium textured, metamorphosed sedimentary rock with a dominantly sandstone protolith.

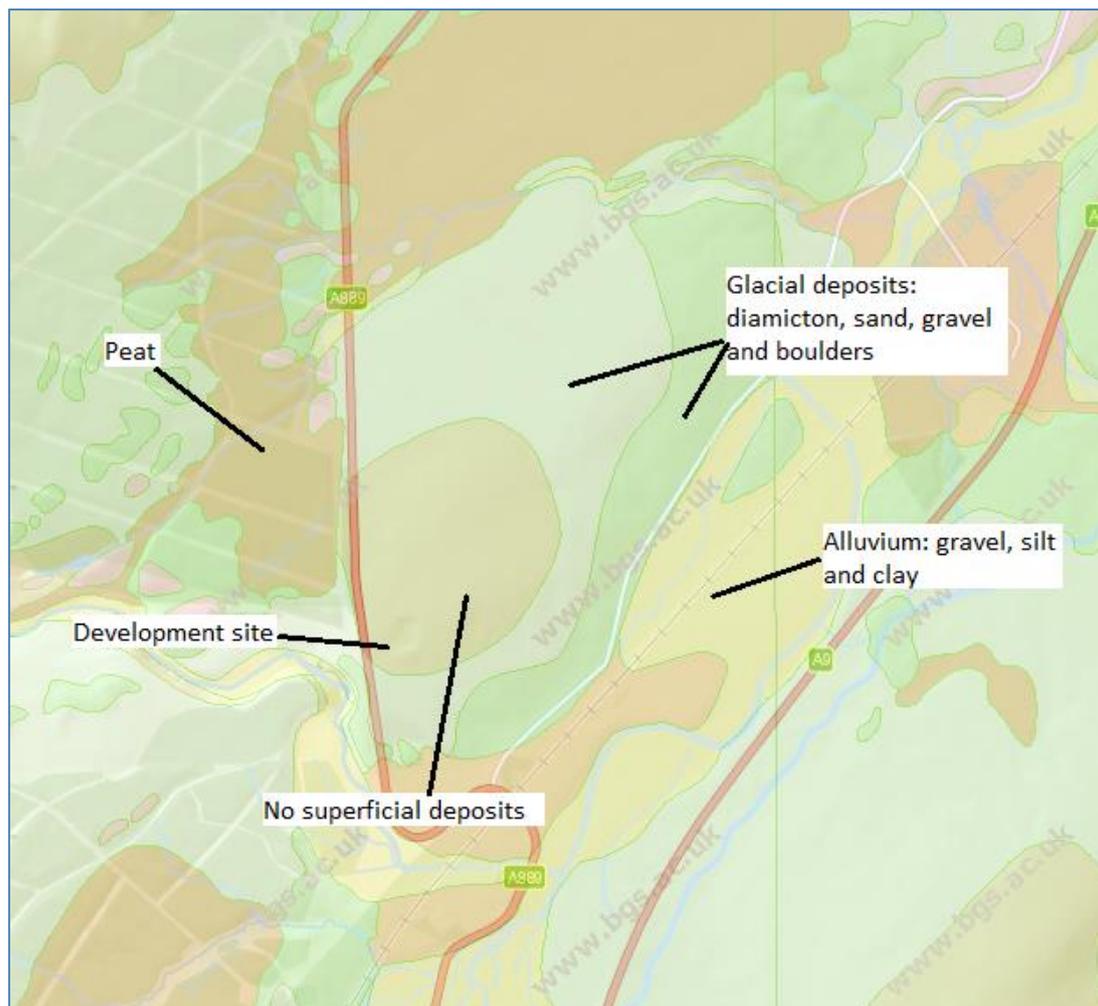
Figure 6 Superficial deposits in the area

The superficial deposits in the area include extensive glacial and alluvial deposits although over the dome feature there are only Talus rock fragments (Figure 6). The alluvial deposits are mainly in the valley of the River Truim while the glacial deposits are on the lower valley slopes extending up to an altitude of approximately 400mAOD. Peat deposits exist to the west of the site but do not extend to the east of the A889 (Figure 6).

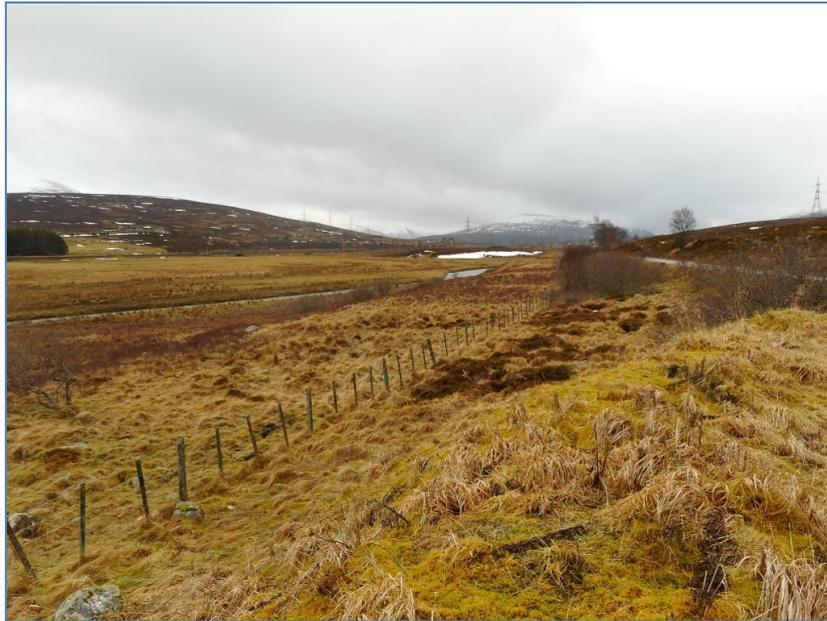
Figure 7 River Truim adjacent to the site

The two largest surface water features in the area are the River Truim (Figure 7), flowing north past Dalwhinnie to join the River Spey at Invertruim, and the Allt an t-Sluic (Figure 8) a smaller river flowing east to join the Truim just north of Dalwhinnie. A smaller watercourse, Allt an t-Slugain, is located to the north of the dome, flowing east into the River Truim.

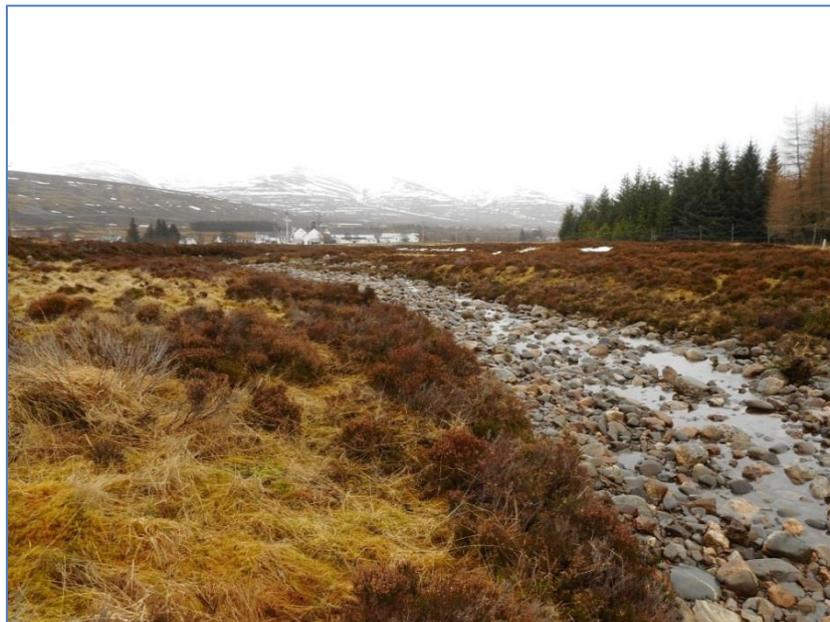
Figure 8 Allt an t-Sluic adjacent to the site

The Allt an t-Sluic, to the west of the site has two concrete intake structures built in the channel (Figures 10 and 11), the upstream one is the intake structure for the Dalwhinnie Distillery while the downstream structure is the intake for an SSE hydropower scheme. Between them the intakes abstract all of the river water so downstream of the SSE intake the river channel is virtually dry (Figure 8).

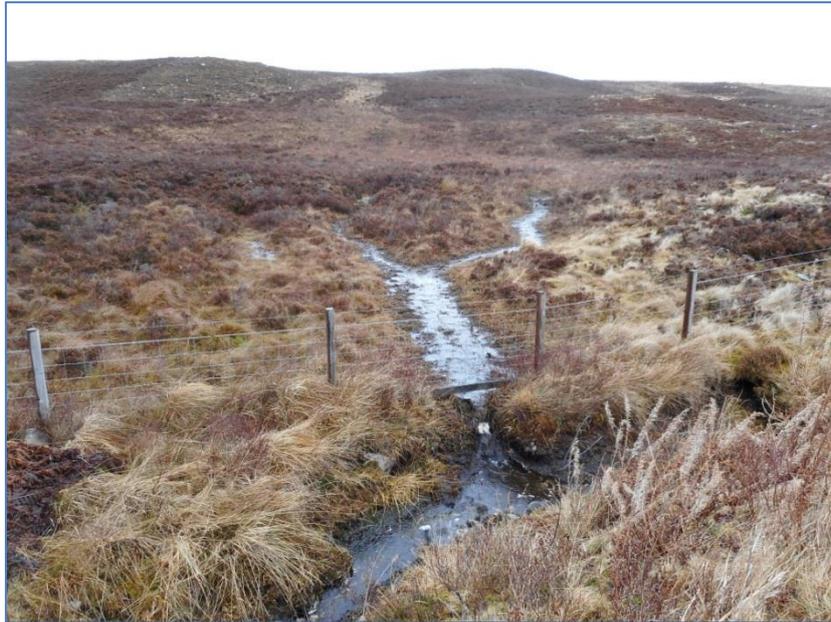
Figure 9 Springs emerging from the base of the dome to the east of the site

Over the dome there are no surface water features although around the base of the dome, to the south and east of the site, there are a number of springs with the water flowing through culverts under the public roads and into the surrounding rivers (Figure 9).

The ground immediately beyond the development site is very similar with no surface watercourses but small areas of standing water. To the north of the site, some 1000m away, there is a small burn (Allt an t-Slugain) which drains the ground to the west of the public road with the water flowing slowly around the north side of the dome feature and discharging into the River Truim. To the south and east of the site there are several springs emerging from the base of the dome immediately above the public road. These springs form small burns which are culverted under the roads. It appears that the spring line is associated with the water which originally fell as precipitation onto the dome, seeping into the soils and fractured rock layer and gradually down the dome to emerge at its base as a series of springs some 430m distance from the site.

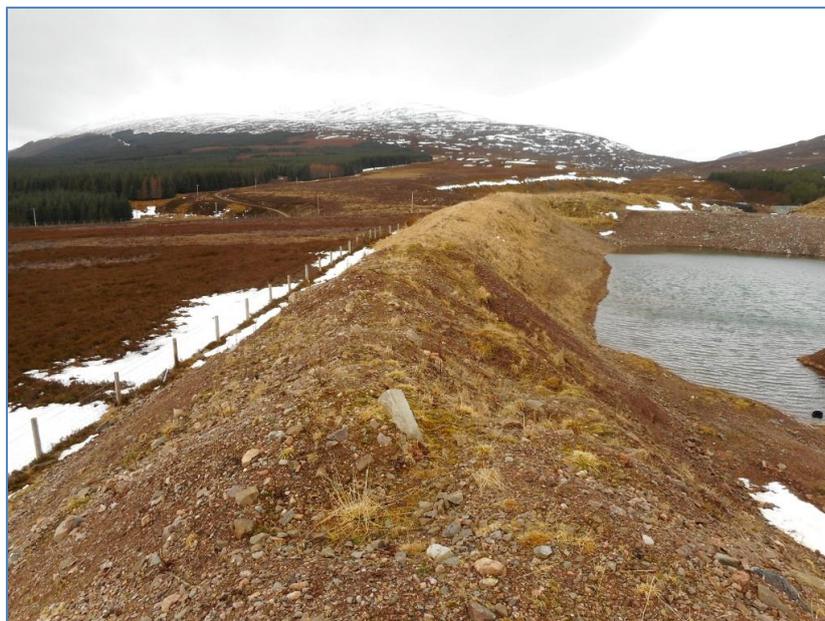
Figure 12 Water in the old quarry

Within the development site the only surface water features present are the accumulation of water in the old quarry (Figure 12) and small areas of standing water and wet soils (Figure 13). The source water in the quarry appears to be primarily precipitation (rain and snow), there is no direct drainage into the quarry but there appears to be slight seepage from the surrounding ground into the quarry. The water level was observed to be at a similar level of the ground beyond the surrounding bund, on the downhill side of the quarry. Data supplied by the operator showed that the water level has been measured at 390.5 to 391.0mAOD with the ground to the south measured at 393.0 to 394.0mAOD confirming that the water level is slightly lower than the adjacent ground.

There is no pump currently on site so it appears that the current outflow from the quarry is from seepage through fractures in the underlying bedrock.

The existing quarry is not operational and without pumping, water accumulates to reach a level slightly below the level of the downhill surface beyond the surrounding bund. This level indicates that the water is draining out of the quarry through the fractured rock horizons. The water in the quarry will rise and fall in response to precipitation but the inflow appears to be balanced by the outflow. When the quarry was operational the water was pumped out to lower the water level. The bund has a low point on the eastern side where the pipes were laid and the water discharged into a trench cut across the slope. There was no sign of overland flow, soil erosion or silt accumulations suggesting that the method for managing water was successful with the vegetation and fractured rock horizon buffering and filtering the discharged water. This therefore appears to be a good method for managing the water in this situation and minimising potential impacts on surrounding environments.

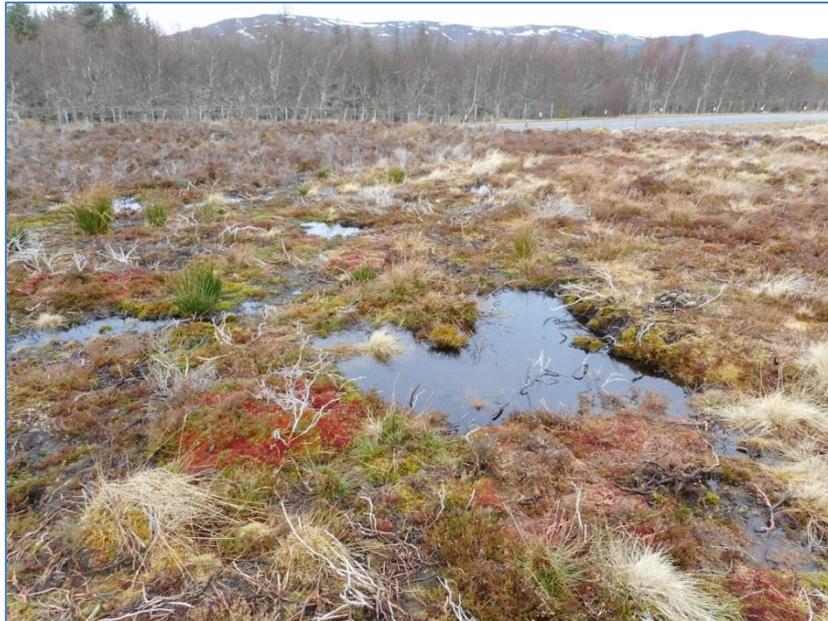
Figure 13 Standing water over the site

The small areas of standing water and wet soils are present over the site and are due to the low infiltration rate of the top soil. The water appears to accumulate in small areas where there are micro hollows. The depths of water are all shallow, less than 20cm.

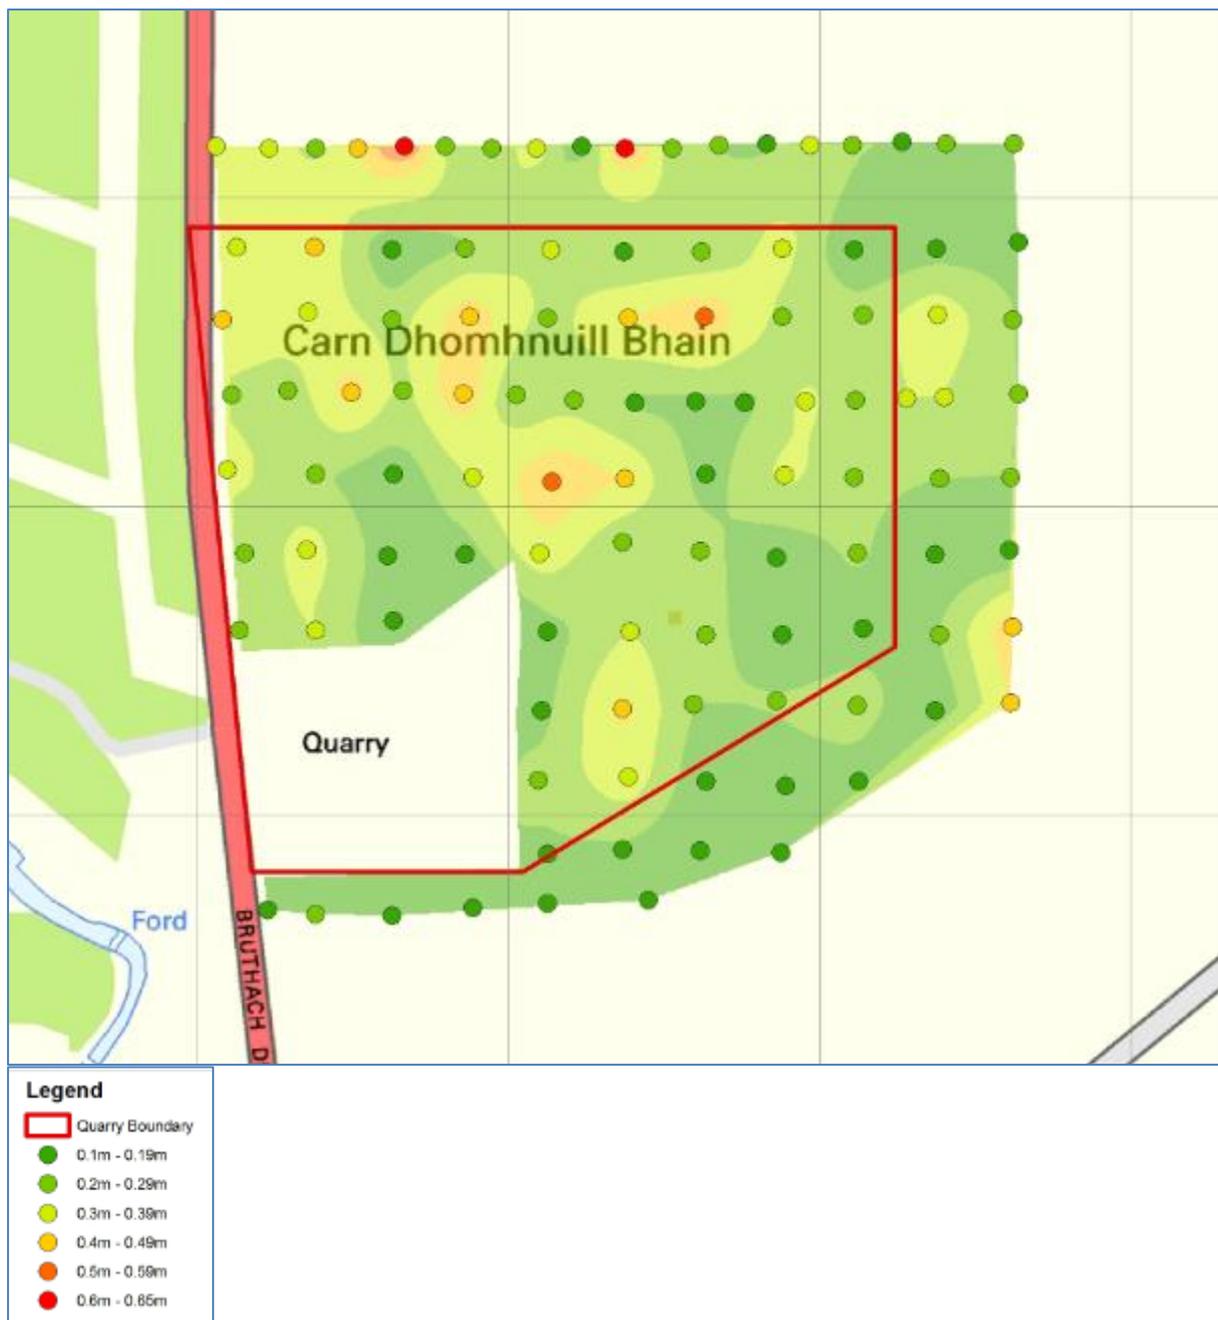
Figure 14 Distribution of peat depths

Peat depth results (Figure 14) show that over most of the site the peat depths are less than 30cm. Only three of the sample sites showed the peat depth was greater than 50cm however these were in isolated sites where small hollows in the surface have filled with water and vegetation matter to form peat.

The potential impacts on any peat deposits are considered to be negligible. The majority of the soils in the development site are shallow with a fibrous structure and little or no decomposition. There are some shallow hollows over the site where water has accumulated and some plant decomposition has occurred, the soils in these hollows could therefore be called peat but the total volume of this material which will be affected by the development is negligible. Therefore due to the lack of peat over the development site, the potential impact on peat is considered to be negligible.

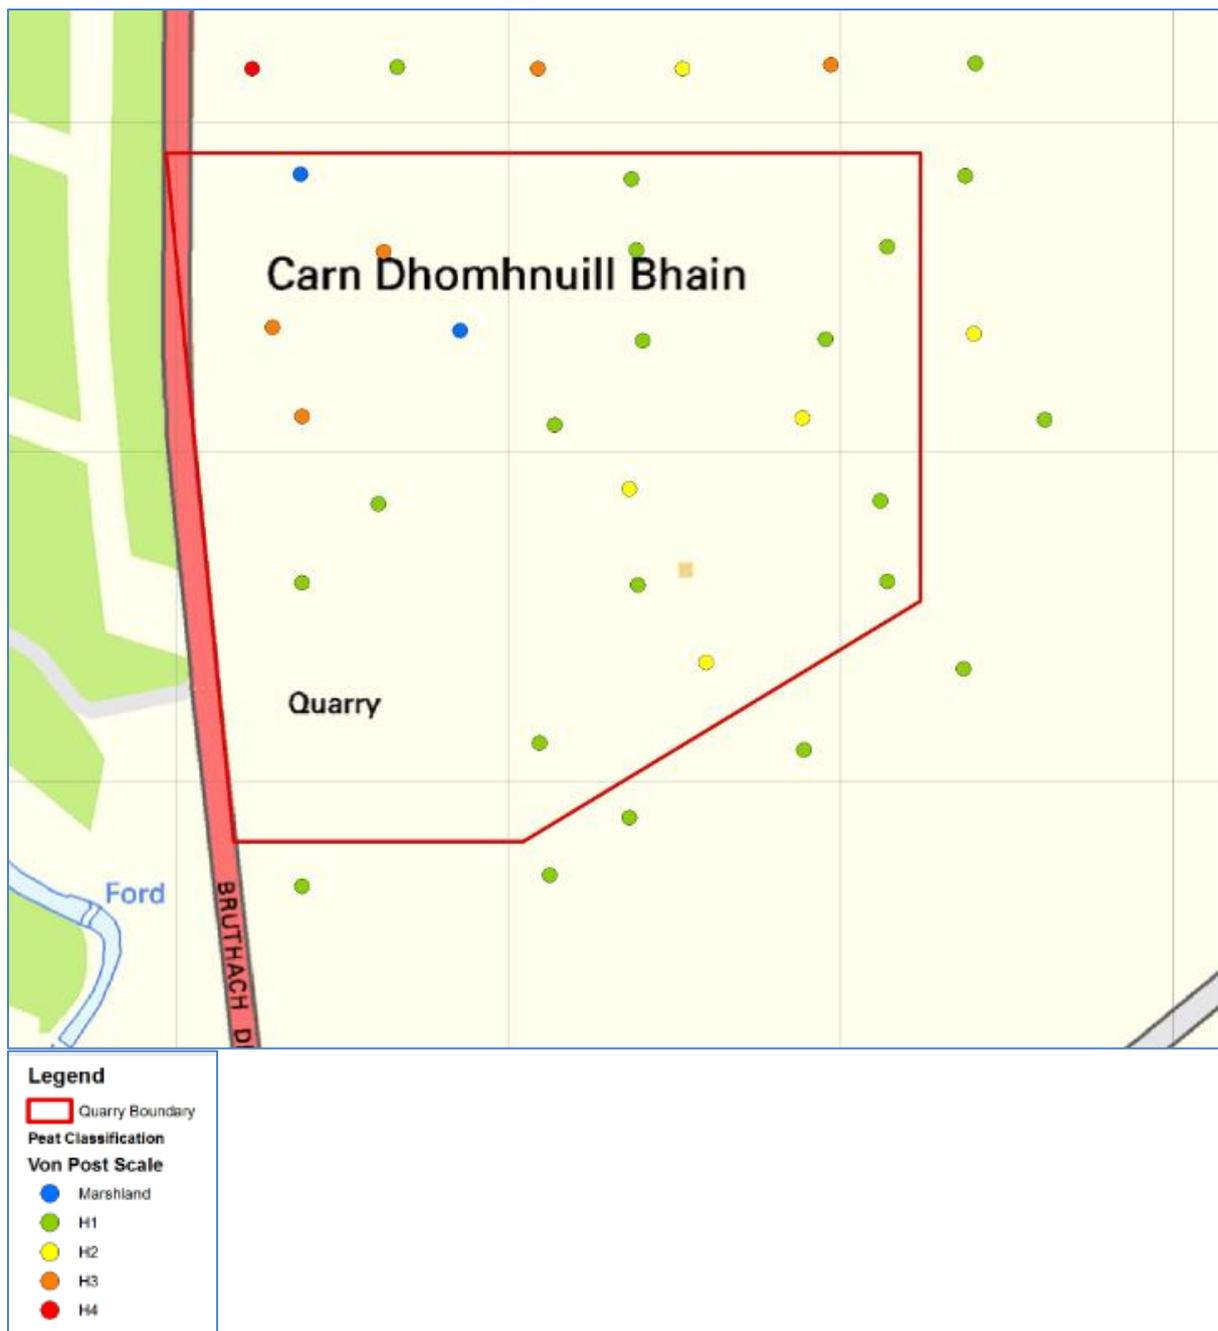
Figure 15 Distribution of peat material

The characteristics of the peat, as classified by the von Post scale (Table 1), are shown in Figure 15. Results show that the peat is all scored 4 or less on the scale indicating the material is fibrous and not decayed. While this survey has been called a peat survey, due to the shallow depth and lack of decomposition, the material is more a fibrous soil rather than a peat (Figure 16).

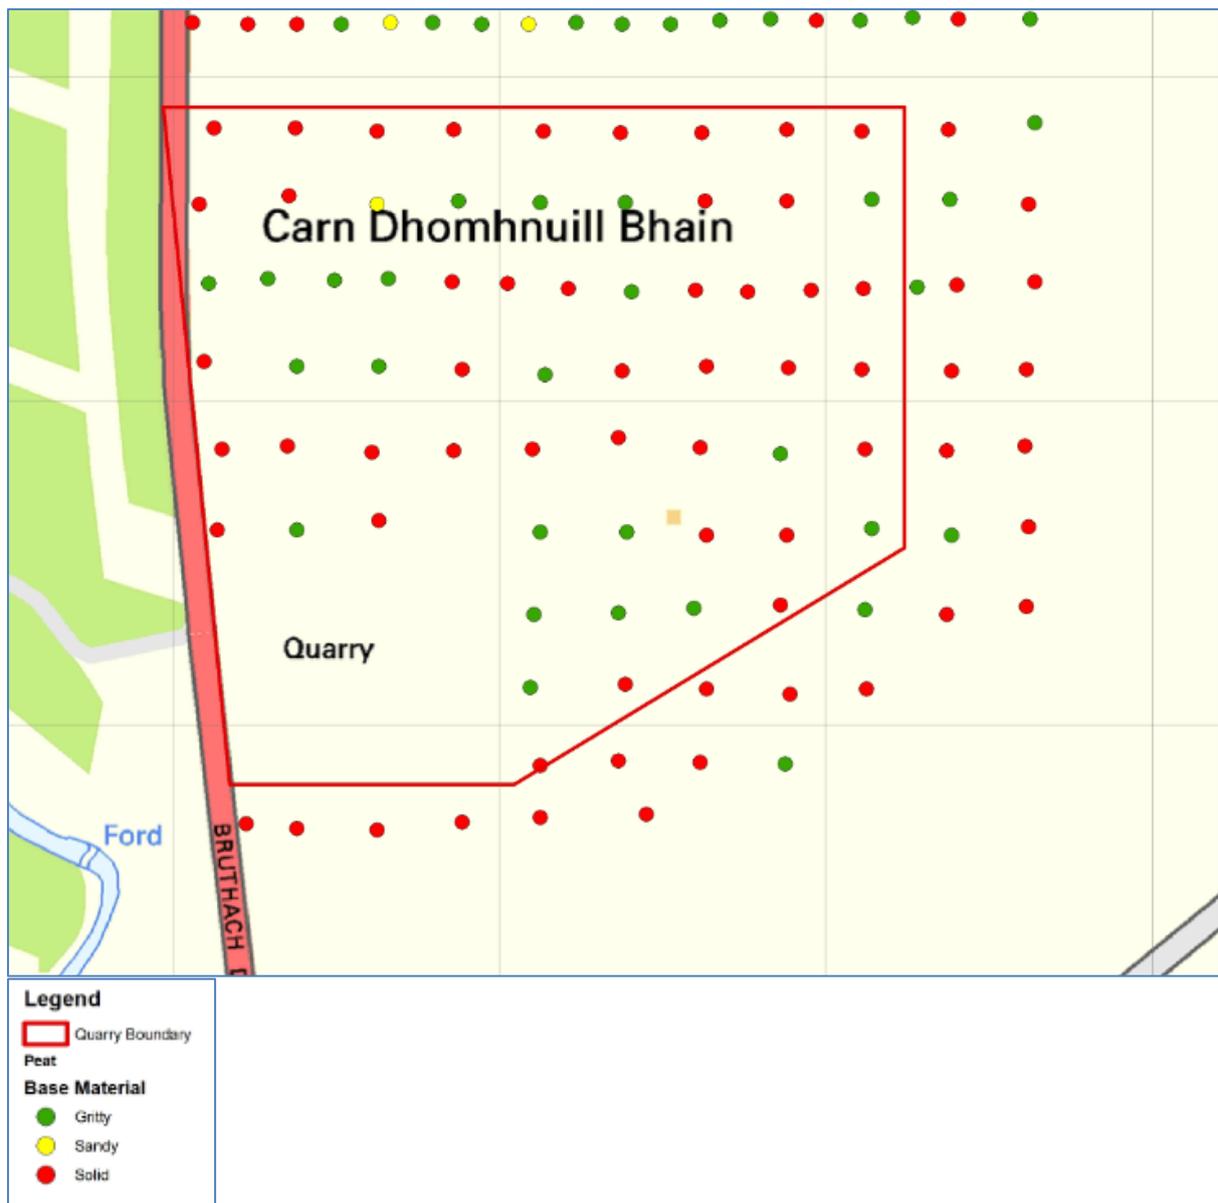
Figure 17 Characteristics of the lower material

The cores penetrated the upper fibrous layer enabling the material at the top of the bedrock layer to be sampled. The material was characterised as either gritty, sandy or solid. Figure 17 shows the results with most of the material either solid or gritty material.
