2018/0151/DET

TRAFFIC STATEMENT

Chapter 11.0
Traffic Statement

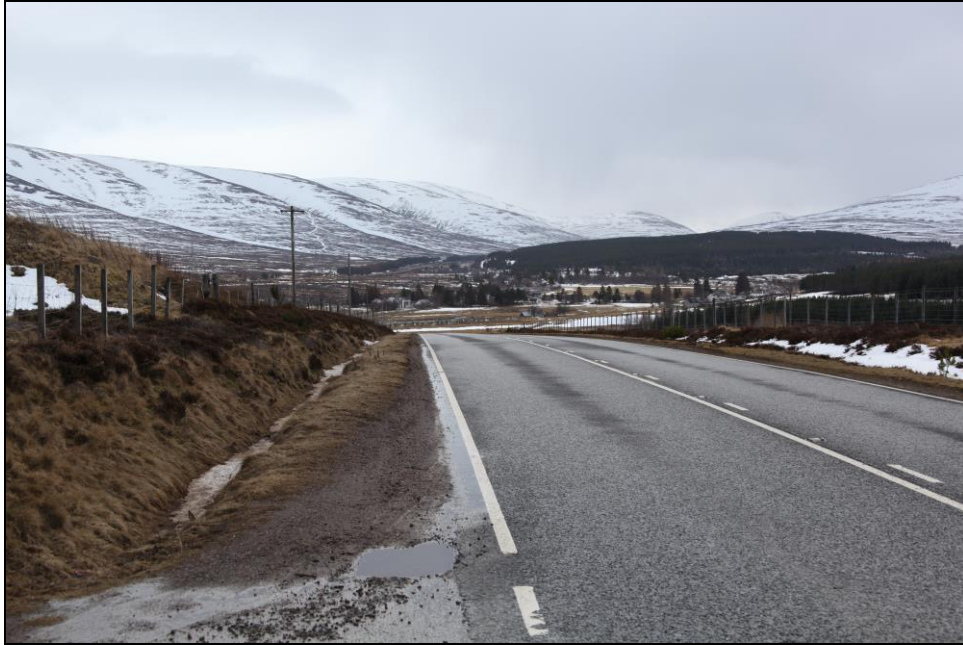
Quarry traffic will utilise the existing surfaced bell-mouth entrance at the Site which provides a suitable access directly onto the A889(T). The Site entrance is well established as illustrated in Photographs 1 and 2 below.

Photograph 1 – View north along the A889(T)

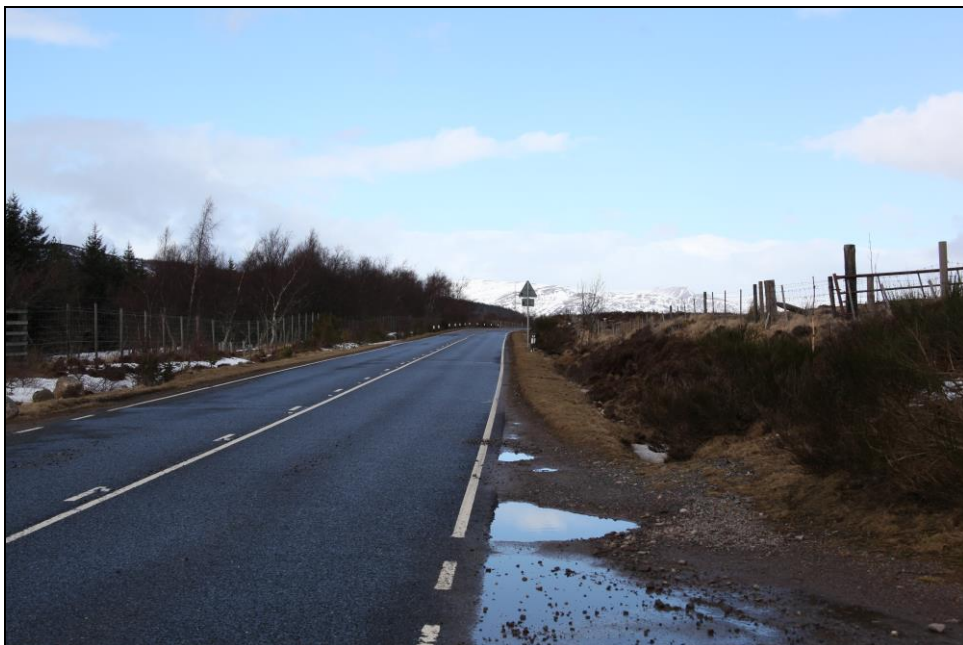
Photograph 2 – View south along the A889(T)

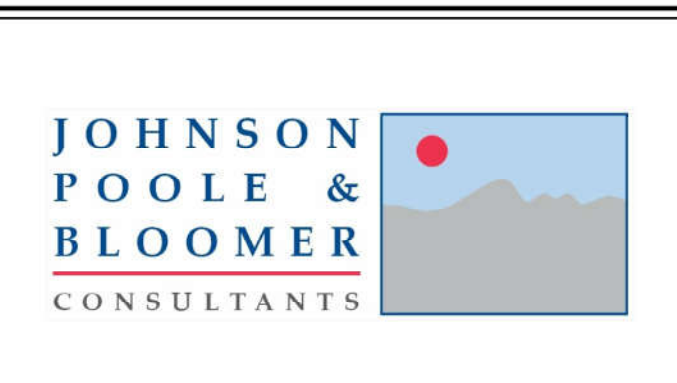
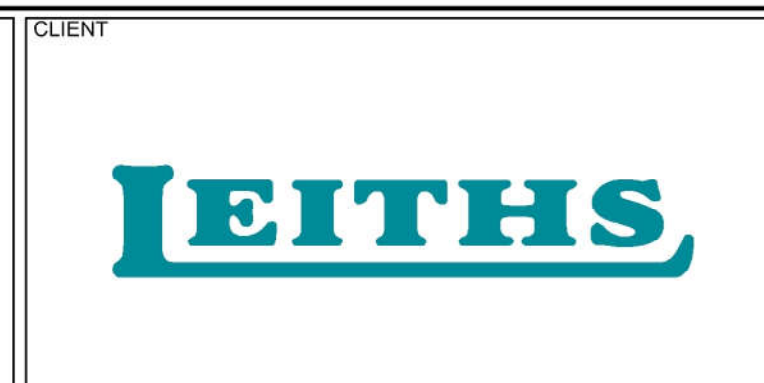
Drawing **RG547/TS/F/02** provides a long section from junction of the Site along the A889(T) towards Dalwhinnie. The long section has been prepared using measured heights from one of the applicant's HGVs which would serve the Site. This has allowed for the HGVs to be modelled accurately within the long section. The eye height for the car illustrated in the aforementioned long section is set to 1.07m.

The long section illustrated in Drawing **RG547/TS/F/02** shows that with an HGV sat waiting to turn right into the Site an HGV, travelling northwards from Dalwhinnie towards the Site, would be able to comfortably see the waiting HGV at a distance of 215m. An HGV waiting to turn into the Site would be visible to a car driver travelling north, at a distance of 201m from the rear of the waiting HGV.

DRAWING TITLE
LONG SECTION FOR AN HGV

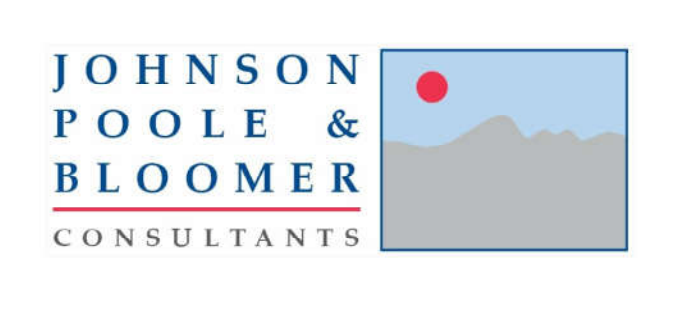
With regards to a car sat waiting to turn right in to the Site, Drawing **RG547/TS/F/03** identifies that an HGV travelling northwards from Dalwhinnie towards the Site would be able to see the waiting car at a distance of 215m. A car waiting to turn into the Site would be visible to another car travelling north at a distance of 182m from the rear of the waiting car. Whilst the applicant proposes an increase in tonnage from the Site, from that previously consented, the number of cars visiting the Site will be in line with the number of cars that would have previously travelled to and from the quarry.
