# 2019/0293/DET

# SUPPORTING STATEMENT

<u>Site Address</u> – Glenbeg Estate, Grandtown On Spey, Moray, PH26 3NT Farm Code – 586/0169

Project - Upgrade of existing private ways for forestry & agriculture (In retrospect)

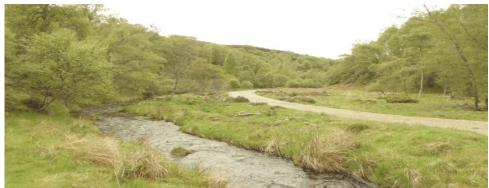
Section of existing Track A – Adjacent to Glenbeg Burn

Running in a mostly east – west direction adjacent to the Glenbeg Burn. Track A is approximately 311m long with an overall ascent of approx 30m.

There are 2no existing natural ford crossings of the burn in the western half of the track with a turning head at the western termination, allowing for articulated timber vehicles to turn freely in a forward gear. Access and egress points to the burn are to be perpendicular to the watercourse where practicable with minimal gradients to the embankments.

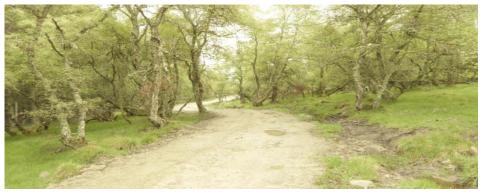
Northern Section of Track B - through woodland

Running south – north from a watercourse south of Glenbeg House to the west of Wester Graggan, where a formal track terminates on the south side of the burn. Track B is approx 650m long with an overall ascent of approx 2m, it then terminates to the north where it meets the boundary of an existing field.
