Cairngorms National Park Partnership Plan 2017-2022

Strategic Environmental Assessment Environmental Report

Appendix 2: Environmental
Baseline

Topic 3: Water
June 2016

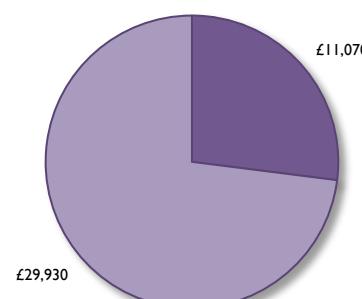
Figure 34 Annual average damages in Newtonmore PVA (PVA 05/13).

The estimated total average annual cost of damage in these areas is £492,000 (**Figures 31 to 36**). Around £335,000 (68%) of this damage is caused by river flooding (Scottish Environment Protection Agency, 2015).
