Upper Spey Embankment Condition Assessment

Final Report Cairngorms National Park Authority cbec eco-engineering UK Ltd January 2025

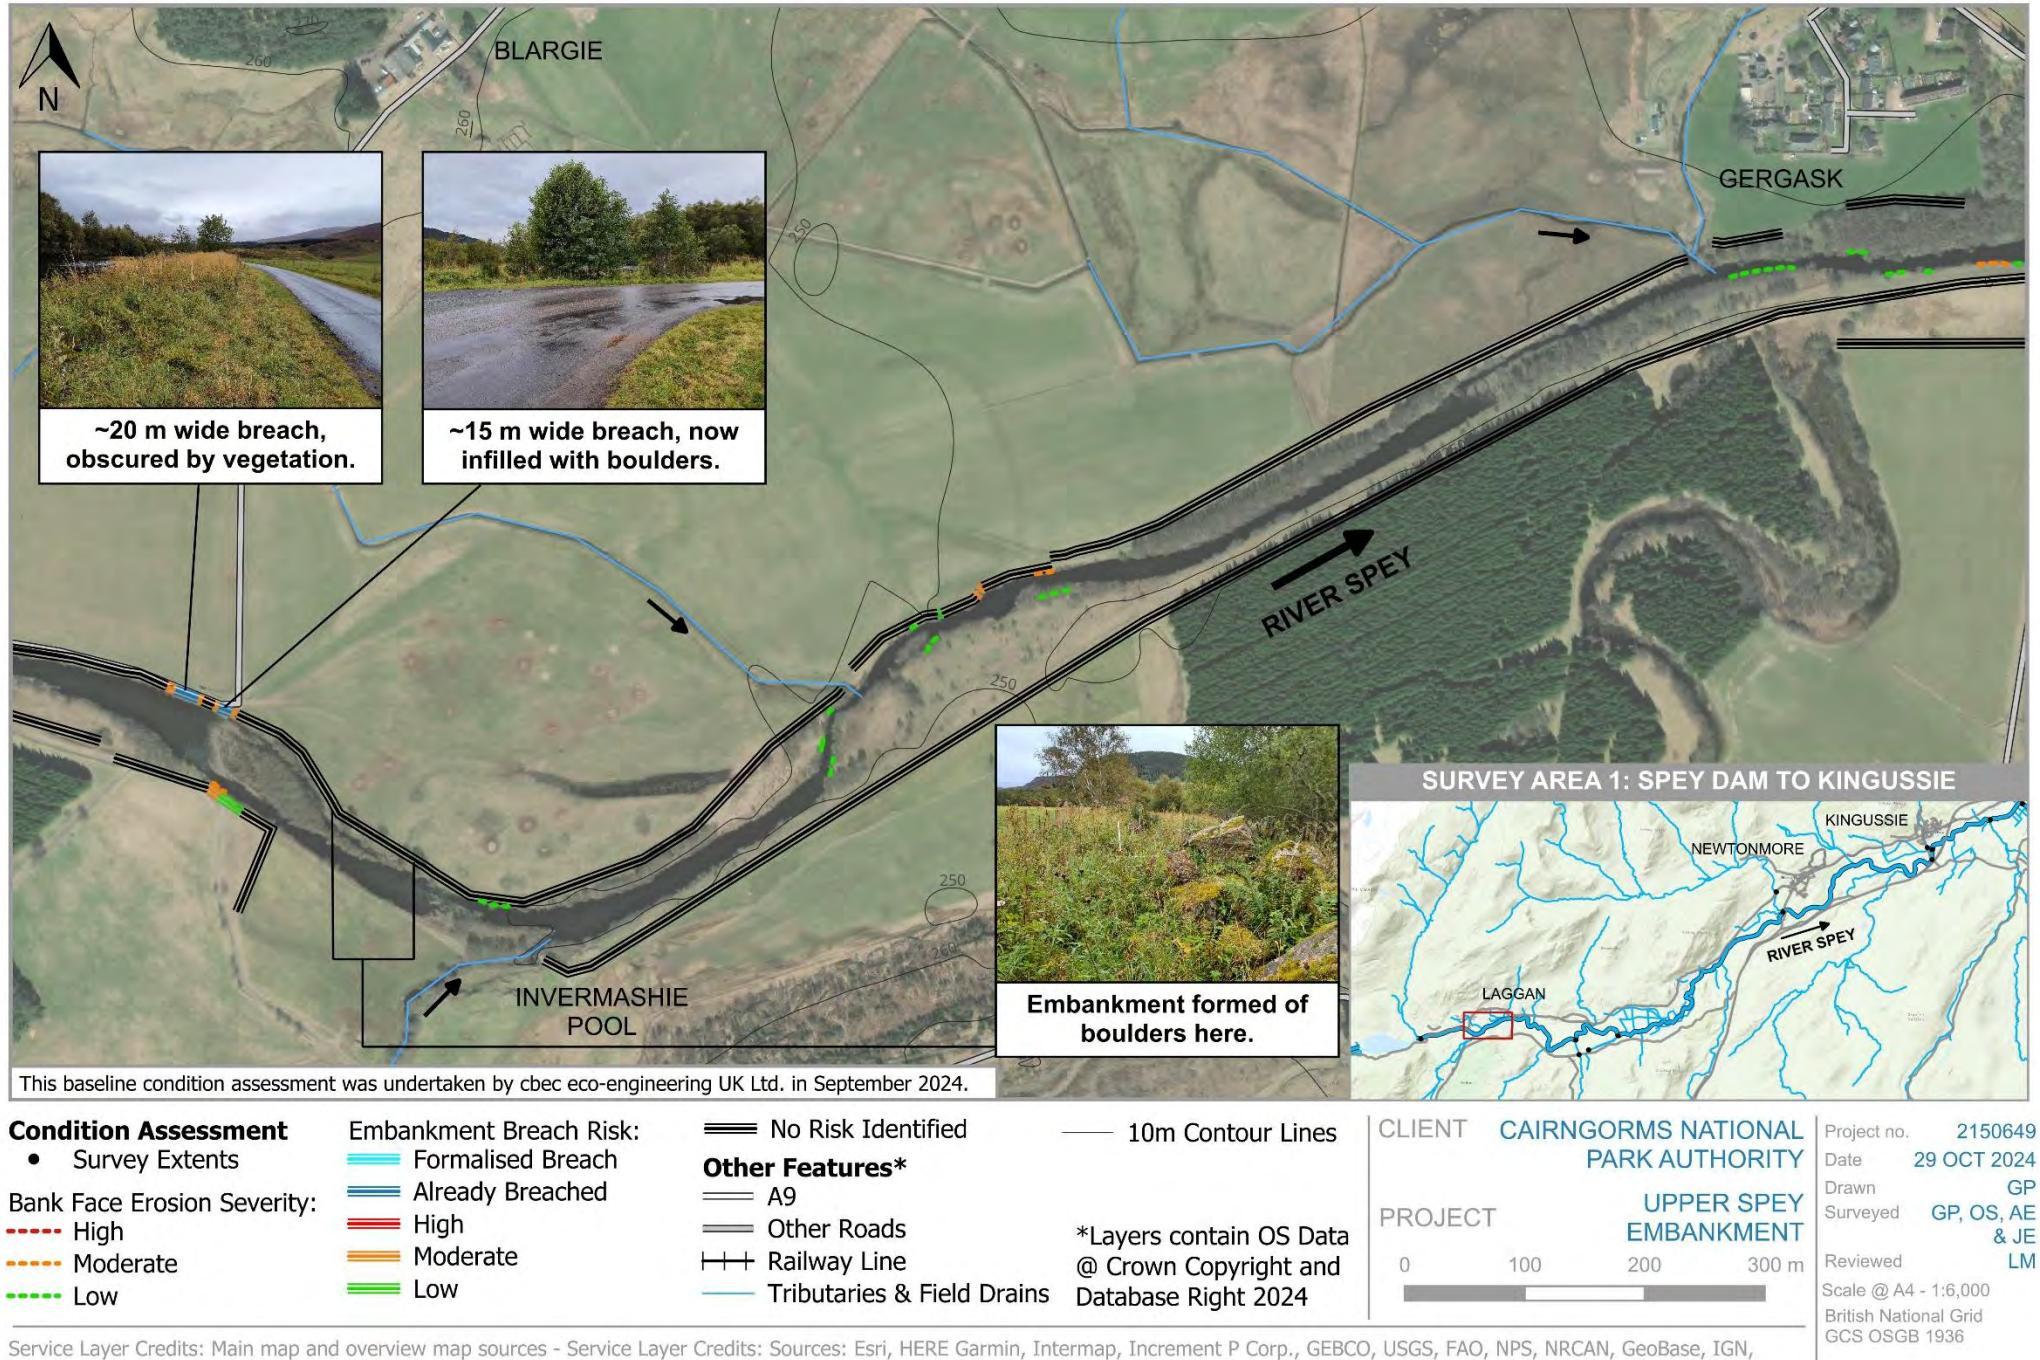
Figure 3.15 Area 1 - Map 2 showing the baseline survey results for the River Spey (Reach 1A).

- Out-of-bank flow during flood events. This flow is not bound by the orientation of the channel banks and therefore follows the most direct path. For example, at meander bends, out-of-bank flow can flow directly towards the embankment (e.g. as at the breaches on the river left (western) bank around the tight meander bend, located just upstream of the River Tromie confluence; Figure 3.32). Similarly, the presence of an island causes the flow to split around this mid-channel feature and flow directly towards the breaches at Blargie Estate (Figure 3.15), which floods the access road.

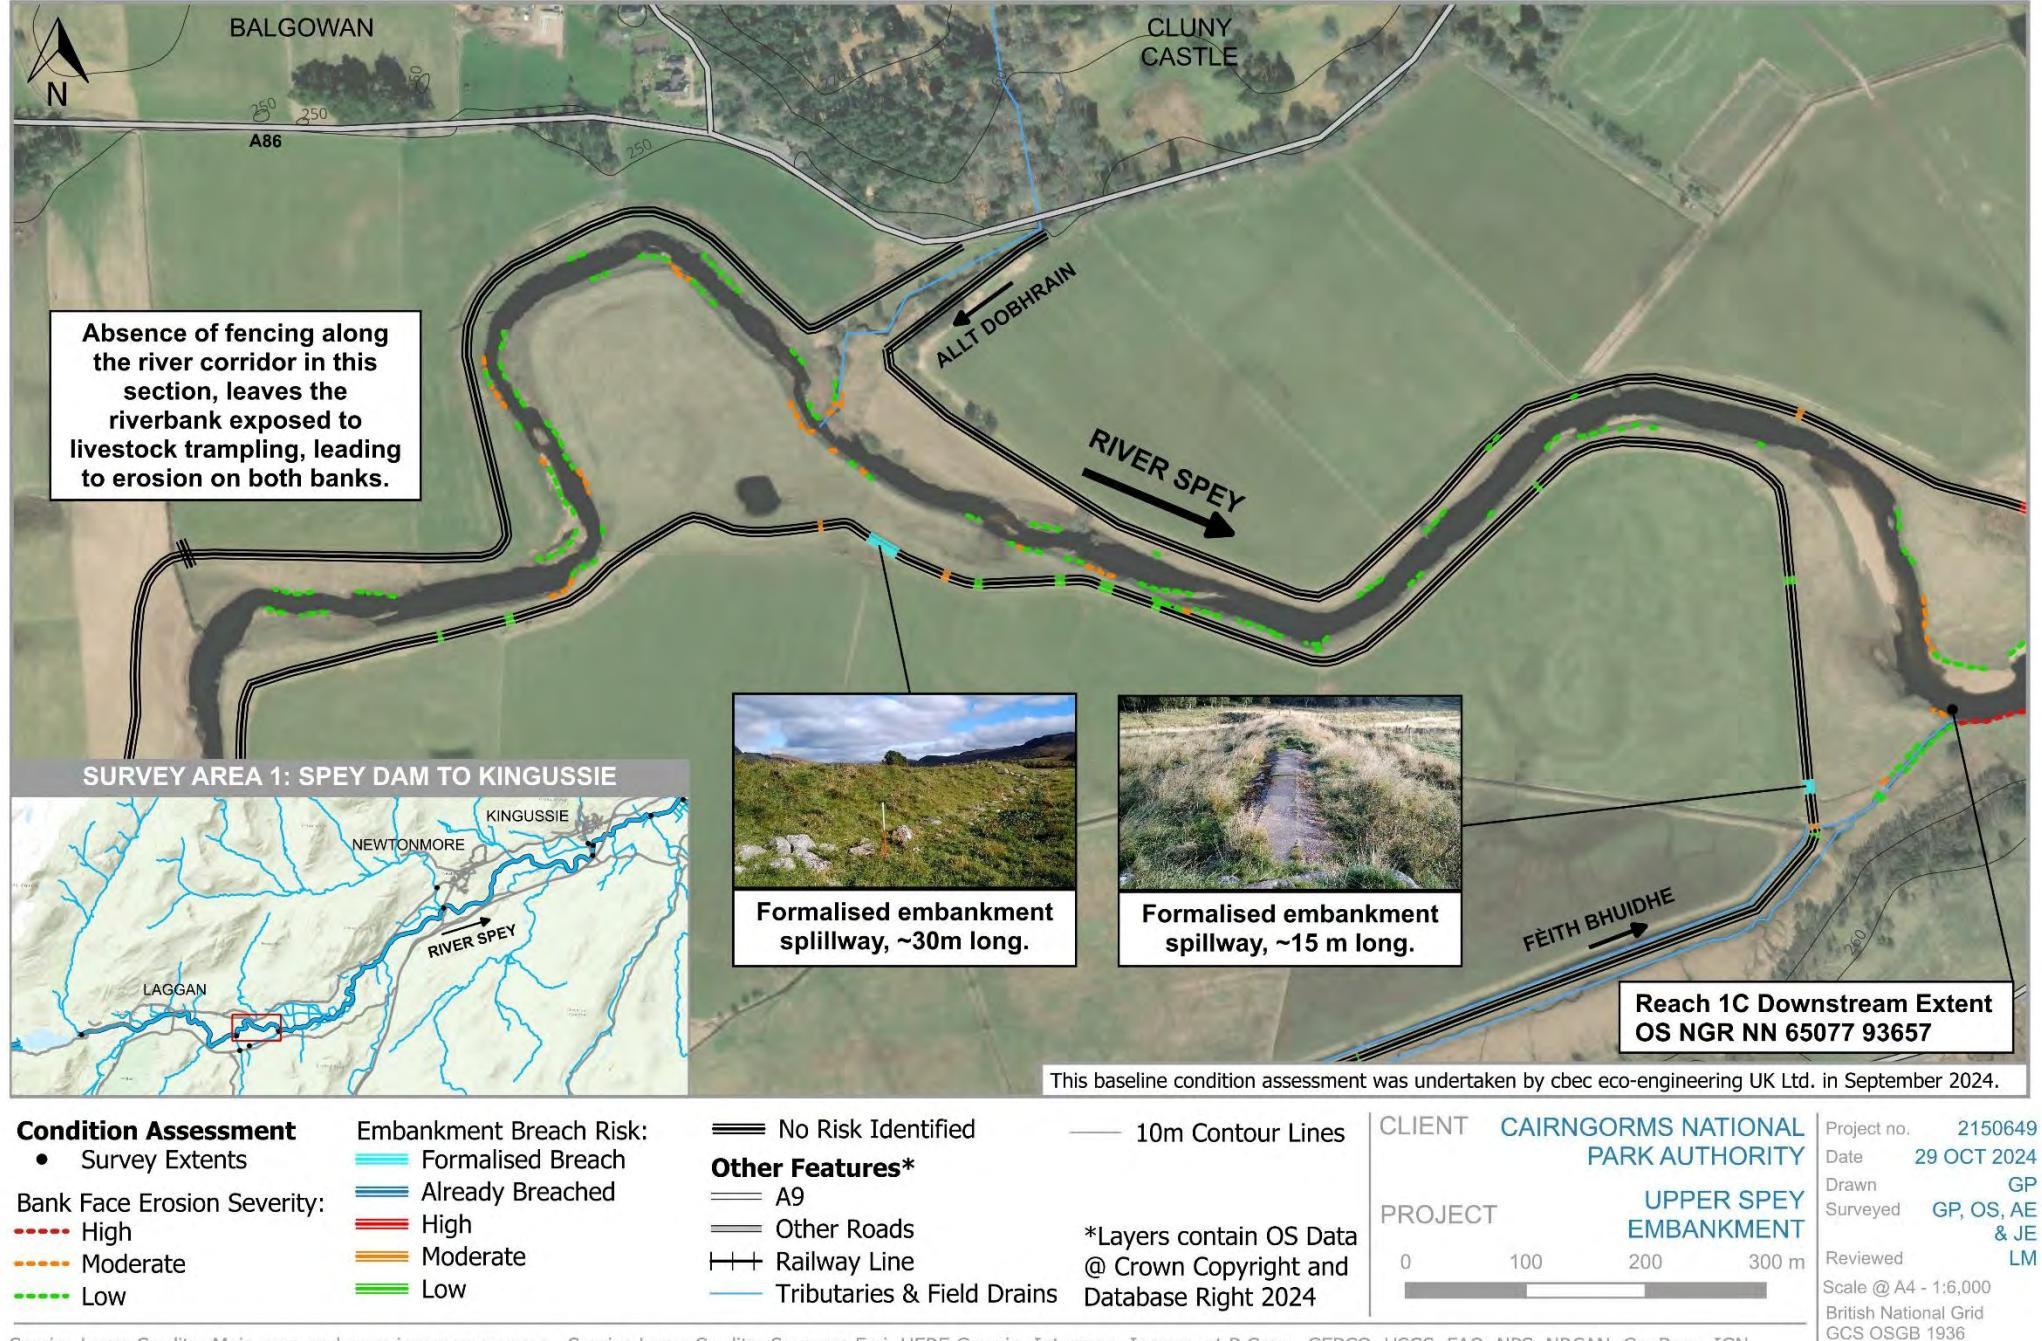
Figure 3.18 Area 1 - Map 5 showing the baseline survey results for the River Spey (Reach 1A).

Two formalised embankment spillways are present at Breakachy Farm, on the river right (eastern) side of the River Spey between Laggan and Newtonmore (Figure 3.18). These have been mapped as formalised breach points, due to the embankment crest being purposefully lowered and lined with concrete and/or boulders to stabilise these overspill zones. Owing to this hard embankment protection, the adjacent sections of embankment were not deemed to be at risk of erosion by water passing over the spillway, as would be expected within an unprotected breach.

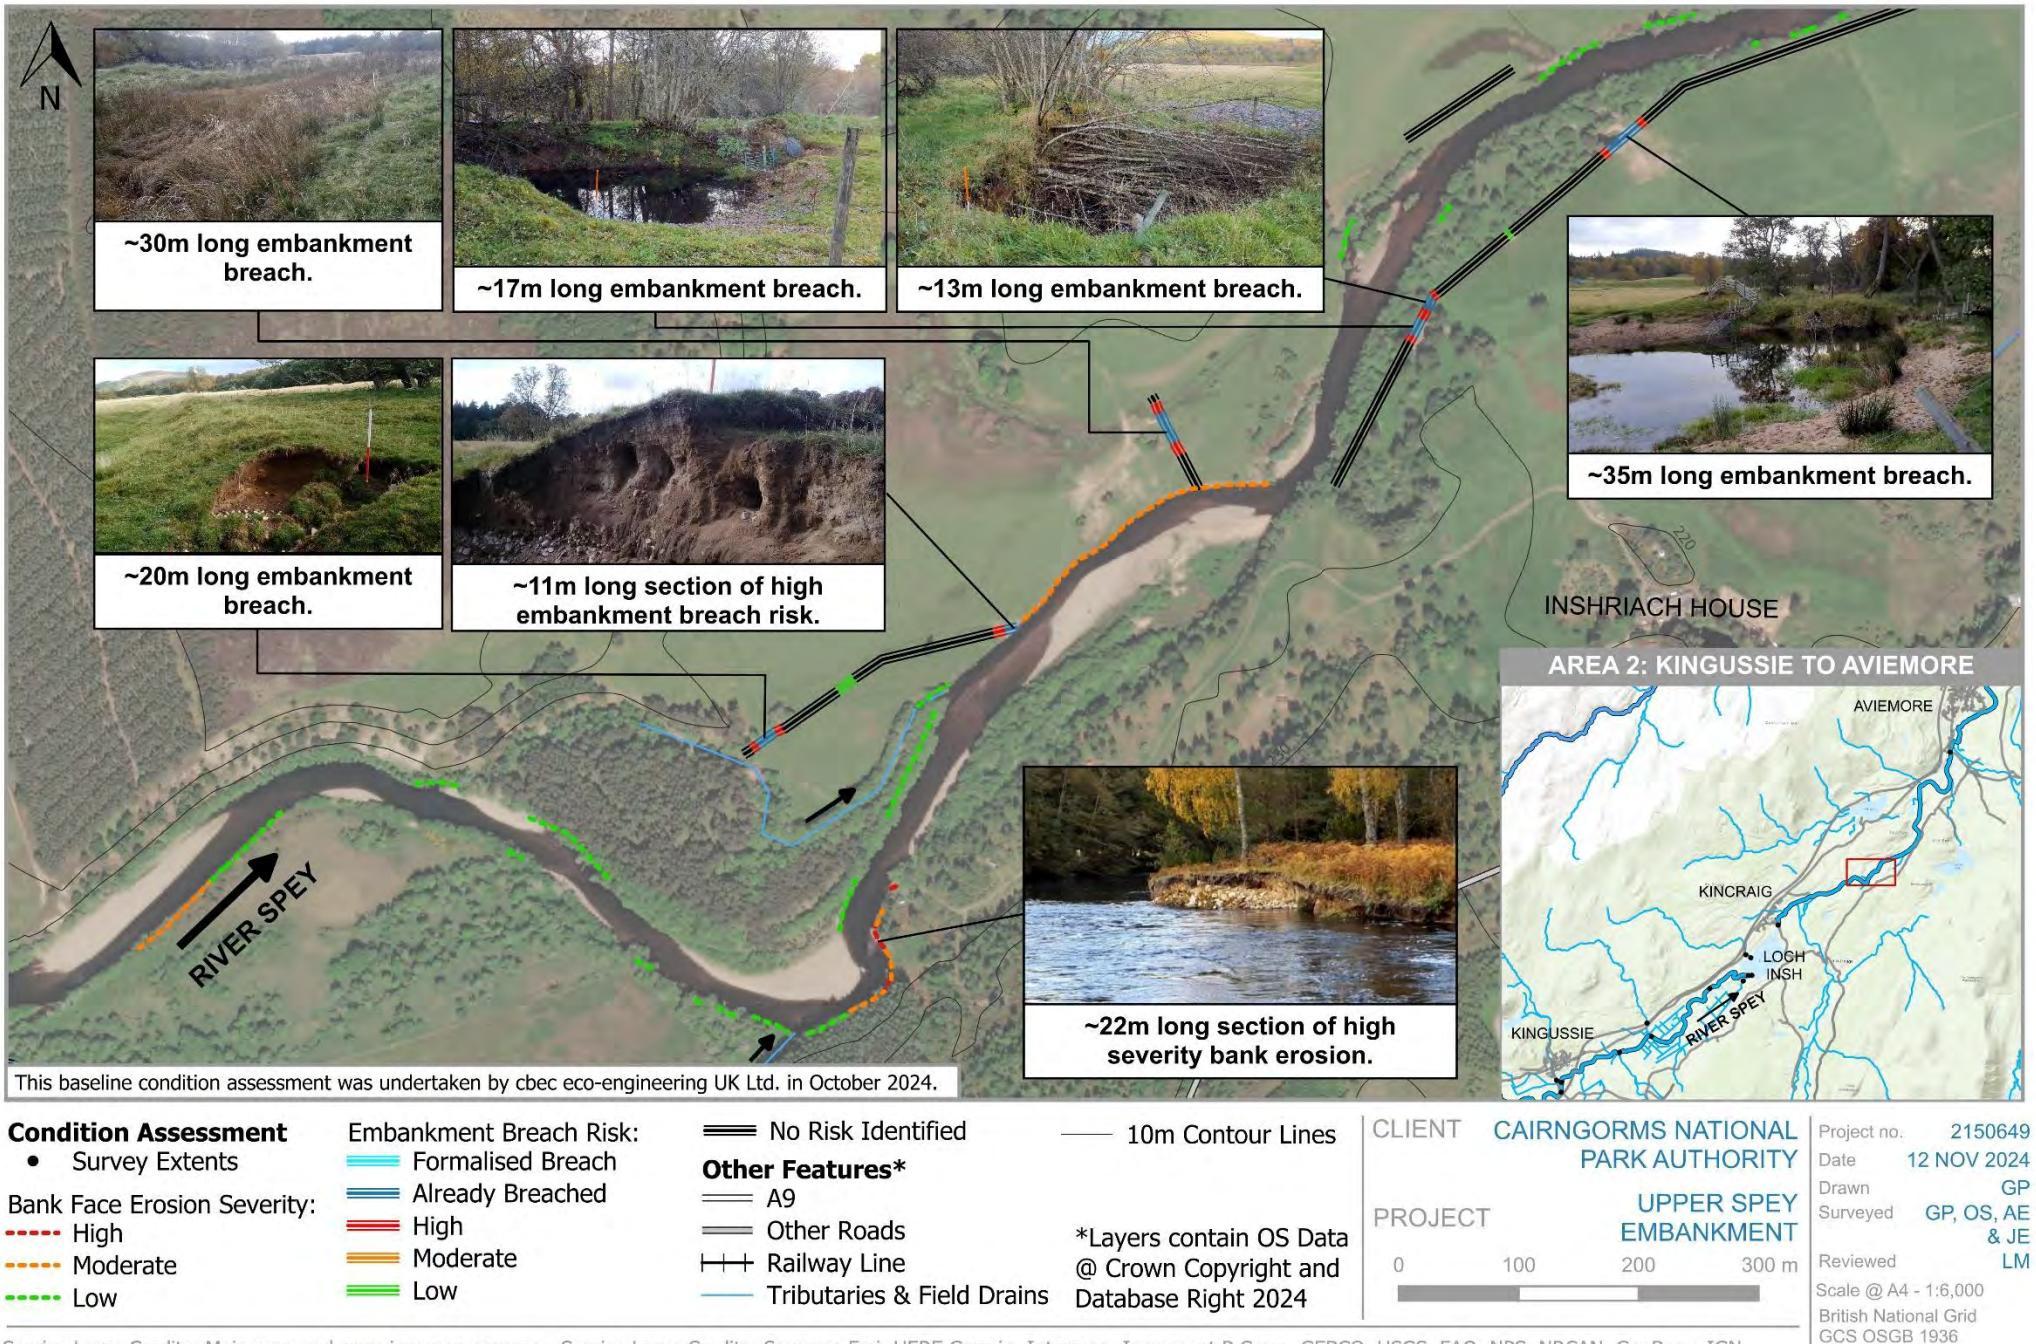
Figure 3.38 Area 2 - Map 8 showing the baseline survey results for the River Spey (Reach 2G).

localised areas, particularly around the outside bends of meanders, with embankments rarely impacted (Figure 3.38, Figure 3.40 and Figure 3.41).

Embankments on the left bank were rare throughout Reach 2G, with occasional sections noted around Kinrara (Figure 3.38 and Figure 3.39) and from the Allt-na-Criche confluence to Aviemore (Figure 3.41 and Figure 3.42). Slumping due to degradation of the embankment condition and trampling by livestock were noted to be the main factors influencing the risk of embankment breach within this reach. Trampling of the embankment by livestock in the lower section of Reach 2G, between Doune Farm and the Milton Burn confluence, was concentrated around mature trees. Livestock lying around, sheltering beneath or rubbing against these trees has led to increased footfall over these sections of the embankment, lowering the crest height and increasing the vulnerability of these areas to breaching. Erection of fencing along the riparian corridor would prevent livestock access to this area, allowing the embankment time to revegetate and increasing the sustainability of any remedial works undertaken.

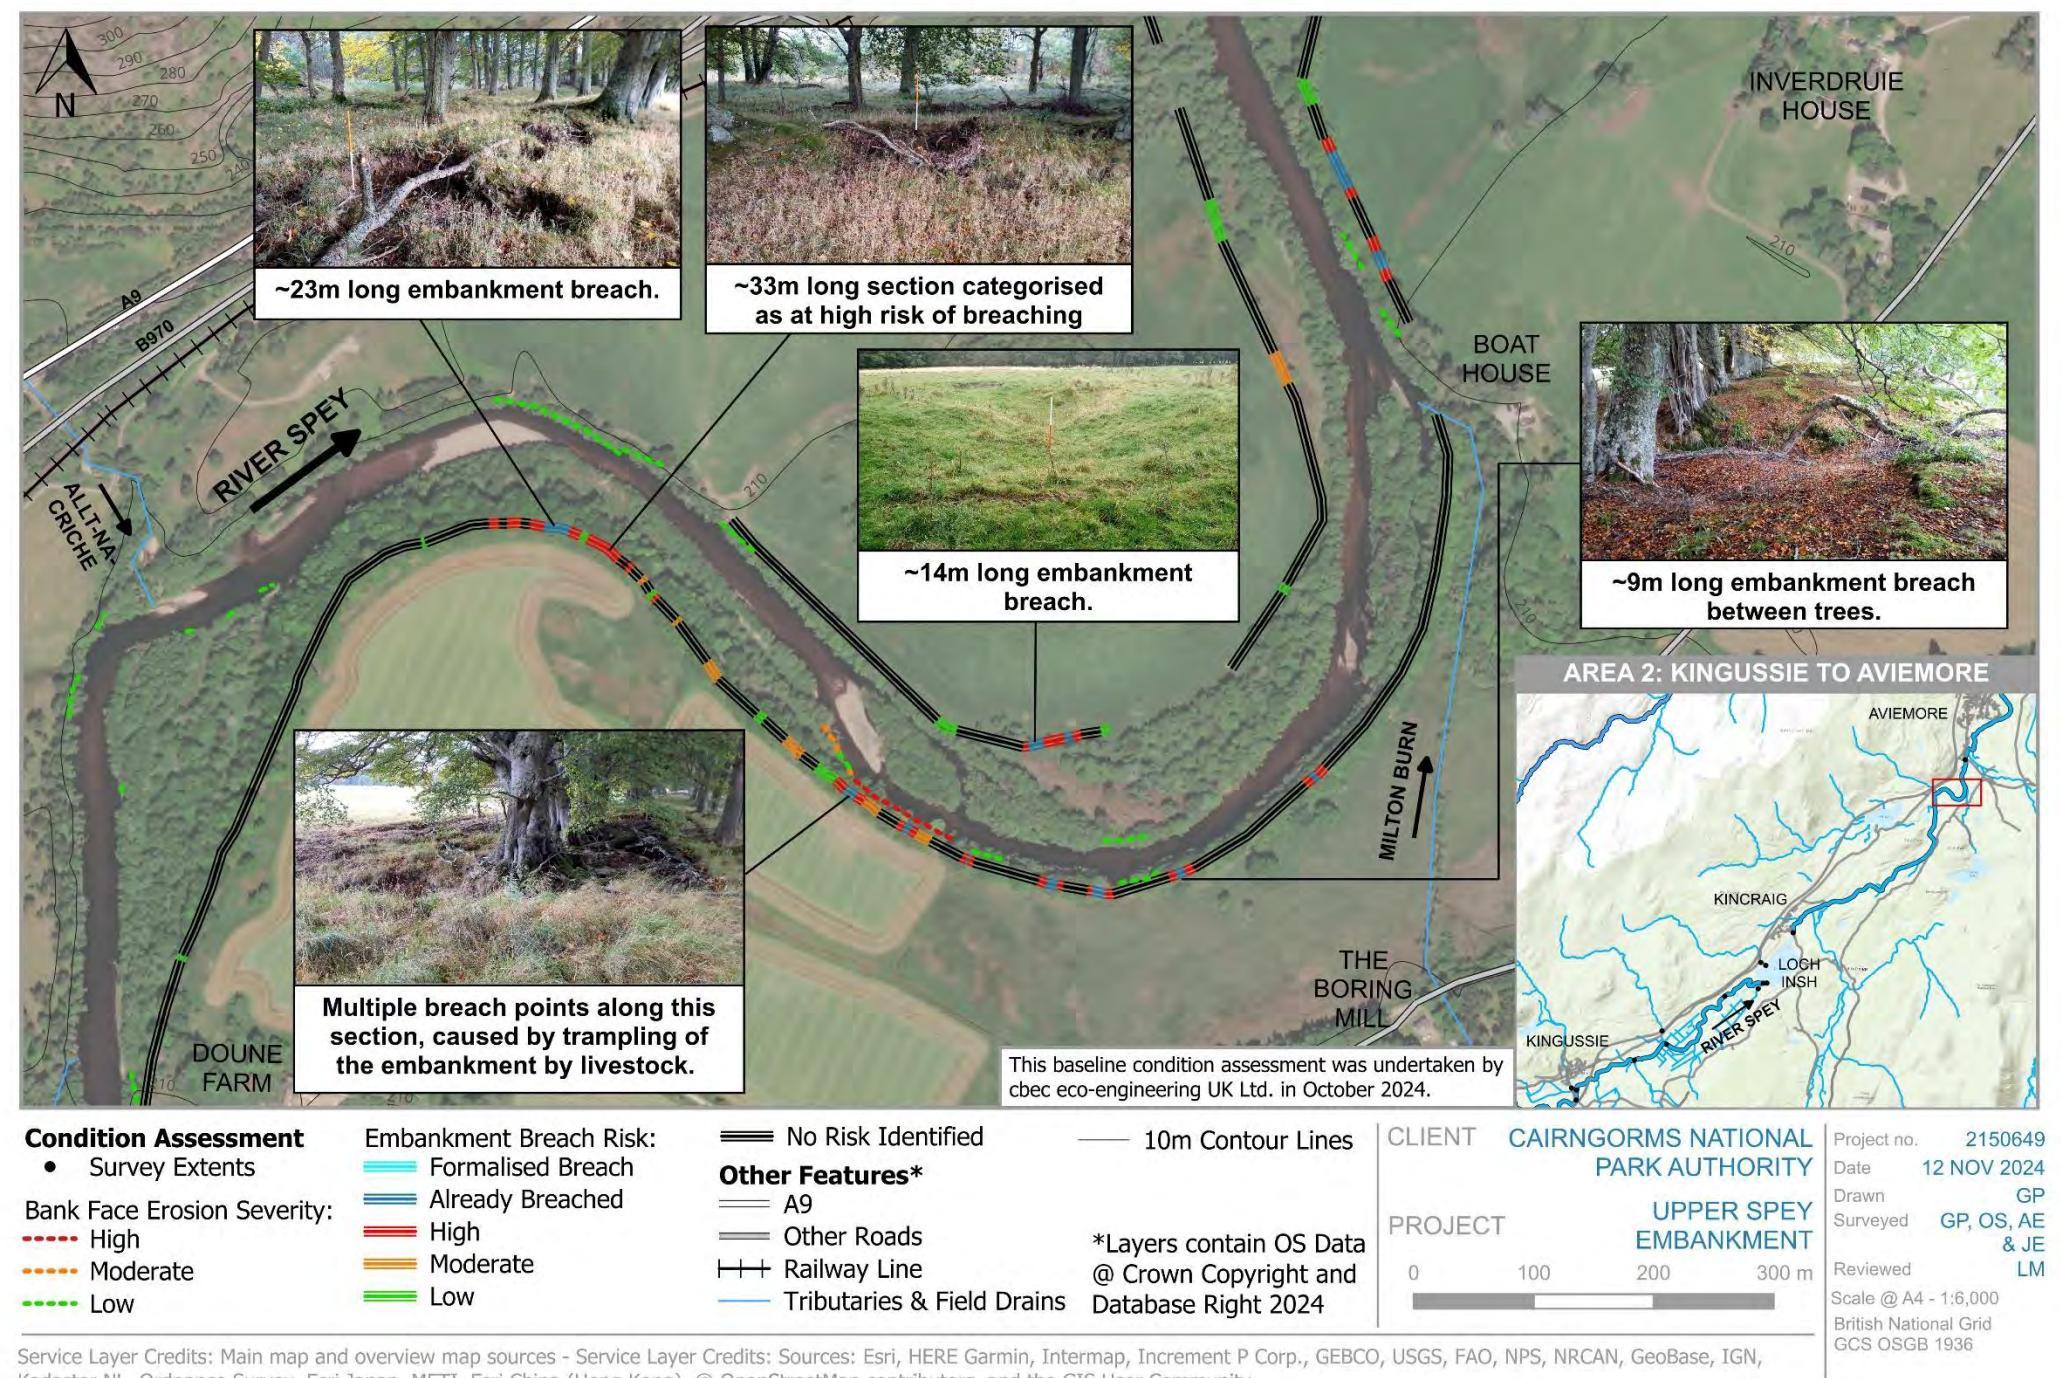
Figure 3.41 Area 2 - Map 11 showing the baseline survey results for the River Spey (Reach 2G).

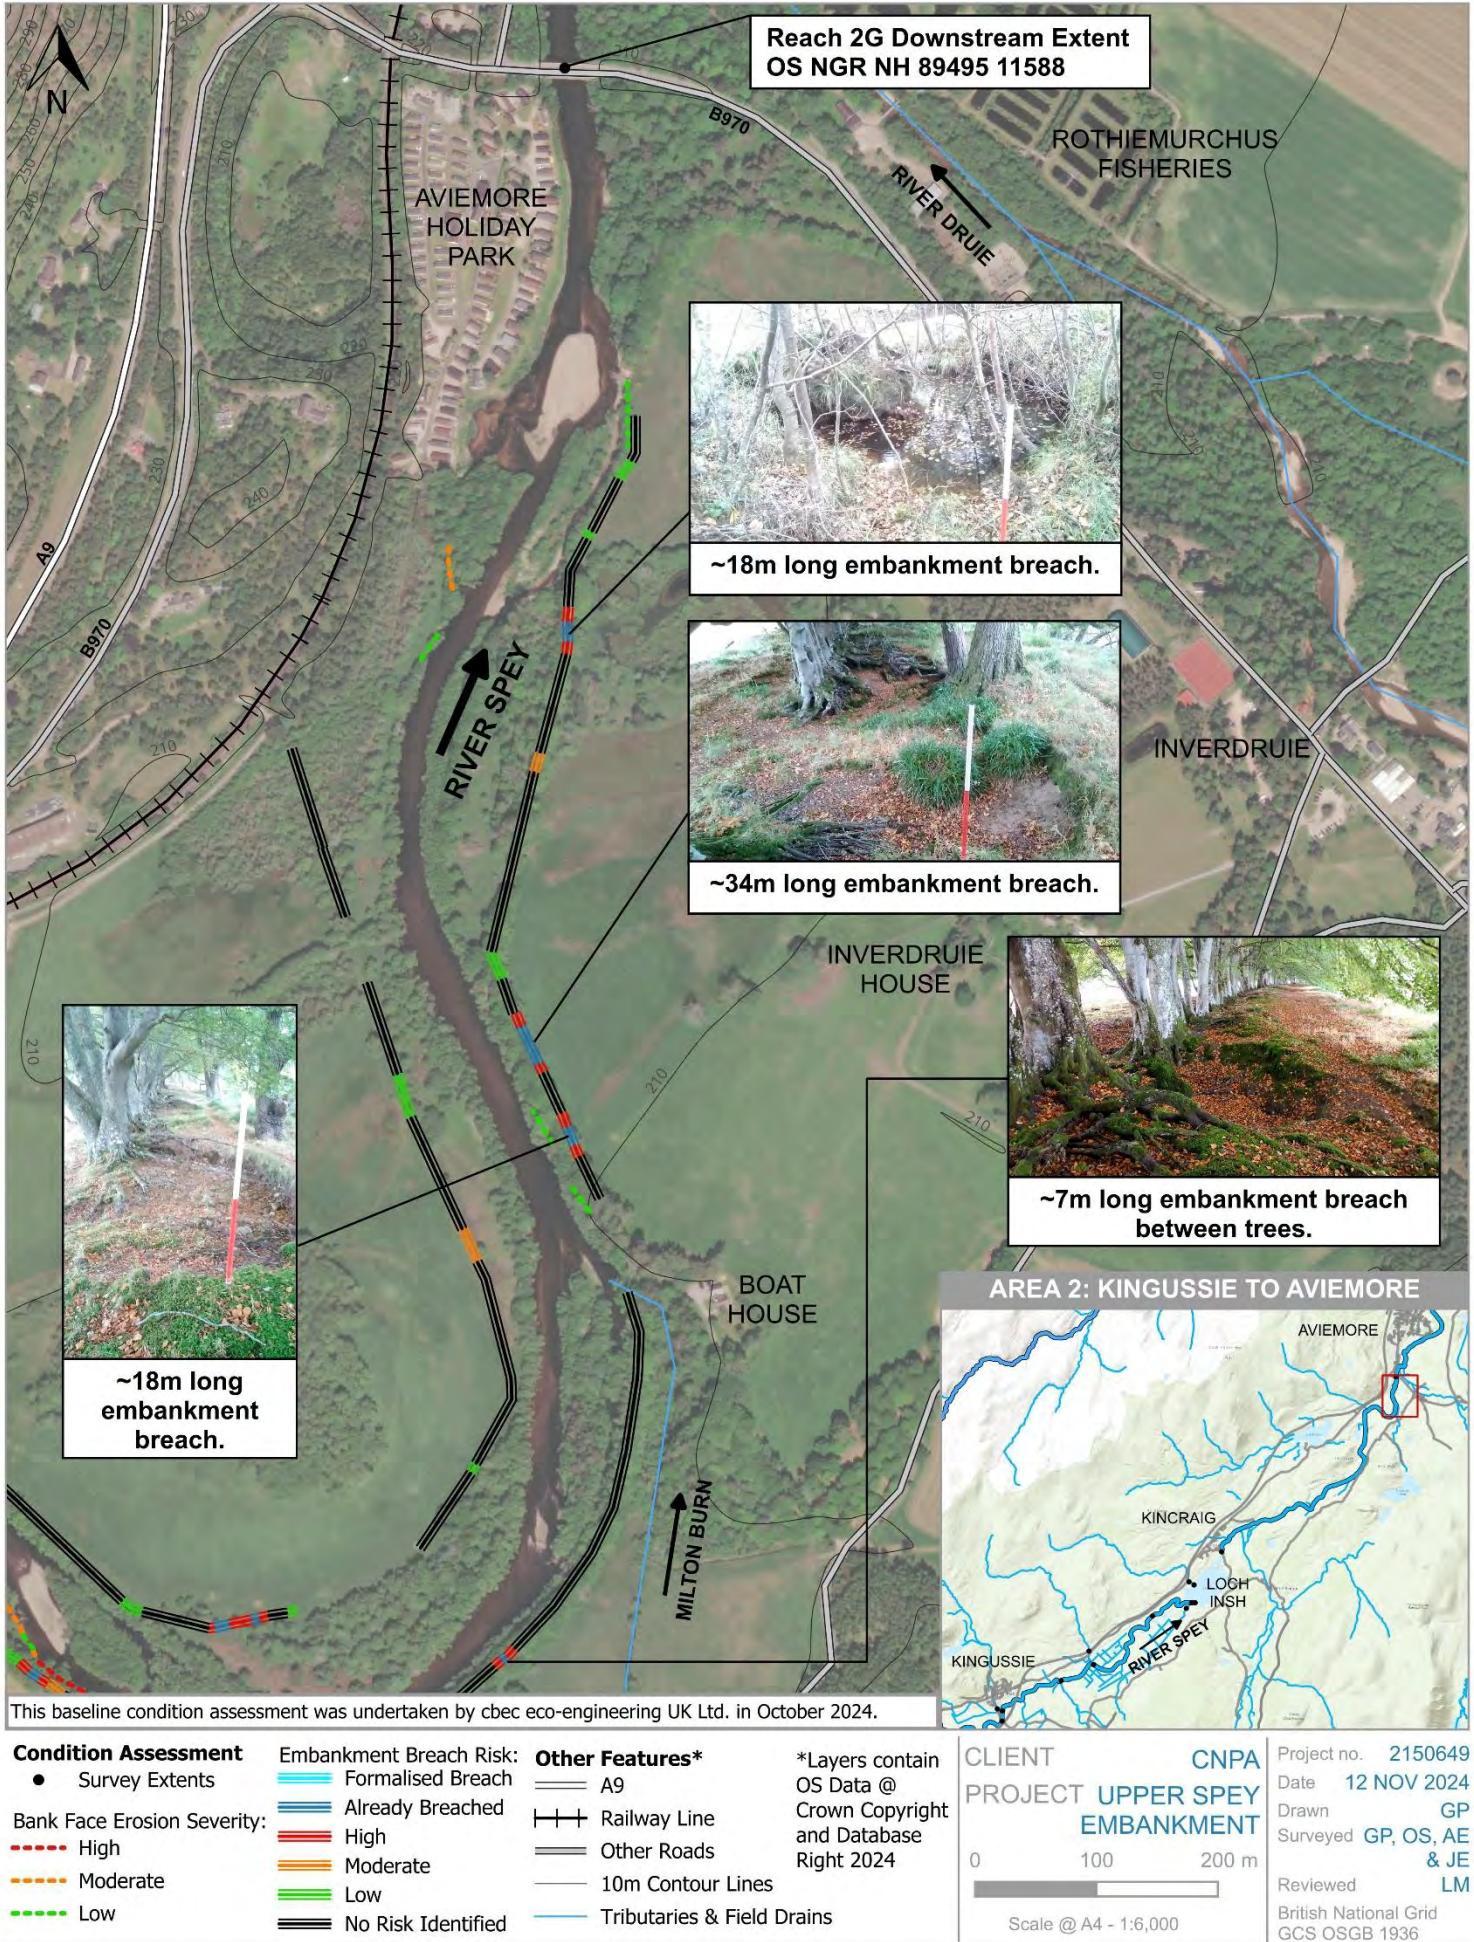
Figure 3.42 Area 2 - Map 12 showing the baseline survey results for the River Spey (Reach 2G).

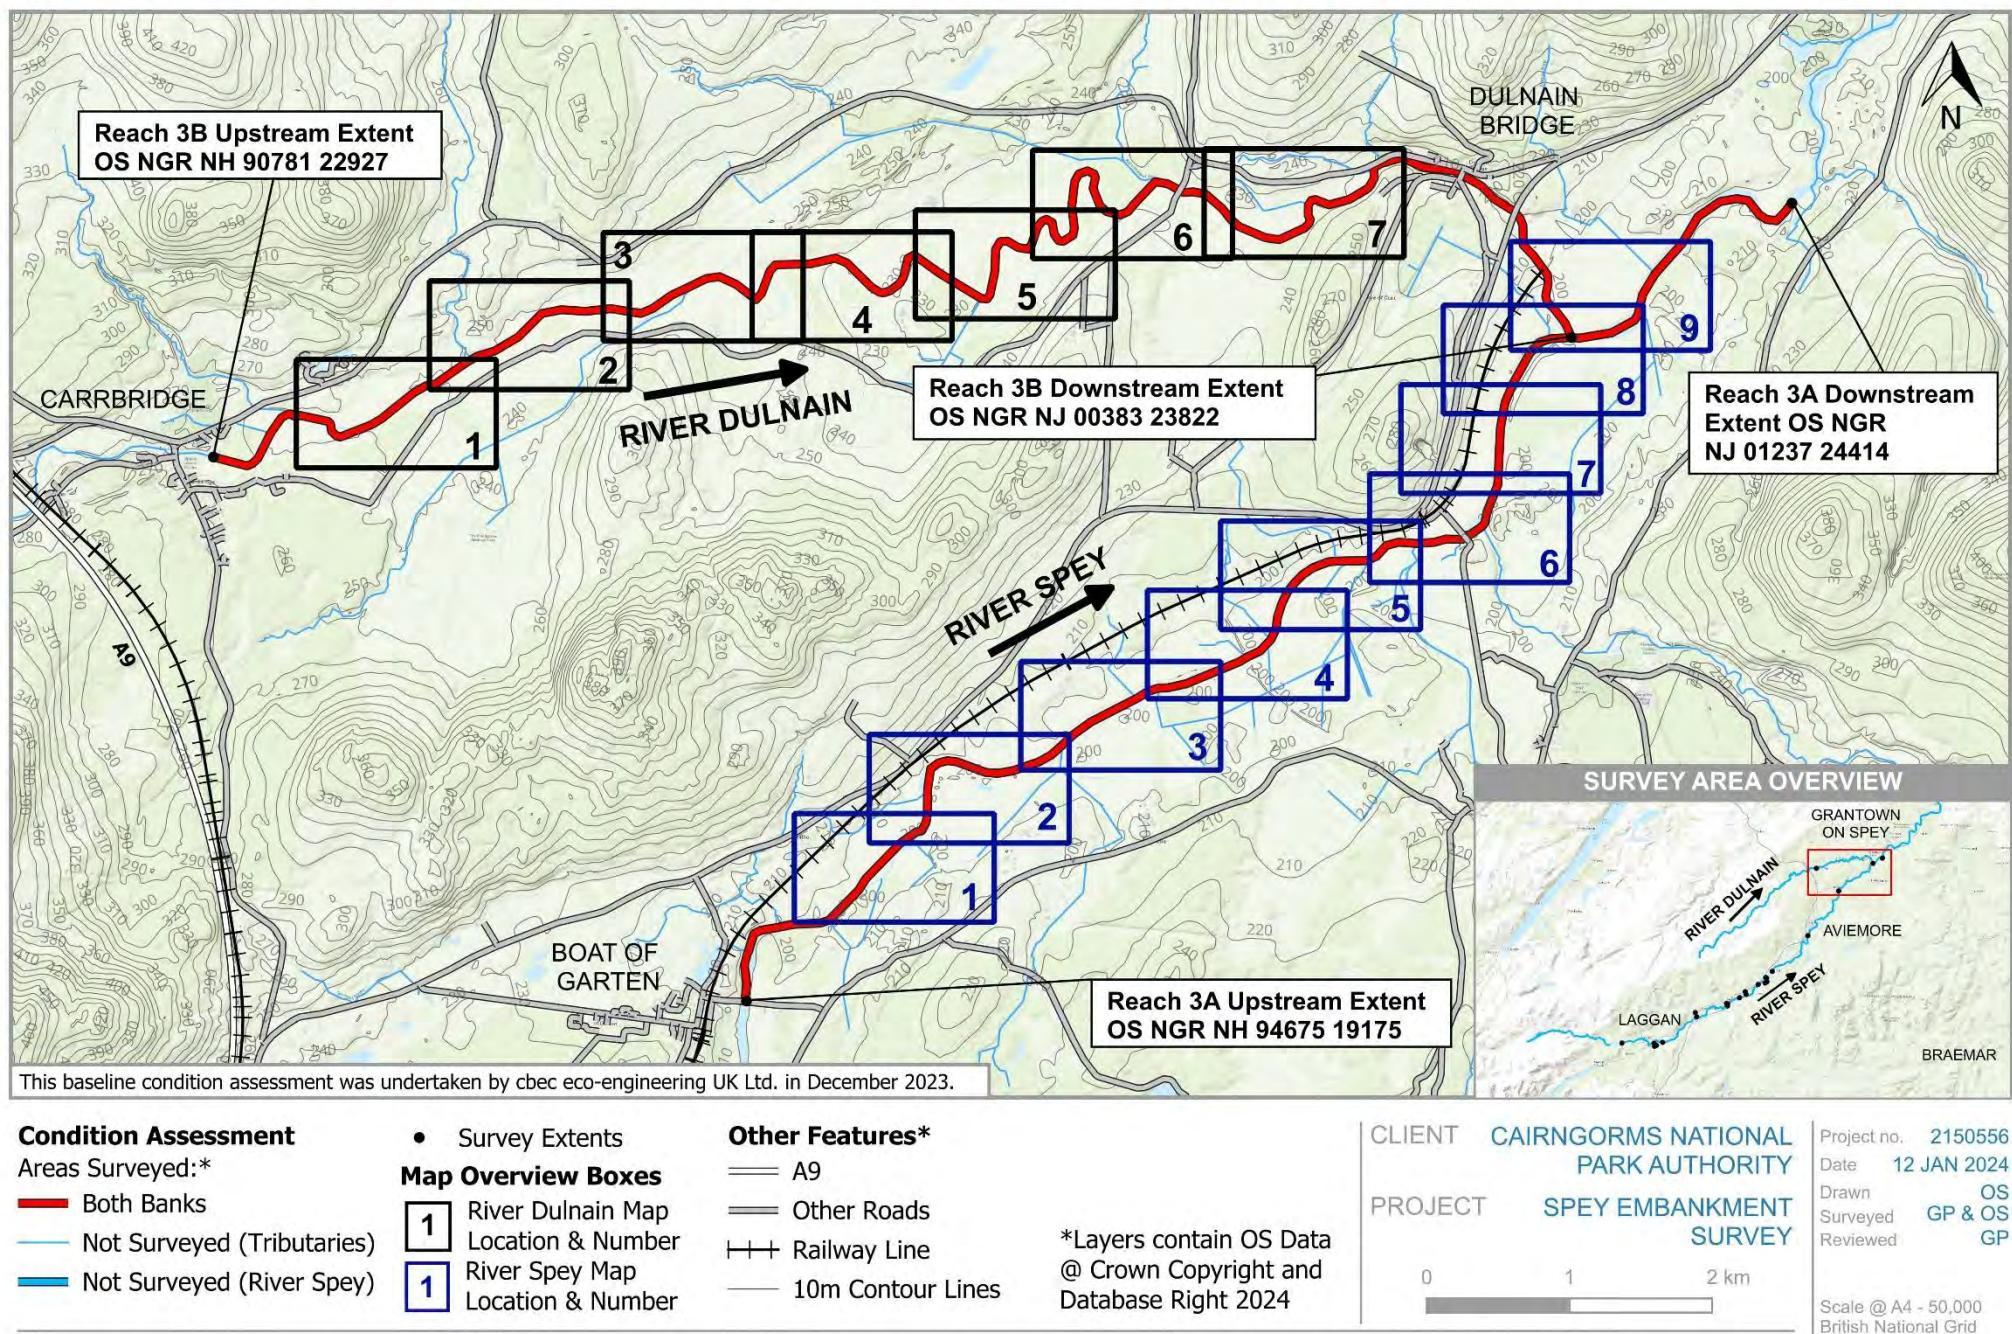
Figure 3.43 Area 3 survey results overview map.

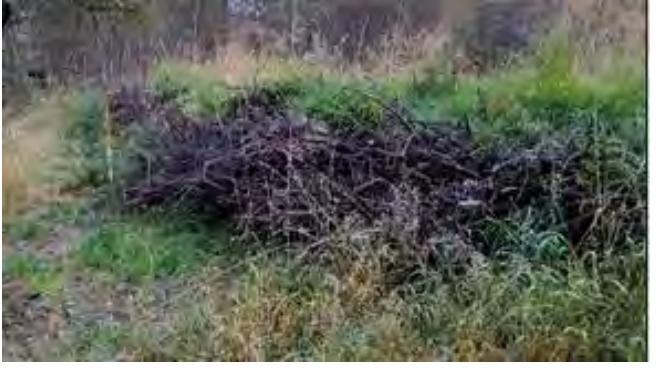
Figure 3.61 Example embankment breach remedial works. Large wood (trunks with root plates still attached) installed to protect the embankment face (OS NGR NH 88320 09028).

- **Remedial works** High erosion risk or already breached locations should be prioritised for remedial works to prevent further deterioration or expansion of these sections. Remedial works could include formalisation of the existing breach for Natural Flood Management (NFM) benefit, as outlined in the point below, or reinstatement of the embankment to pre-breach conditions (which could include embankment face protection such as that observed along a \sim 25 m section of embankment near West Lodge; Figure 3.61). Remedial works may be essential in some locations to facilitate access or land management practices, such as the road through Blargie Estate (Figure 3.14). However, it is recommended that some existing breaches are formalised to facilitate temporary floodplain storage and deliver NFM benefits. Remedial works are noted to have already been carried out for a breach at Balliefuth Farm (Reach 3A) and to repair a section of eroding embankment surface at Tomachrochar, upstream of the dismantled railway embankment on the river right side of the Spey. For increased longevity of such remedial works, it is recommended that the surface vegetation of the embankment is removed as sheets of turf, the damage to the embankment infilled and compacted with an excavator bucket, before being re-turfed to ensure stability.

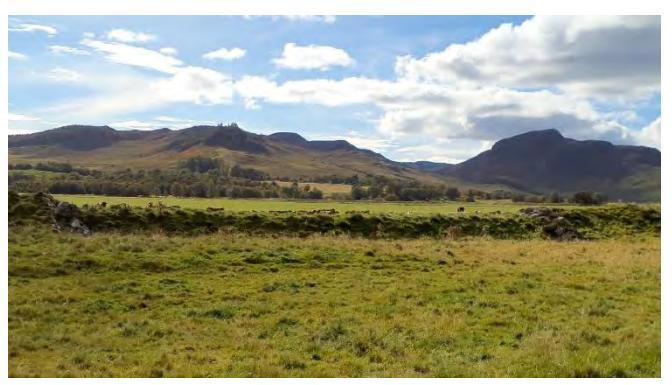
Figure 3.62. Lowering of the embankment crest to form a spillway (formalised embankment breach) at Breakachy Farm (OS NGR NN 64187 93793).

sections of the embankment have been lowered and reinforced with stone or concrete to form floodwater spillways at Breakachy Farm (Figure 3.18) and (2) a naturally formed embankment breach at Cluny Farm (Figure 3.20 and Figure 3.62). Anecdotal evidence suggested that the latter is thought to be providing flood alleviation benefits to neighbouring landowners, by enabling temporary floodplain storage within the field behind the breach.

Flood modelling would be required to identify the most beneficial locations and optimal lengths of spillway required to maximise the NFM benefits. During landowner liaison with Breakchy Farm it was noted that one spillway functions more effectively than the other, highlighting the importance of hydraulic modelling to ensure the functionality and optimisation of these formalised breach points.

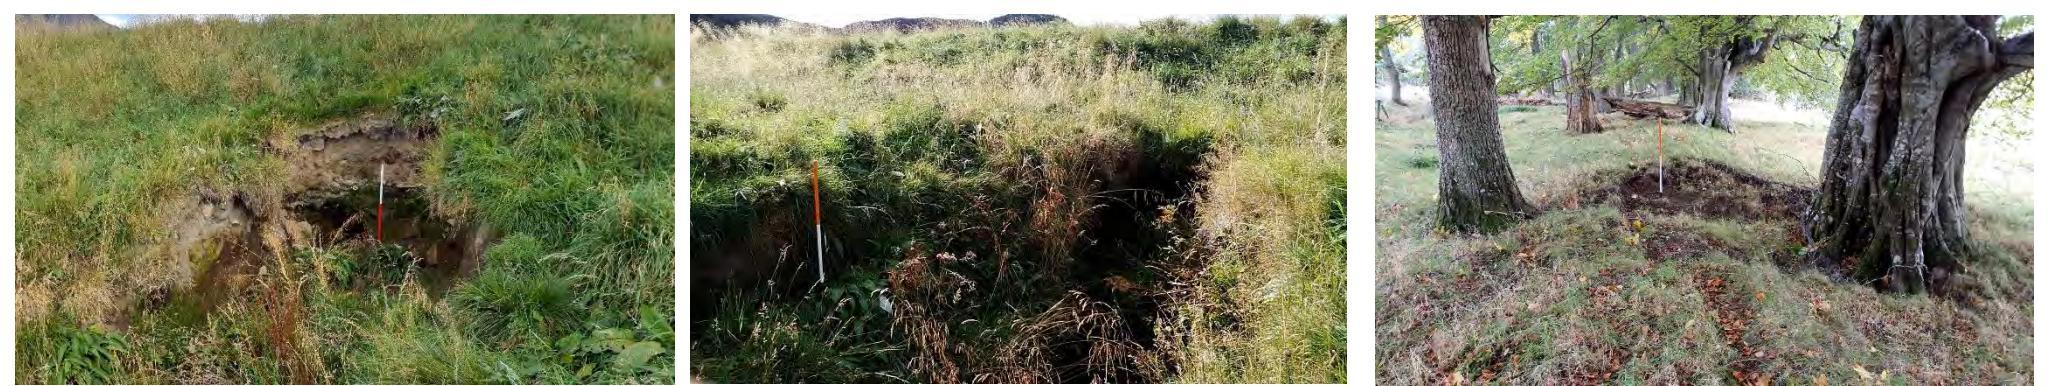
Figure 3.63 Culvert through the embankment with erosion around the inlet at Drumgask Farm (OS NGR NN 61927 94037).

Figure 3.64 Culvert with erosion around the outlet at Drumgask Farm (OS NGR NN 61927 94037).

undersized for the volume of water received (Figure 3.63). Riverbank erosion at the outlet could be reduced by tapering the bank line away from the outlet or extending the pipe to discharge into the River Spey at the bank toe, rather than set back into the bank (Figure 3.64).
