# Upper Spey Embankment Condition Assessment

Final Report

Cairngorms National Park Authority

cbec eco-engineering UK Ltd

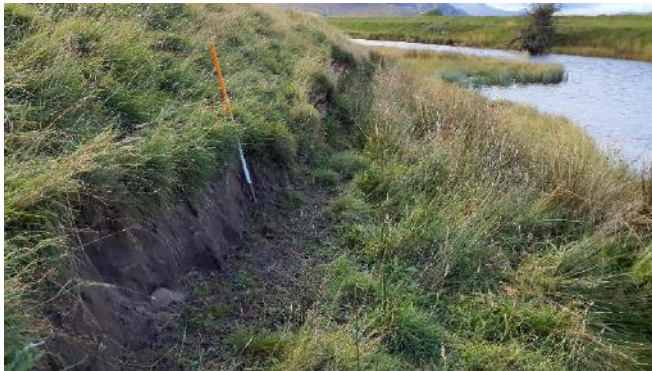
Figure 3.1. Low-severity riverbank erosion.

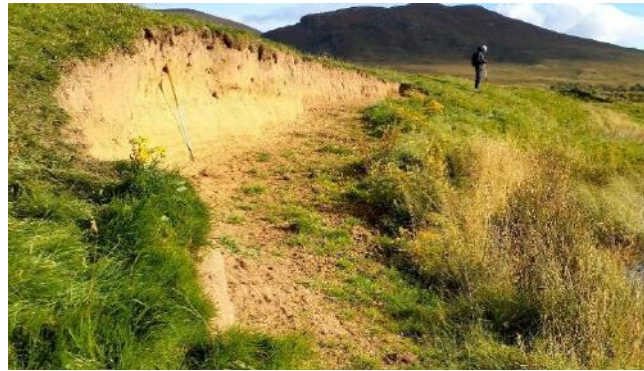
Figure 3.2 Moderate-severity riverbank erosion.

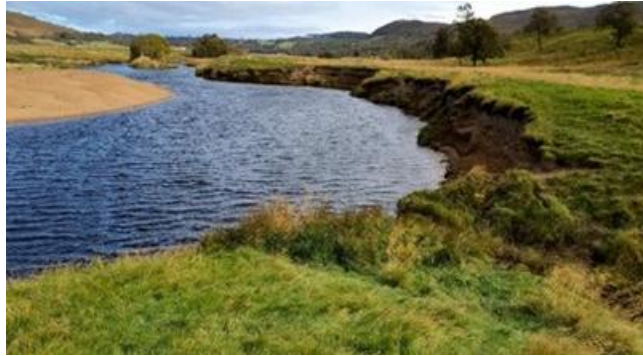
- **Channel planform.** In rivers, erosive force is focused around the outside of the meander bend, leading to natural lateral migration of the channel over time (Figure 3.8). Multiple areas of erosion around the outsides of meander bends were noted, particularly where riparian vegetation was limited. It is understood that channel adjustment, while a natural river process, may be undesirable within an agricultural setting; therefore, this erosion could be managed by undertaking riparian planting and/or fencing along the bank to improve bank stability.

**Figure 3.8 Bank erosion on the outer bank of a meander is a natural process in meandering channels. Native riparian planting and set-back fencing could promote increased stability in such areas over time.**

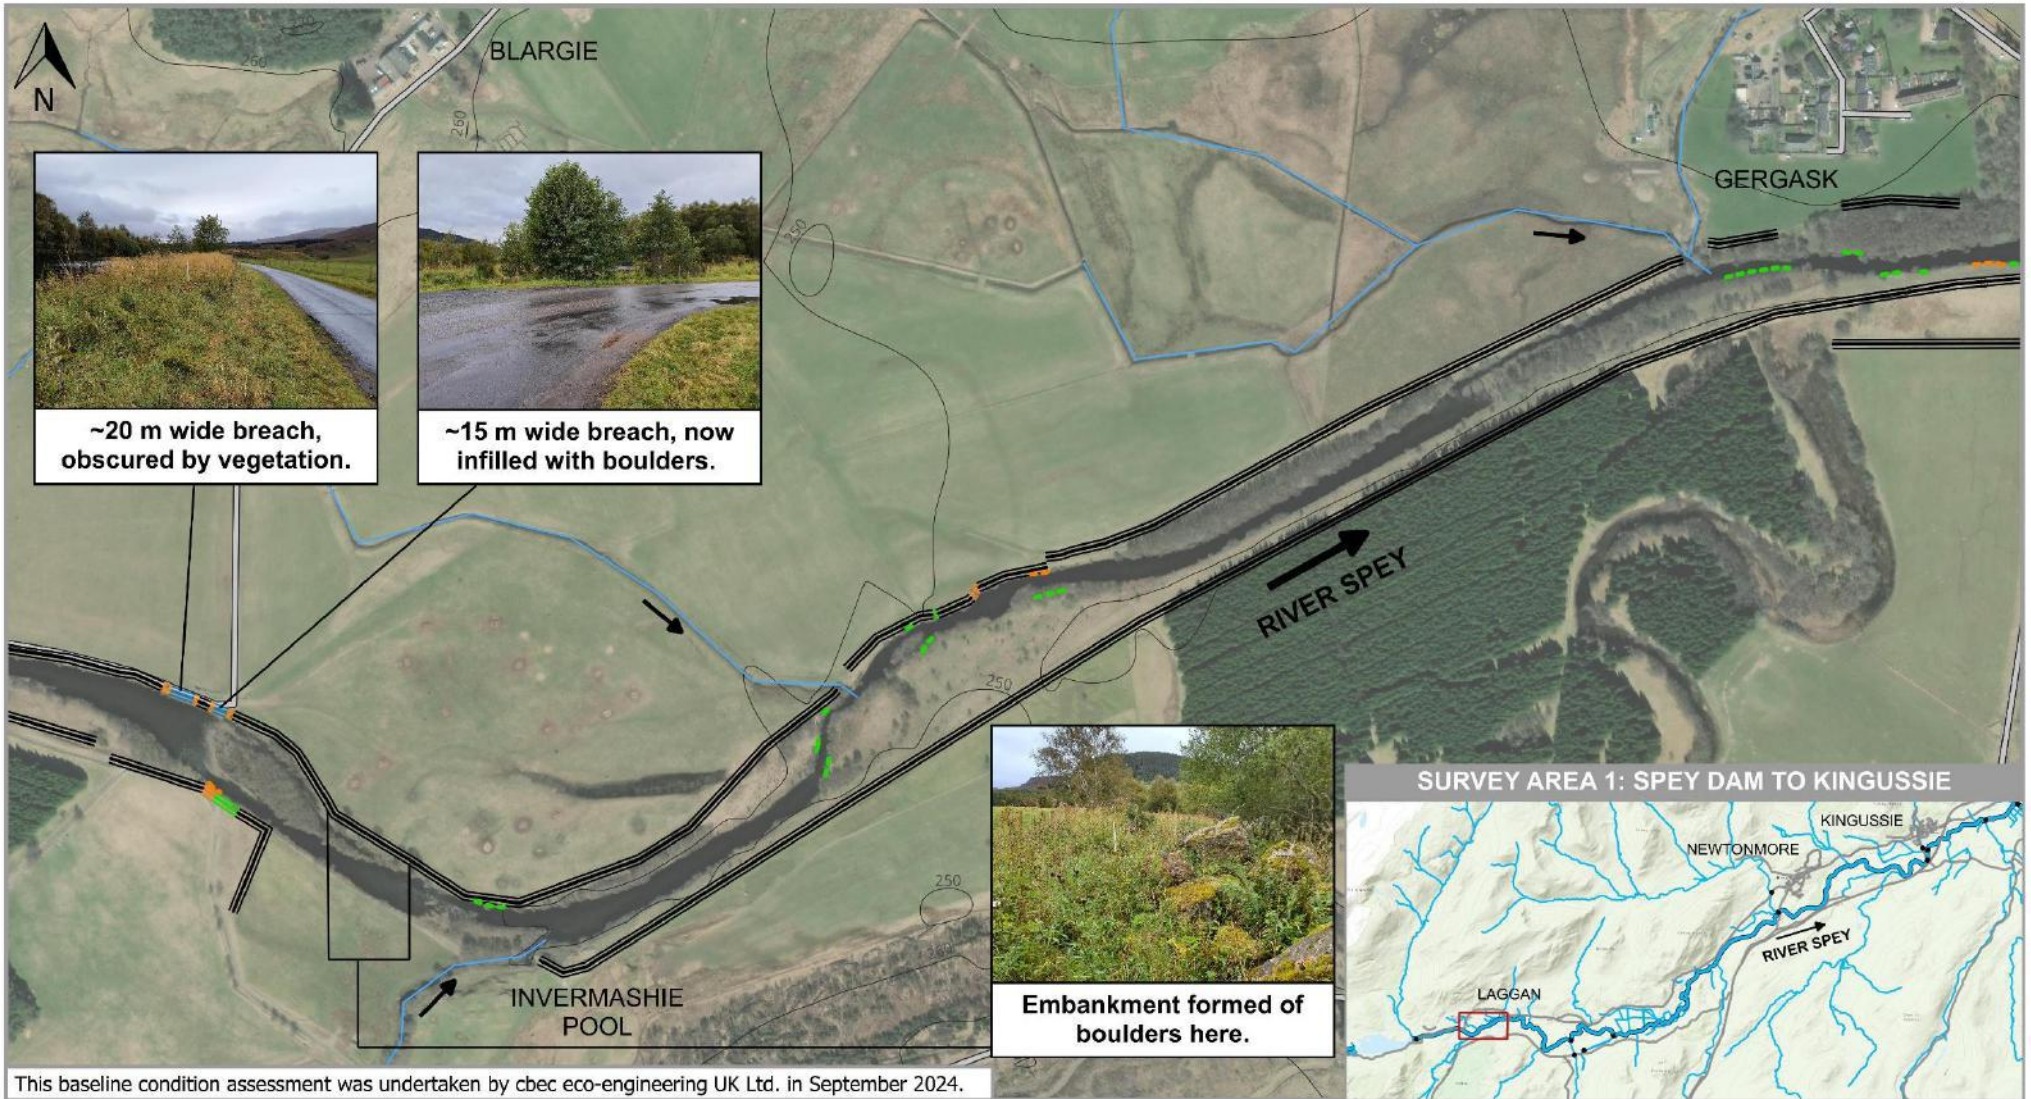
Figure 3.15 Area 1 - Map 2 showing the baseline survey results for the River Spey (Reach 1A).

- **Out-of-bank flow during flood events.** This flow is not bound by the orientation of the channel banks and therefore follows the most direct path. For example, at meander bends, out-of-bank flow can flow directly towards the embankment (e.g. as at the breaches on the river left (western) bank around the tight meander bend, located just upstream of the River Tromie confluence; Figure 3.32). Similarly, the presence of an island causes the flow to split around this mid-channel feature and flow directly towards the banks or embankment. This was observed as a contributing factor towards the breaches at Blargie Estate (Figure 3.15), which floods the access road.

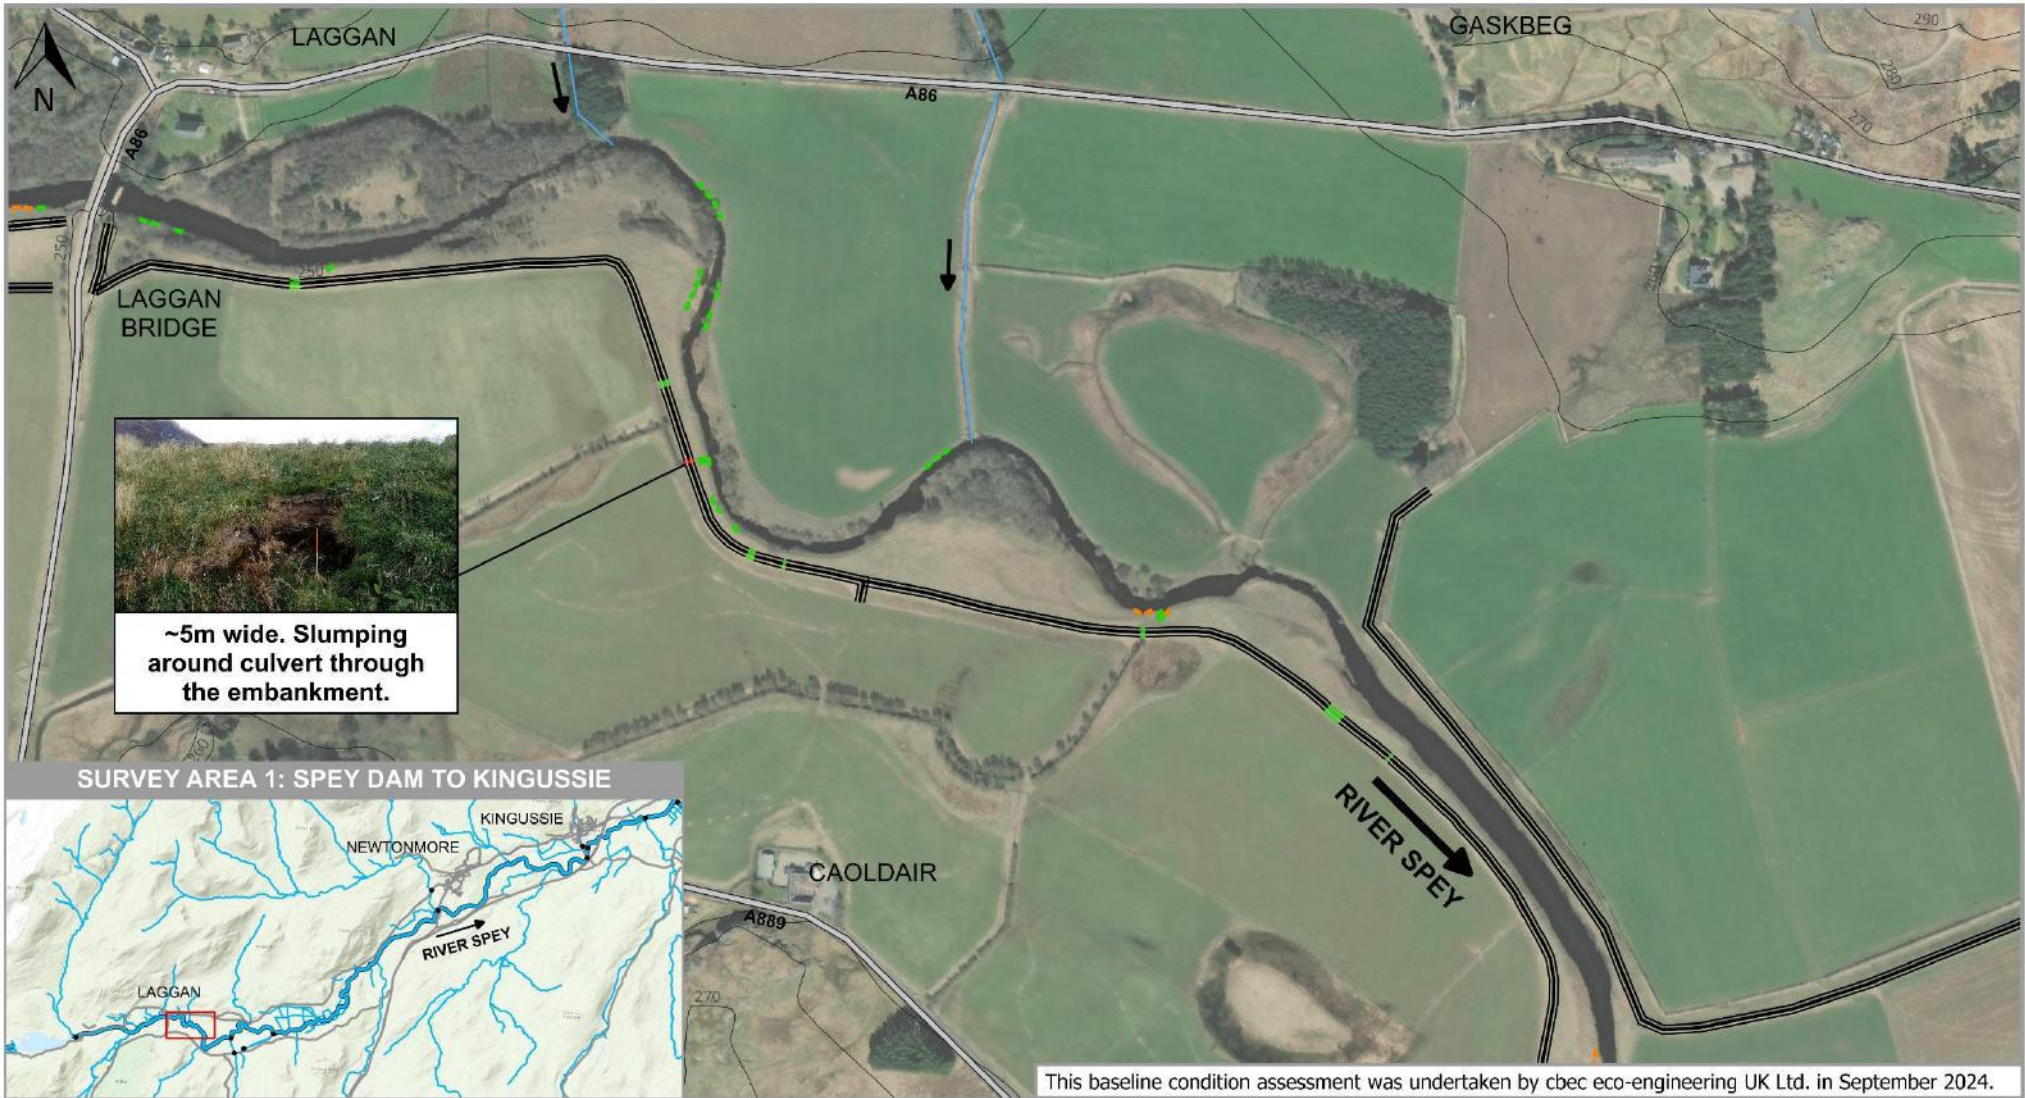
Figure 3.16 Area 1 - Map 3 showing the baseline survey results for the River Spey (Reach 1A).

At Drumgask Farm, culverts facilitating drainage through the embankment and into the River Spey were noted in three locations, two of which were experiencing erosion with potential risks to embankment stability (Figure 3.16). Culverts through an embankment have the potential to aid surface water flow as it recedes back to the River Spey following flood events, which can help to maintain the stability of the embankment by reducing pressure caused by the water stored behind it. The drainage channel banks and the face of the embankment around these pipes were noted to be eroding at Drumgask. This erosion may be due to the volume of water and narrow size of the pipe present.

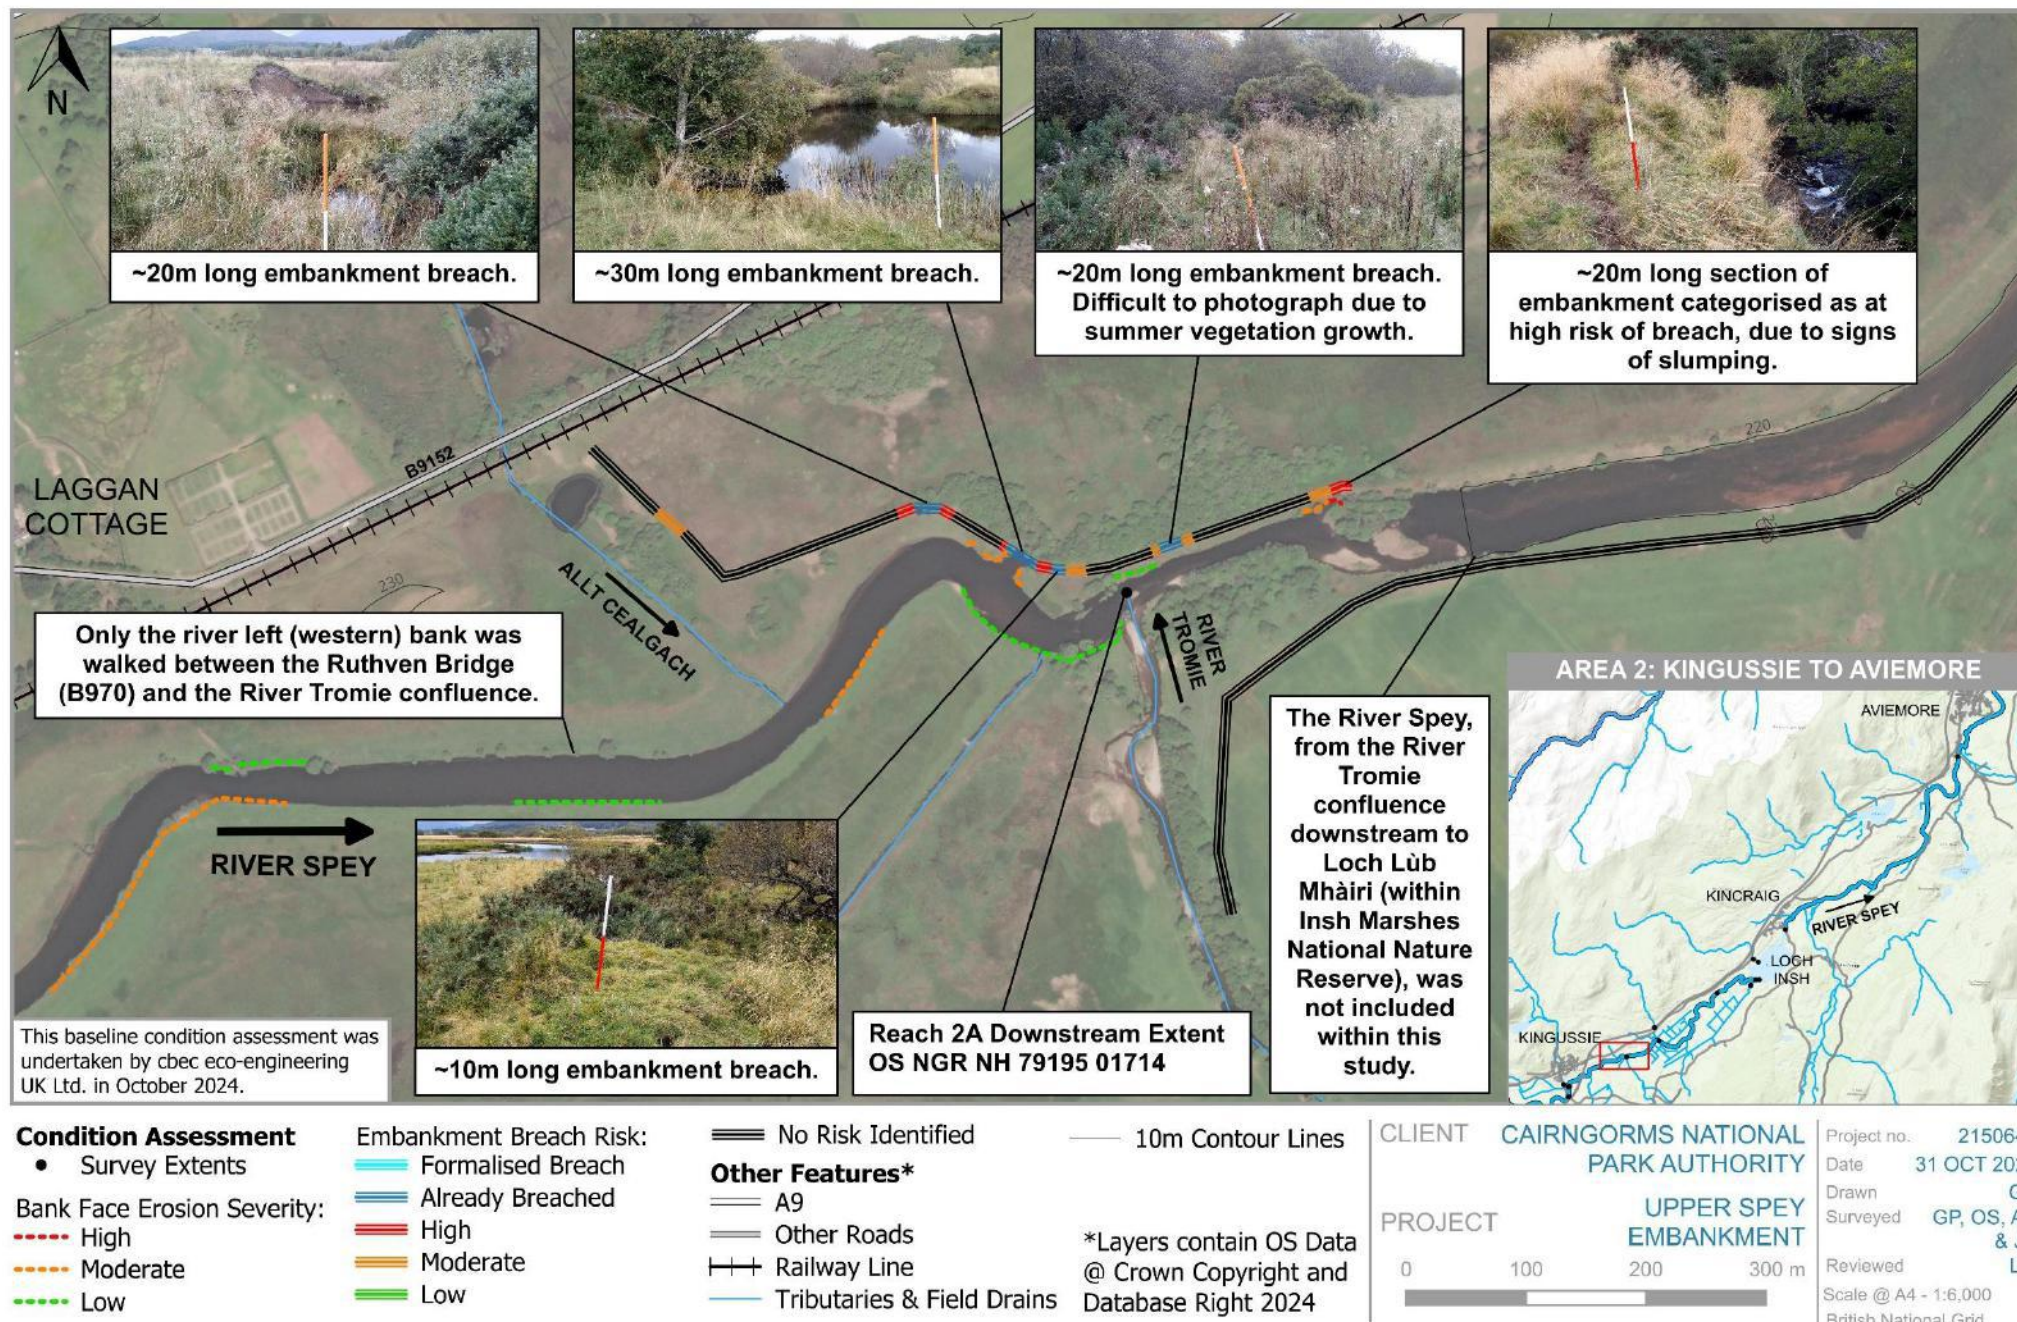
Figure 3.31 Area 2 - Map 1 showing the baseline survey results for the River Spey (Reach 2A) and the Gynack Burn (Reach 2B).

Downstream of Kingussie, moderate- to high-severity erosion was noted along the river right (eastern) bank (Figure 3.31 and Figure 3.32). Erosion severity within this area is likely related to the lack of riparian corridor vegetation, input from tributaries (i.e. Gynack Burn) and the meandering planform. As outlined in relation to Area 1, erosion around the outer bend of meanders is a natural process facilitating lateral channel adjustment. Therefore, the erosion noted between Kingussie and the River Tromie is not uncharacteristic of a meandering channel such as this section of the River Spey, although may be exacerbated by land use and management. A cluster of embankment breaches was noted around the River Tromie confluence (Figure 3.32). These breaches may be a result of the river planform (i.e. the flow of water exiting from the tight meander bend ~200 m upstream of the Tromie confluence) and the direction of flow from the tributary joining the main channel.

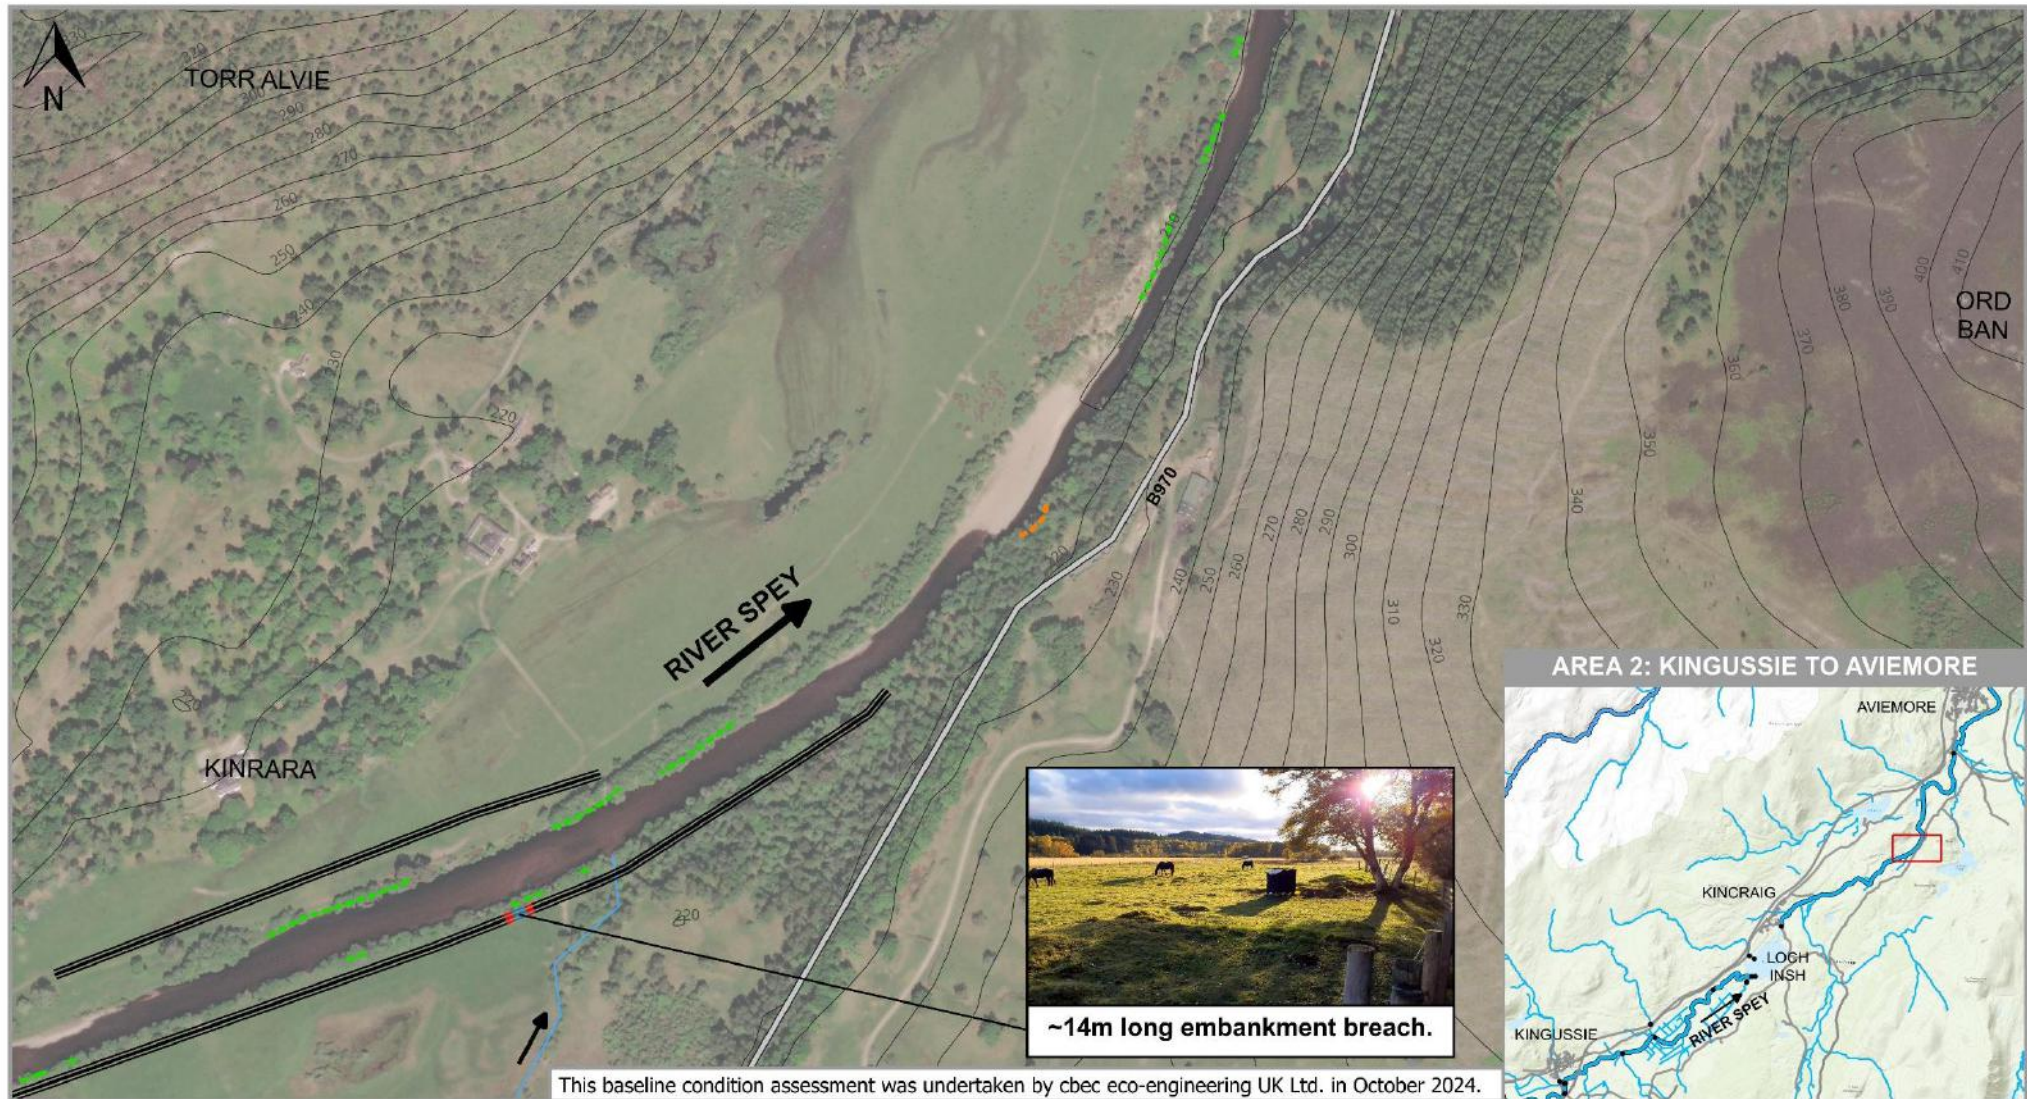
Figure 3.38 Area 2 - Map 8 showing the baseline survey results for the River Spey (Reach 2G).

localised areas, particularly around the outside bends of meanders, with embankments rarely impacted (Figure 3.38, Figure 3.40 and Figure 3.41).

Embankments on the left bank were rare throughout Reach 2G, with occasional sections noted around Kinrara (Figure 3.38 and Figure 3.39) and from the Allt-na-Criche confluence to Aviemore (Figure 3.41 and Figure 3.42). Slumping due to degradation of the embankment condition and trampling by livestock were noted to be the main factors influencing the risk of embankment breach within this reach. Trampling of the embankment by livestock in the lower section of Reach 2G, between Doune Farm and the Milton Burn confluence, was concentrated around mature trees. Livestock lying around, sheltering beneath or rubbing against these trees has led to increased footfall over these sections of the embankment, lowering the crest height and increasing the vulnerability of these areas to breaching. Erection of fencing along the riparian corridor would prevent livestock access to this area, allowing the embankment time to revegetate and increasing the sustainability of any remedial works undertaken.

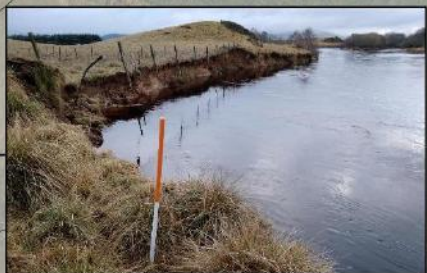
~40m long embankment breach.

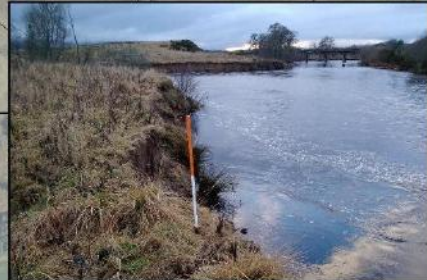
~140m long section of high severity bank erosion.

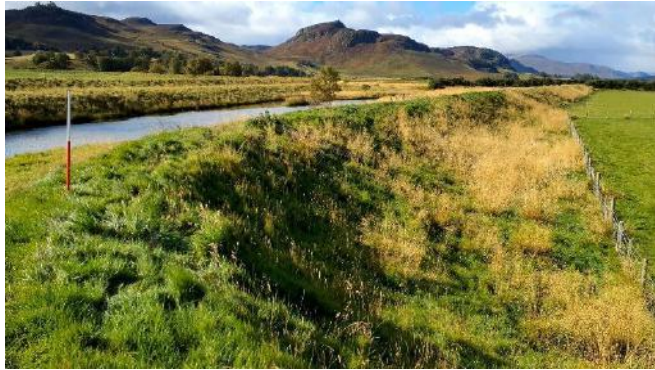
**Figure 3.60. Fencing positioned along the dry side (furthest from the channel) of embankments and river corridors to mitigate against trampling by livestock.**

- **Fencing** – Trampling by livestock was noted as the primary cause of embankment and riverbank erosion throughout Areas 1 and 2, where fencing was absent or discontinuous along the river corridor. It is noted that fencing along the river corridor is a substantial financial cost to landowners, and flood damage threatens the longevity and sustainability of these boundary lines. Recording the extent and condition of fence lines was not included within the scope of the walkover. However, it was observed that fences positioned on the dry side (i.e. furthest from the channel), directly behind the embankment were in better condition overall (Figure 3.60). This suggests that this positioning shelters the fence lines from the floodwater. Embankments and riverbanks separated from livestock by a continuous fence were found to be in good condition, with continuous vegetation cover and an absence of bare soil or damage/pitting to the ground surface. Therefore, it was concluded that the risk to embankments/riverbanks could be substantially reduced through improved fencing.

Primarily, it is recommended that fences are installed along the river corridor if absent or set back to the dry side of the embankment if already present, to help reduce erosional pressure on the embankment in reaches with moderate and high breach risk/erosion severity. However, continuous fencing along the river corridor throughout the study areas would provide the greatest benefit for erosion and breach prevention. Livestock drinking stations may also need to be installed in combination with this fencing work if the river is currently used as a drinking point.

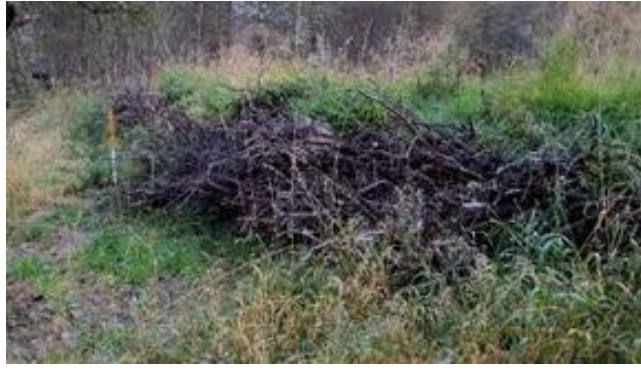
**Figure 3.61 Example embankment breach remedial works. Large wood (trunks with root plates still attached) installed to protect the embankment face (OS NGR NH 88320 09028).**

- **Remedial works** – High erosion risk or already breached locations should be prioritised for remedial works to prevent further deterioration or expansion of these sections. Remedial works could include formalisation of the existing breach for Natural Flood Management (NFM) benefit, as outlined in the point below, or reinstatement of the embankment to pre-breach conditions (which could include embankment face protection such as that observed along a ~25 m section of embankment near West Lodge; Figure 3.61). Remedial works may be essential in some locations to facilitate access or land management practices, such as the road through Blargie Estate (Figure 3.14). However, it is recommended that some existing breaches are formalised to facilitate temporary floodplain storage and deliver NFM benefits. Remedial works are noted to have already been carried out for a breach at Balliefuth Farm (Reach 3A) and to repair a section of eroding embankment surface at Tomachrochar, upstream of the dismantled railway embankment on the river right side of the Spey. For increased longevity of such remedial works, it is recommended that the surface vegetation of the embankment is removed as sheets of turf, the damage to the embankment infilled and compacted with an excavator bucket, before being re-turfed to ensure stability.

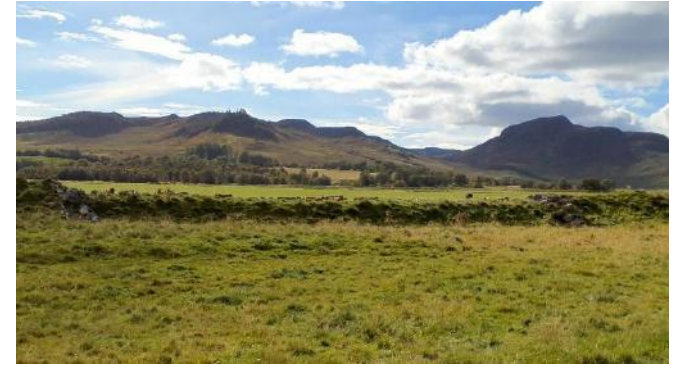
**Figure 3.62. Lowering of the embankment crest to form a spillway (formalised embankment breach) at Breakachy Farm (OS NGR NN 64187 93793).**

sections of the embankment have been lowered and reinforced with stone or concrete to form floodwater spillways at Breakachy Farm (Figure 3.18) and (2) a naturally formed embankment breach at Cluny Farm (Figure 3.20 and Figure 3.62). Anecdotal evidence suggested that the latter is thought to be providing flood alleviation benefits to neighbouring landowners, by enabling temporary floodplain storage within the field behind the breach.

Flood modelling would be required to identify the most beneficial locations and optimal lengths of spillway required to maximise the NFM benefits. During landowner liaison with Breakachy Farm it was noted that one spillway functions more effectively than the other, highlighting the importance of hydraulic modelling to ensure the functionality and optimisation of these formalised breach points.

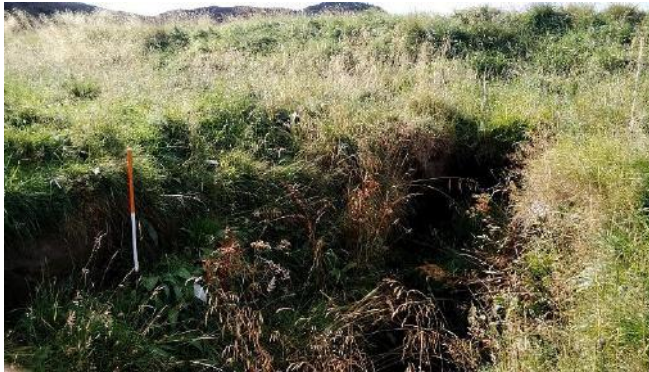
**Figure 3.64 Culvert with erosion around the outlet at Drumgask Farm (OS NGR NN 61927 94037).**

undersized for the volume of water received (Figure 3.63). Riverbank erosion at the outlet could be reduced by tapering the bank line away from the outlet or extending the pipe to discharge into the River Spey at the bank toe, rather than set back into the bank (Figure 3.64).
