# Upper Spey Embankment Condition Assessment

Final Report

Cairngorms National Park Authority

cbec eco-engineering UK Ltd

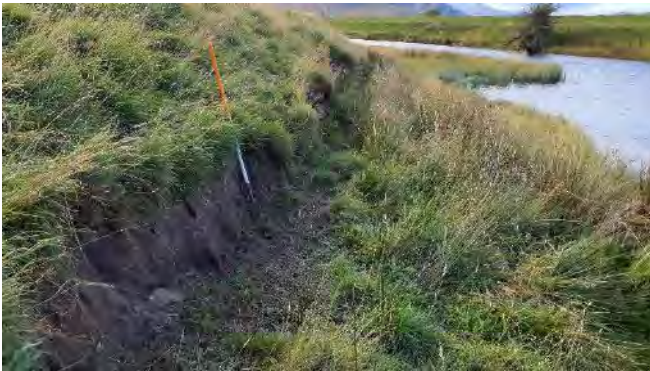
Figure 3.1. Low-severity riverbank erosion.

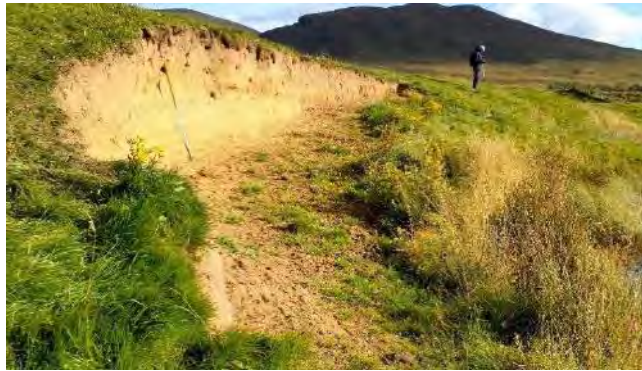
Figure 3.2 Moderate-severity riverbank erosion.

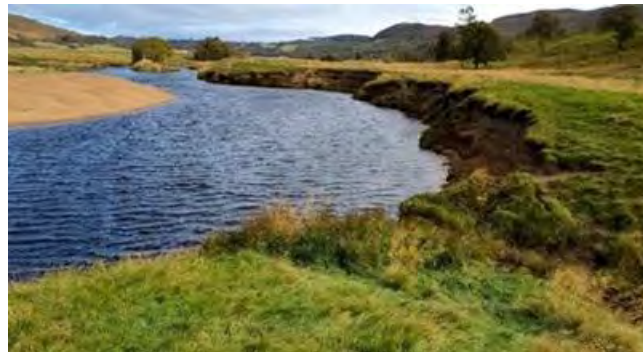
**Figure 3.8** Bank erosion on the outer bank of a meander is a natural process in meandering channels. Native riparian planting and set-back fencing could promote increased stability in such areas over time.

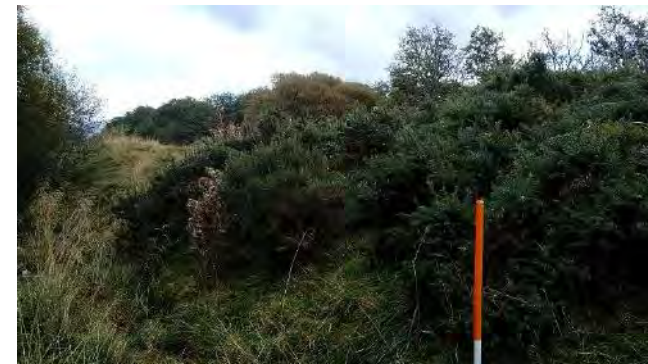
**Figure 3.9.** Scrub growth on the crest and face of an embankment.

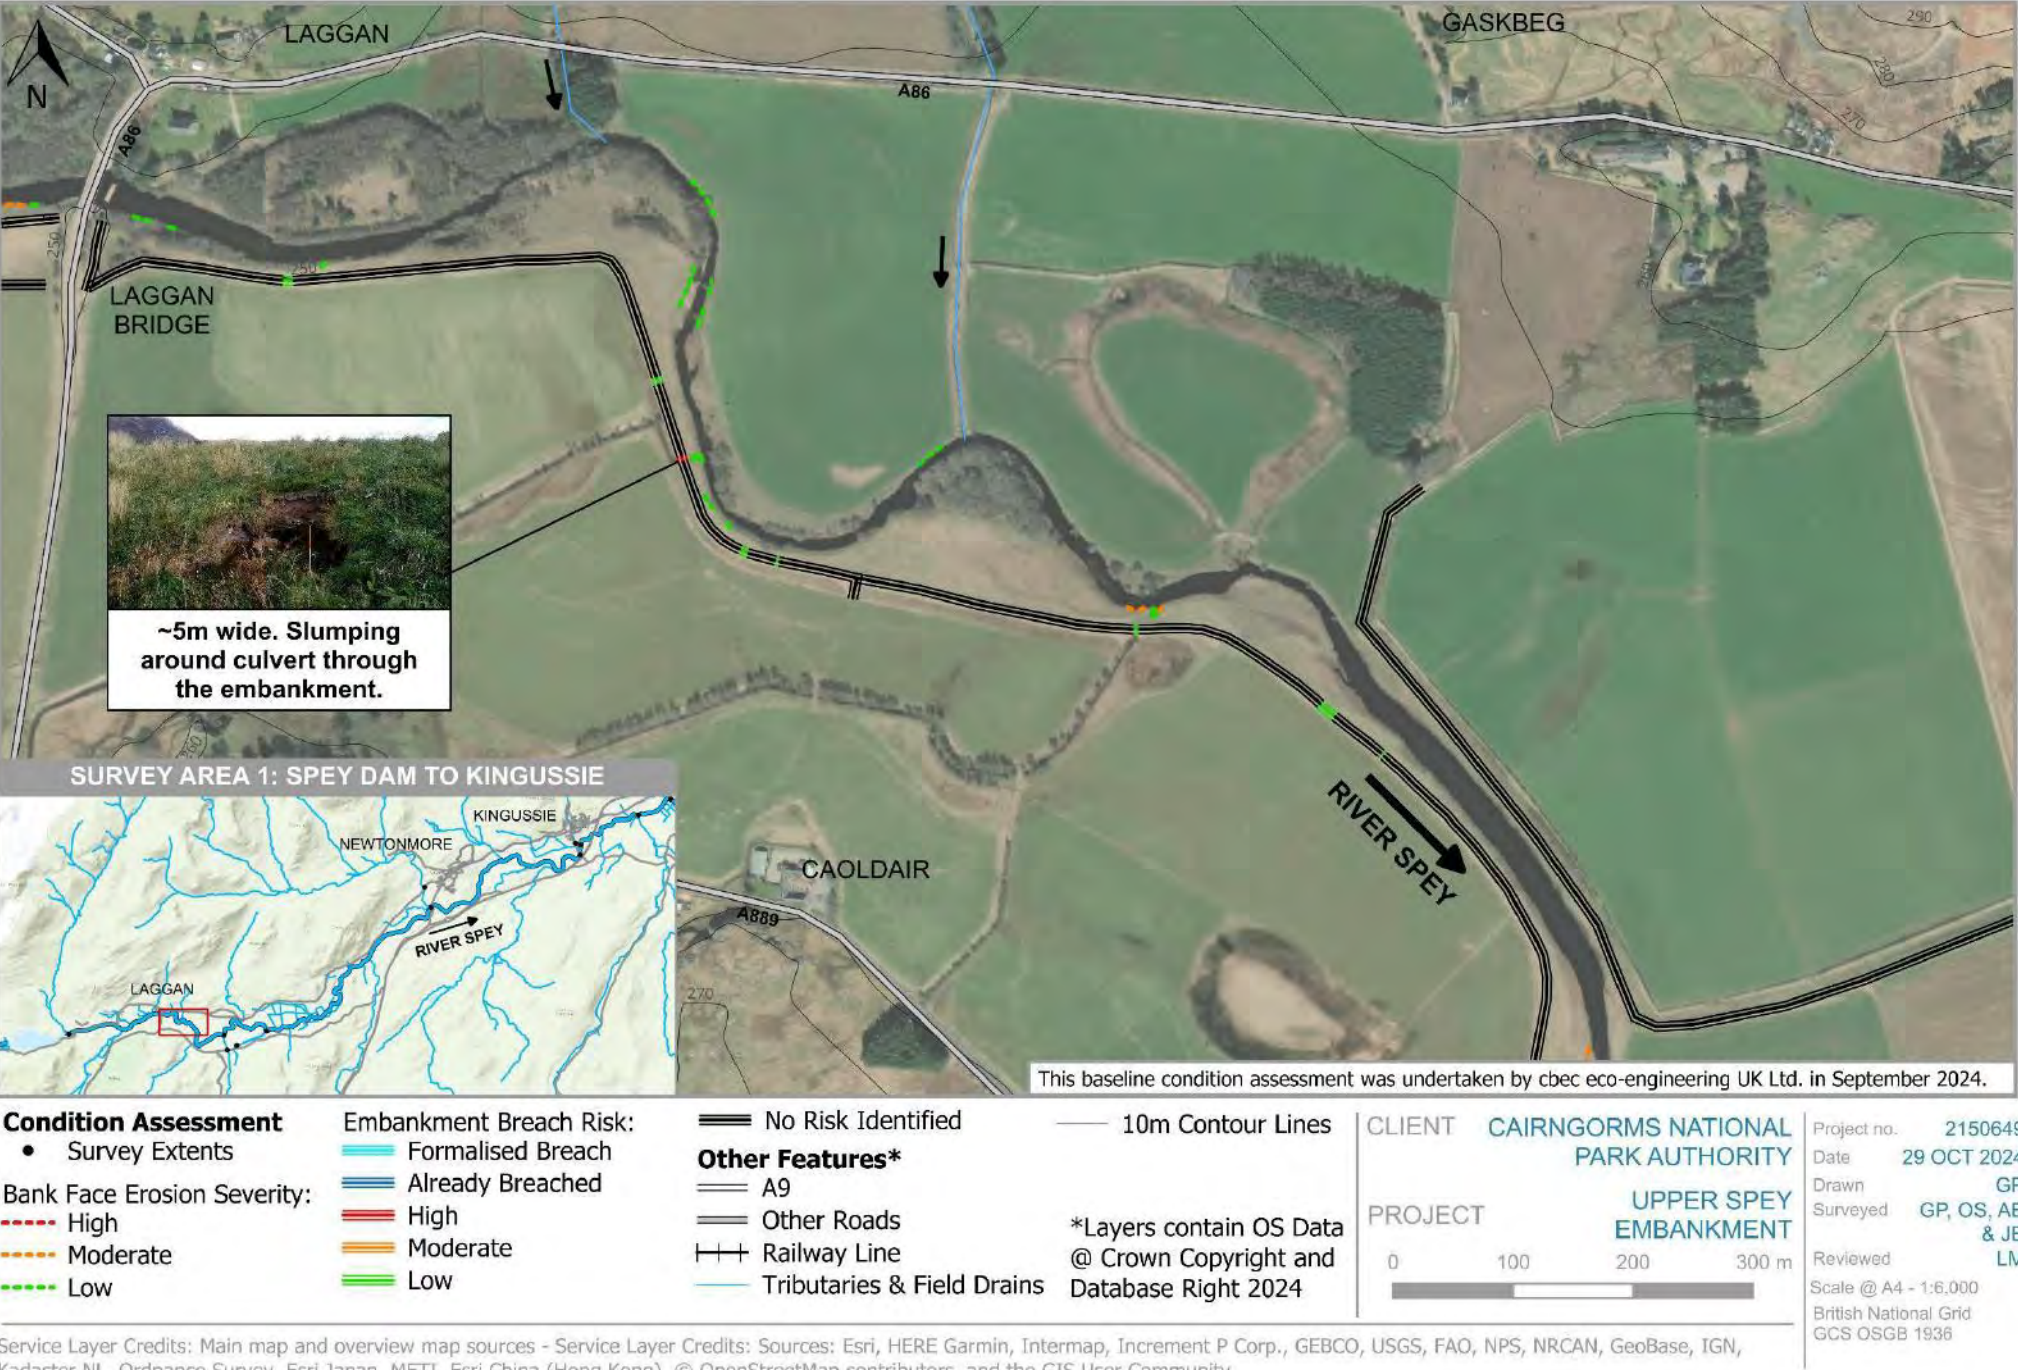
Figure 3.16 Area 1 - Map 3 showing the baseline survey results for the River Spey (Reach 1A).

At Drumgask Farm, culverts facilitating drainage through the embankment and into the River Spey were noted in three locations, two of which were experiencing erosion with potential risks to embankment stability (Figure 3.16). Culverts through an embankment have the potential to aid surface water flow as it recedes back to the River Spey following flood events, which can help to maintain the stability of the embankment by reducing pressure caused by the water stored behind it. The drainage channel banks and the face of the embankment around these pipes were noted to be eroding at Drumgask. This erosion may be due to the volume of water and narrow size of the pipe present.

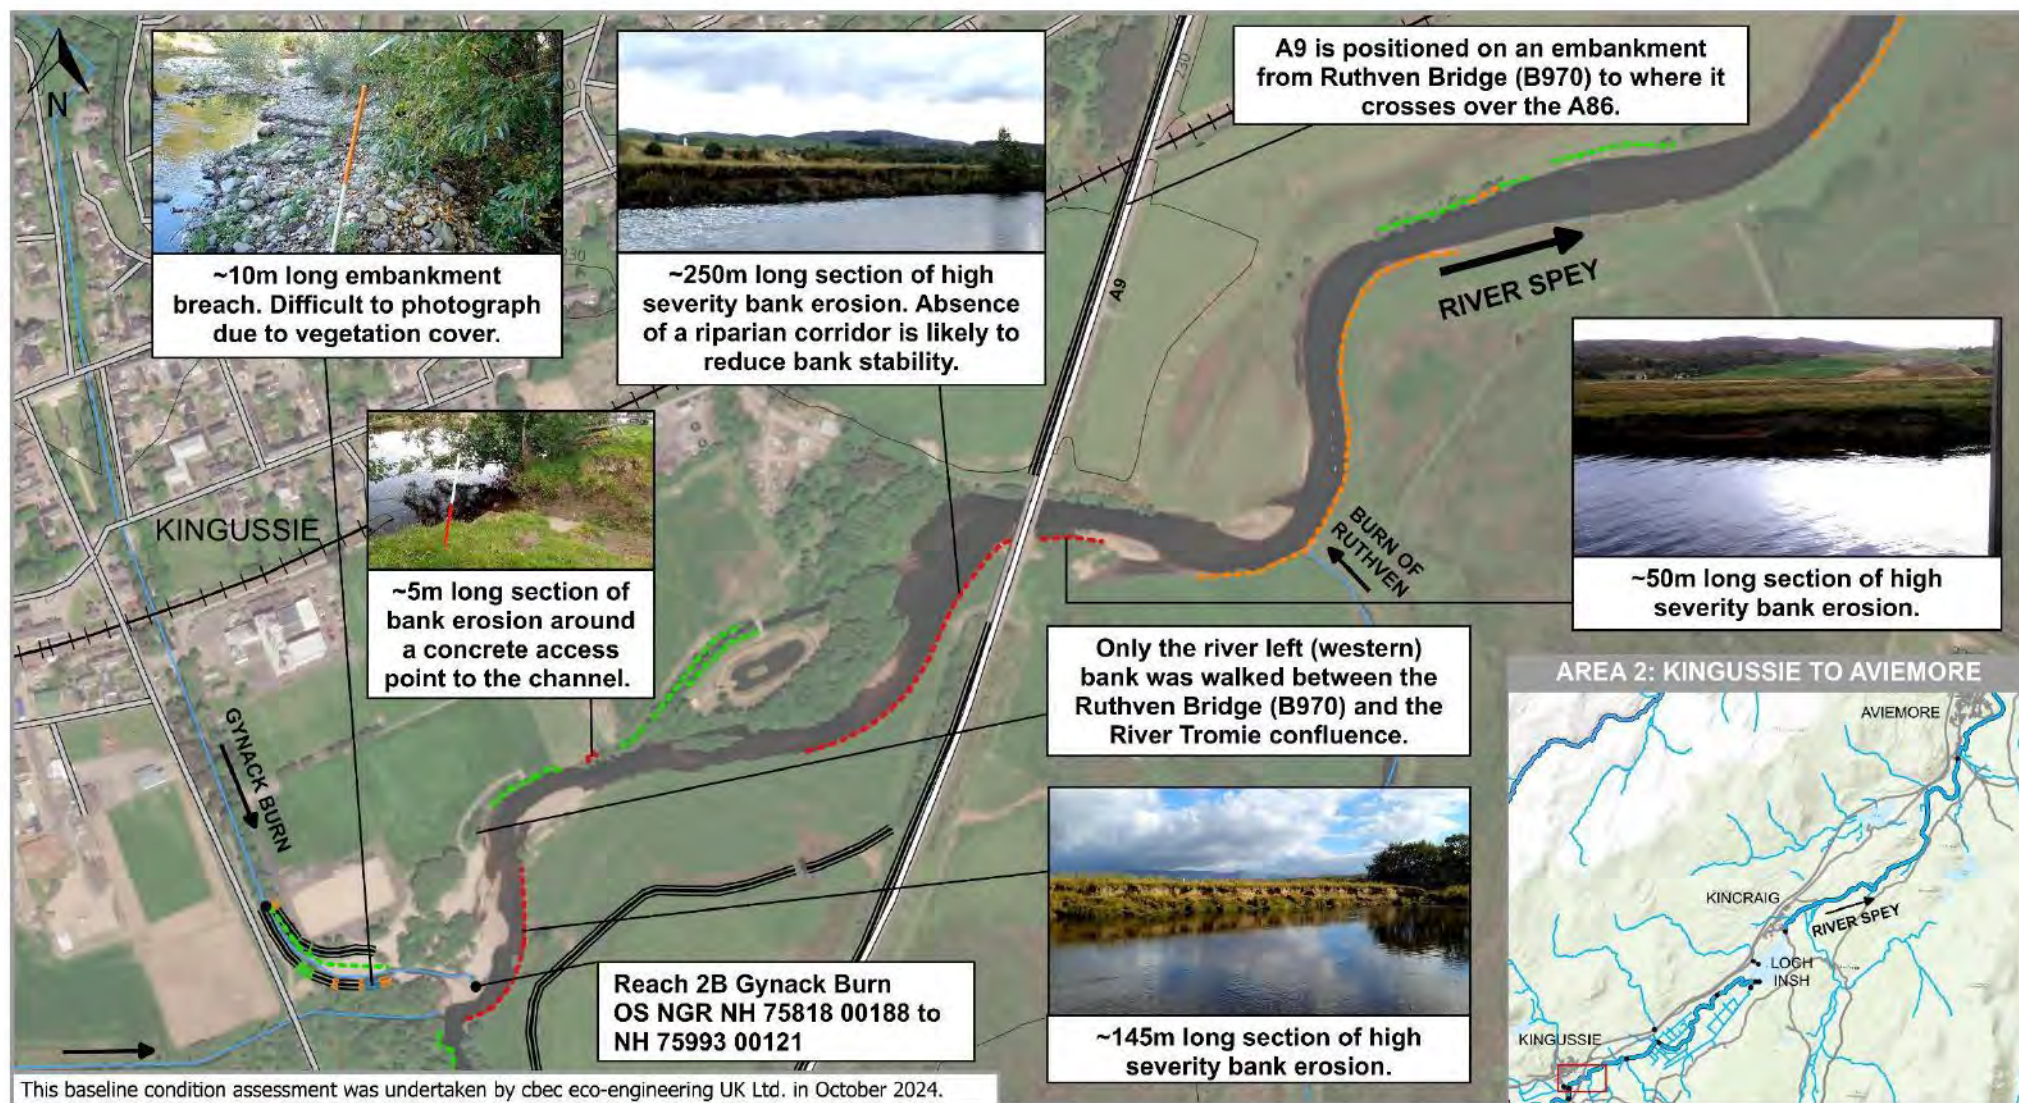
Figure 3.31 Area 2 - Map 1 showing the baseline survey results for the River Spey (Reach 2A) and the Gynack Burn (Reach 2B).

Downstream of Kingussie, moderate- to high-severity erosion was noted along the river right (eastern) bank (Figure 3.31 and Figure 3.32). Erosion severity within this area is likely related to the lack of riparian corridor vegetation, input from tributaries (i.e. Gynack Burn) and the meandering planform. As outlined in relation to Area 1, erosion around the outer bend of meanders is a natural process facilitating lateral channel adjustment. Therefore, the erosion noted between Kingussie and the River Tromie is not uncharacteristic of a meandering channel such as this section of the River Spey, although may be exacerbated by land use and management. A cluster of embankment breaches was noted around the River Tromie confluence (Figure 3.32). These breaches may be a result of the river planform (i.e. the flow of water exiting from the tight meander bend ~200 m upstream of the Tromie confluence) and the direction of flow from the tributary joining the main channel.

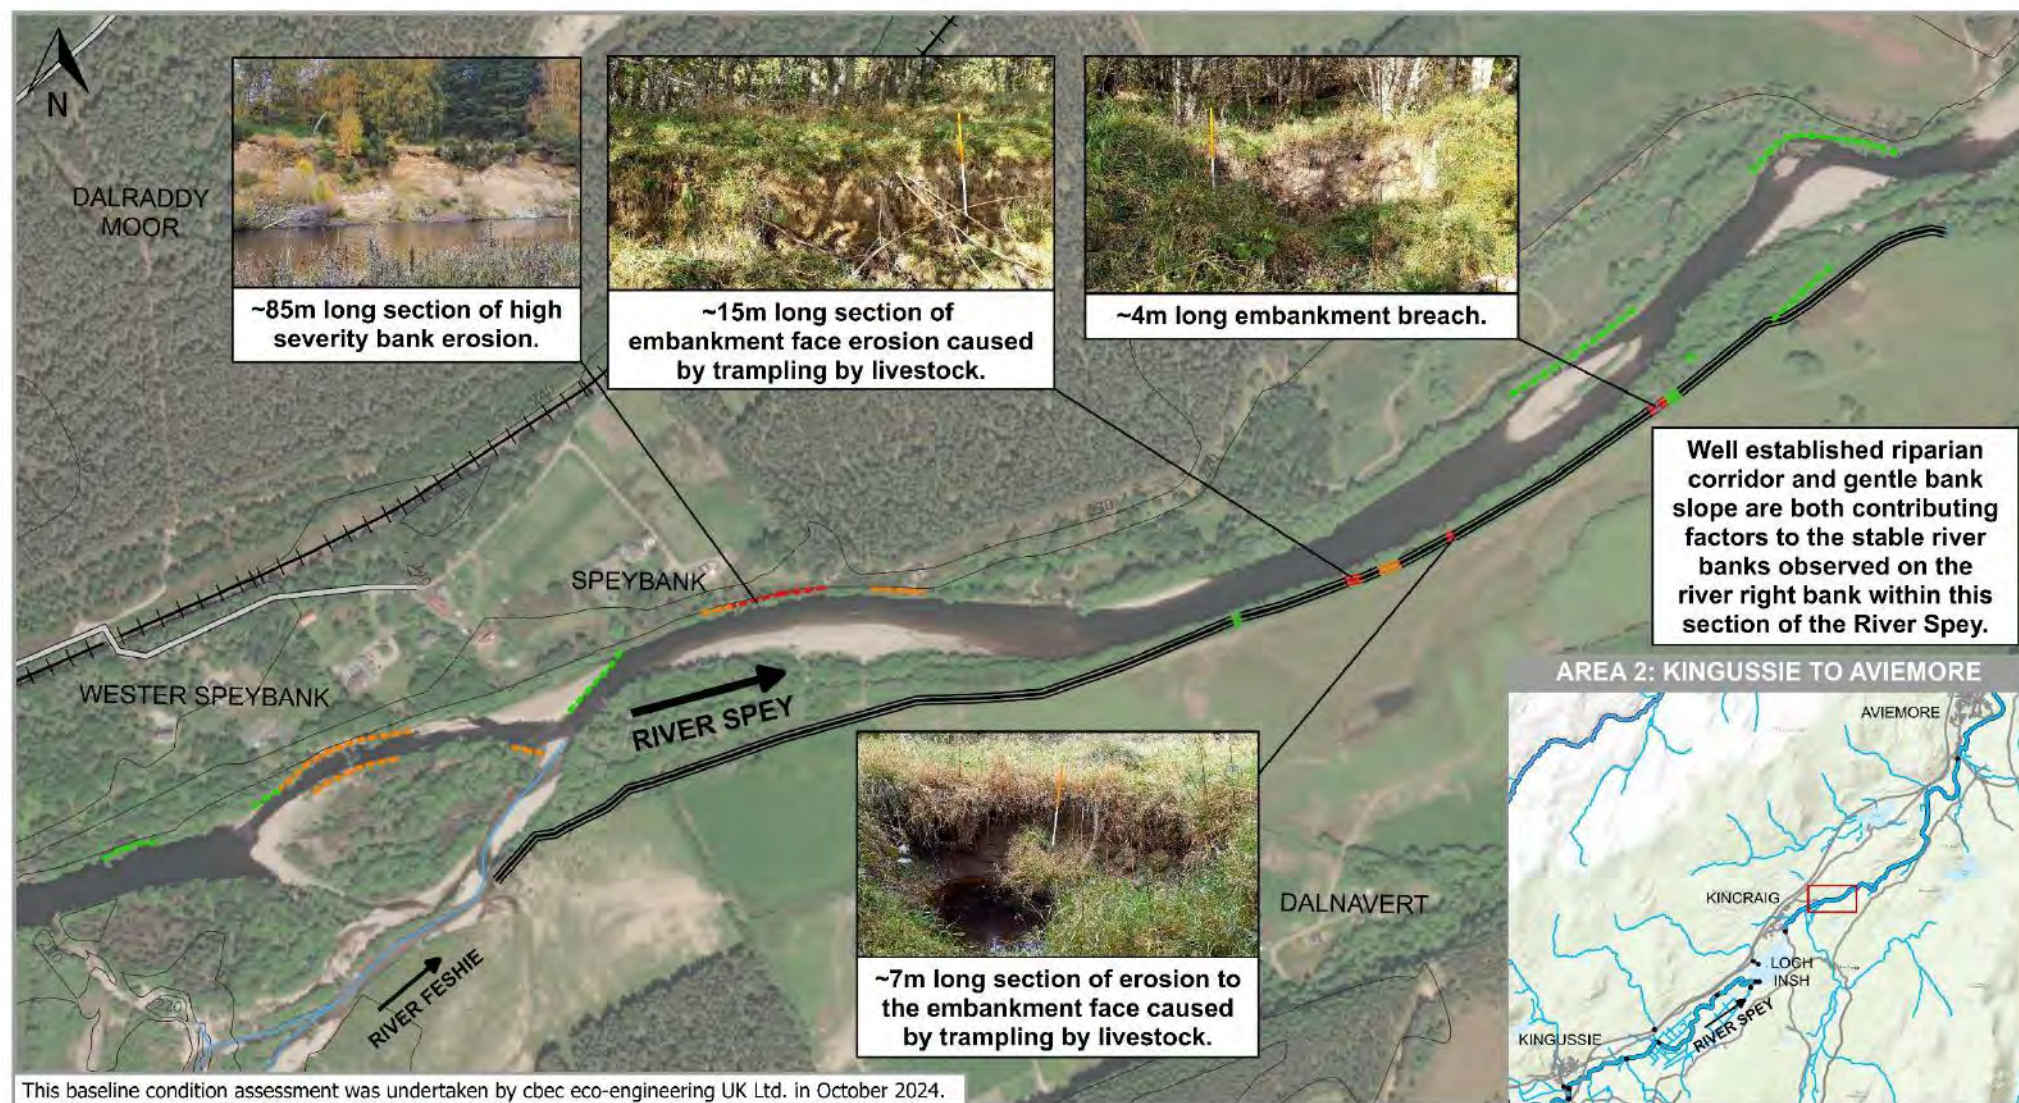
Figure 3.36 Area 2 - Map 6 showing the baseline survey results for the River Spey (Reach 2G).

Downstream of Loch Insh, the River Spey was surveyed from Kinraig downstream to the B970 bridge on the southern side of Aviemore (Reach 2G; Figure 3.36 to Figure 3.42). Steep banks are present on the river left (western) side of the Spey throughout the first ~2.3 km of this section, with moderate- to high-severity erosion recorded between Wester Speybank and Speybank, owing to the height and sheer face of this part of the bank. Throughout the remainder of this reach, the riverbanks were found to be well vegetated, with a combination of ruderal vegetation and tree cover within the riparian corridor. Resultant of the vegetation cover and gentle gradient, most of the riverbanks within Reach 2G were classified as exhibiting low-severity or no erosion, not deemed to be significant enough to pose a threat to the embankments. Occasional moderate- to high-severity erosion was noted in

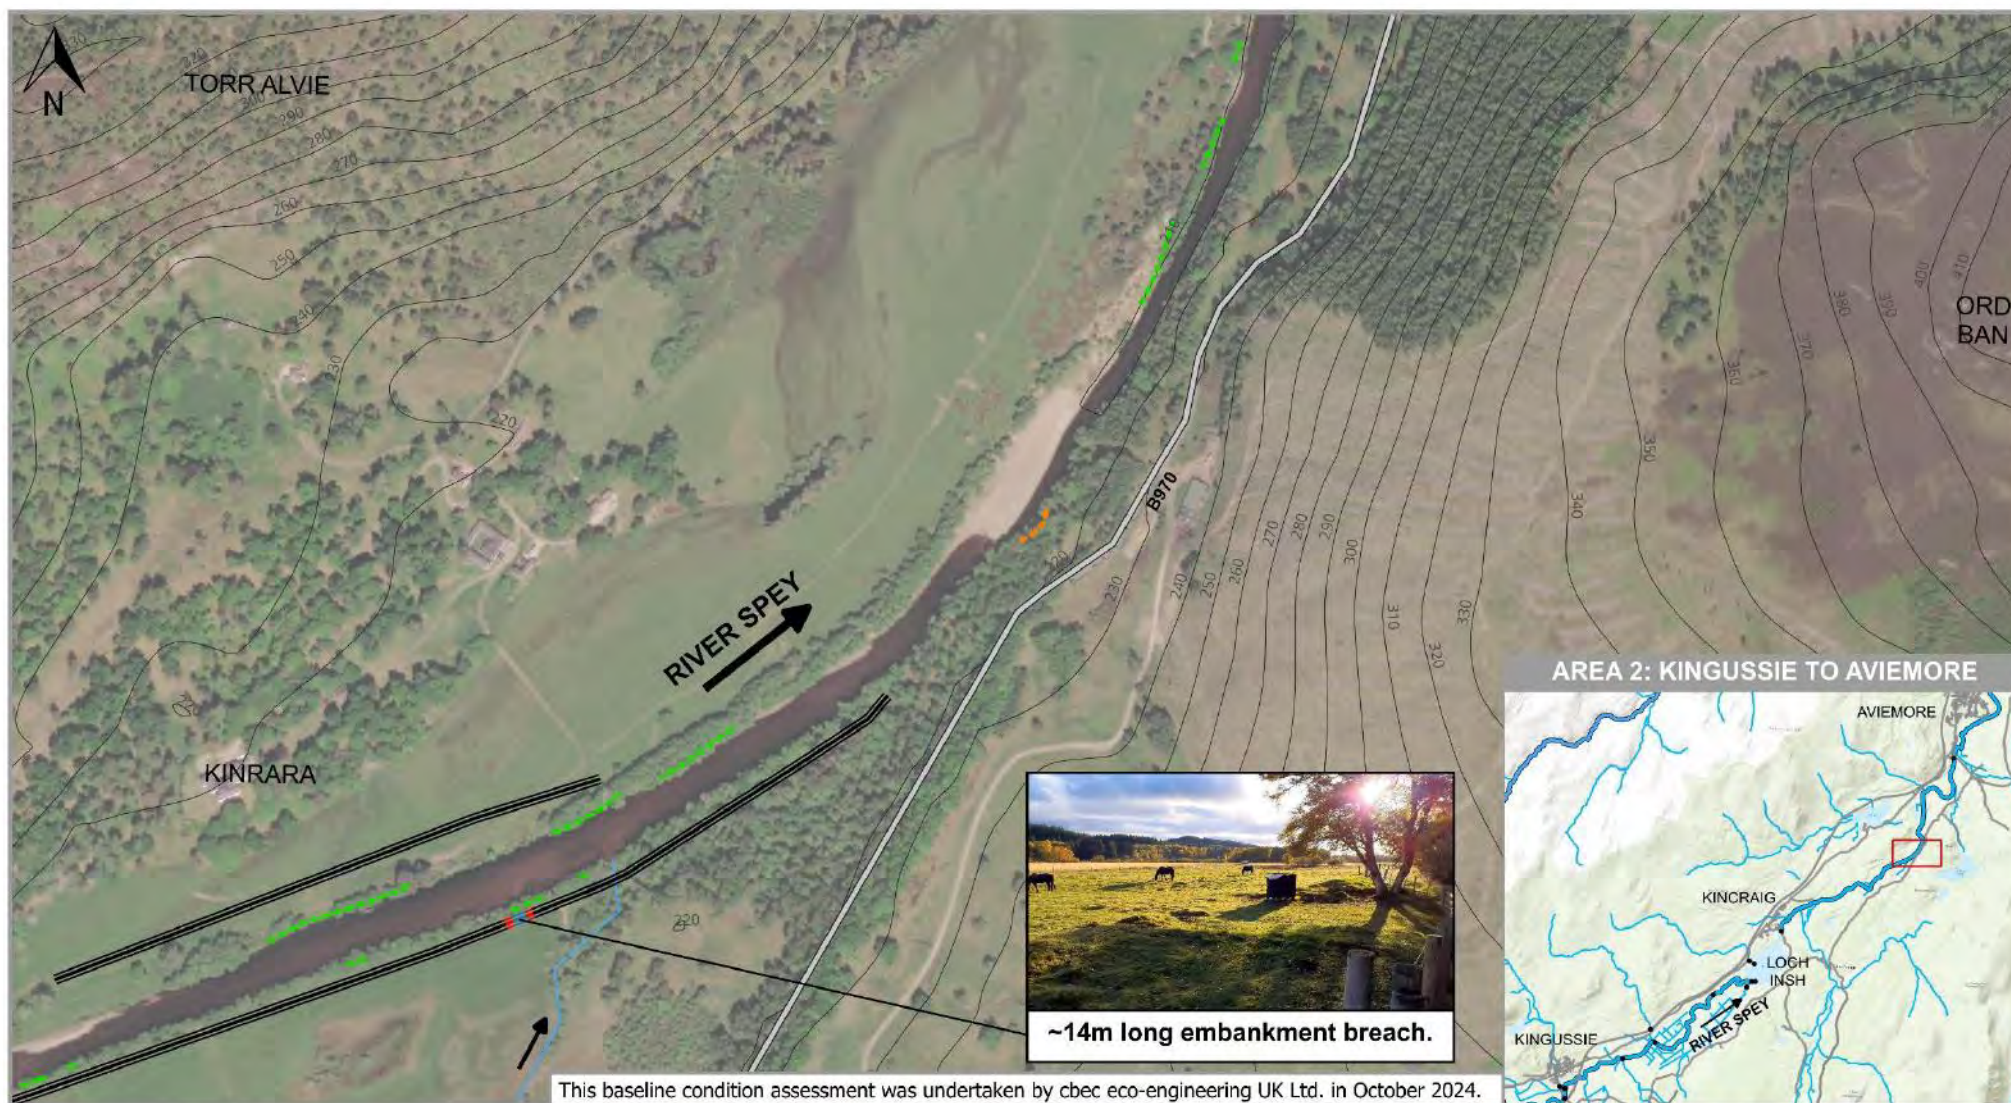
Figure 3.38 Area 2 - Map 8 showing the baseline survey results for the River Spey (Reach 2G).

localised areas, particularly around the outside bends of meanders, with embankments rarely impacted (Figure 3.38, Figure 3.40 and Figure 3.41).

Embankments on the left bank were rare throughout Reach 2G, with occasional sections noted around Kinrara (Figure 3.38 and Figure 3.39) and from the Allt-na-Criche confluence to Aviemore (Figure 3.41 and Figure 3.42). Slumping due to degradation of the embankment condition and trampling by livestock were noted to be the main factors influencing the risk of embankment breach within this reach. Trampling of the embankment by livestock in the lower section of Reach 2G, between Doune Farm and the Milton Burn confluence, was concentrated around mature trees. Livestock lying around, sheltering beneath or rubbing against these trees has led to increased footfall over these sections of the embankment, lowering the crest height and increasing the vulnerability of these areas to breaching. Erection of fencing along the riparian corridor would prevent livestock access to this area, allowing the embankment time to revegetate and increasing the sustainability of any remedial works undertaken.

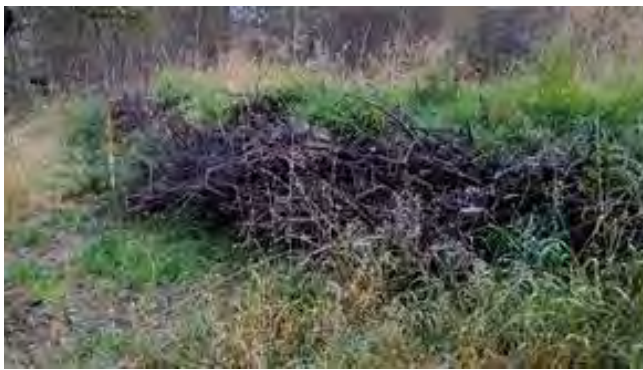
Figure 3.61 Example embankment breach remedial works. Large wood (trunks with root plates still attached) installed to protect the embankment face (OS NGR NH 88320 09028).

- **Remedial works** – High erosion risk or already breached locations should be prioritised for remedial works to prevent further deterioration or expansion of these sections. Remedial works could include formalisation of the existing breach for Natural Flood Management (NFM) benefit, as outlined in the point below, or reinstatement of the embankment to pre-breach conditions (which could include embankment face protection such as that observed along a ~25 m section of embankment near West Lodge; Figure 3.61). Remedial works may be essential in some locations to facilitate access or land management practices, such as the road through Blargie Estate (Figure 3.14). However, it is recommended that some existing breaches are formalised to facilitate temporary floodplain storage and deliver NFM benefits. Remedial works are noted to have already been carried out for a breach at Balliefuth Farm (Reach 3A) and to repair a section of eroding embankment surface at Tomachrochar, upstream of the dismantled railway embankment on the river right side of the Spey. For increased longevity of such remedial works, it is recommended that the surface vegetation of the embankment is removed as sheets of turf, the damage to the embankment infilled and compacted with an excavator bucket, before being re-turfed to ensure stability.
