2016/0295/DET

APPLICANT RESPONSE  
TO CONTRIBUTIONS

# CML responses to representations relating to the access track alongside the new Sheiling Tow.

## Planning application (2016/0295/DET)

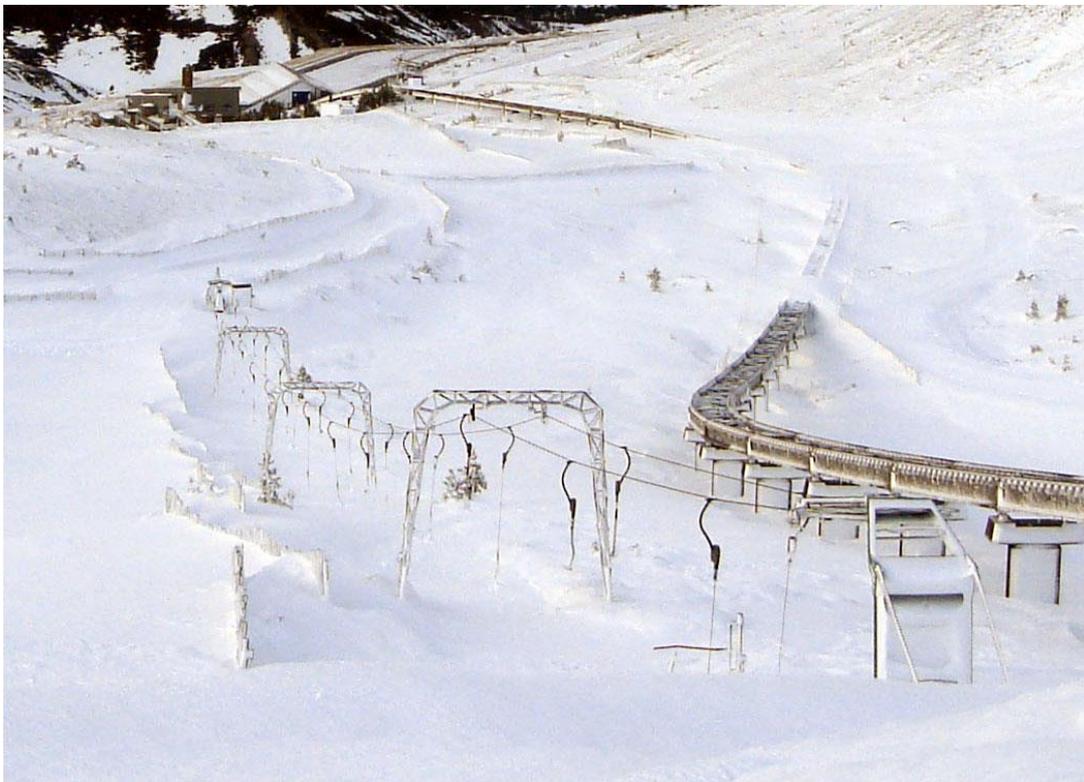
*Image showing original locations of pine trees in old tow track embankments, which had to be moved and was part of re-grading under planning approval.*

5. The new Sheiling tow requires less mid-point maintenance as it has no interim towers (see image above) but all ski lifts require maintenance at the drive stations and return stations. CML has never stated that a service track was no longer required. All lifts require access at times, the type of access is dependent on the yearly maintenance programme. Every tow now requires a yearly return wheel inspection where

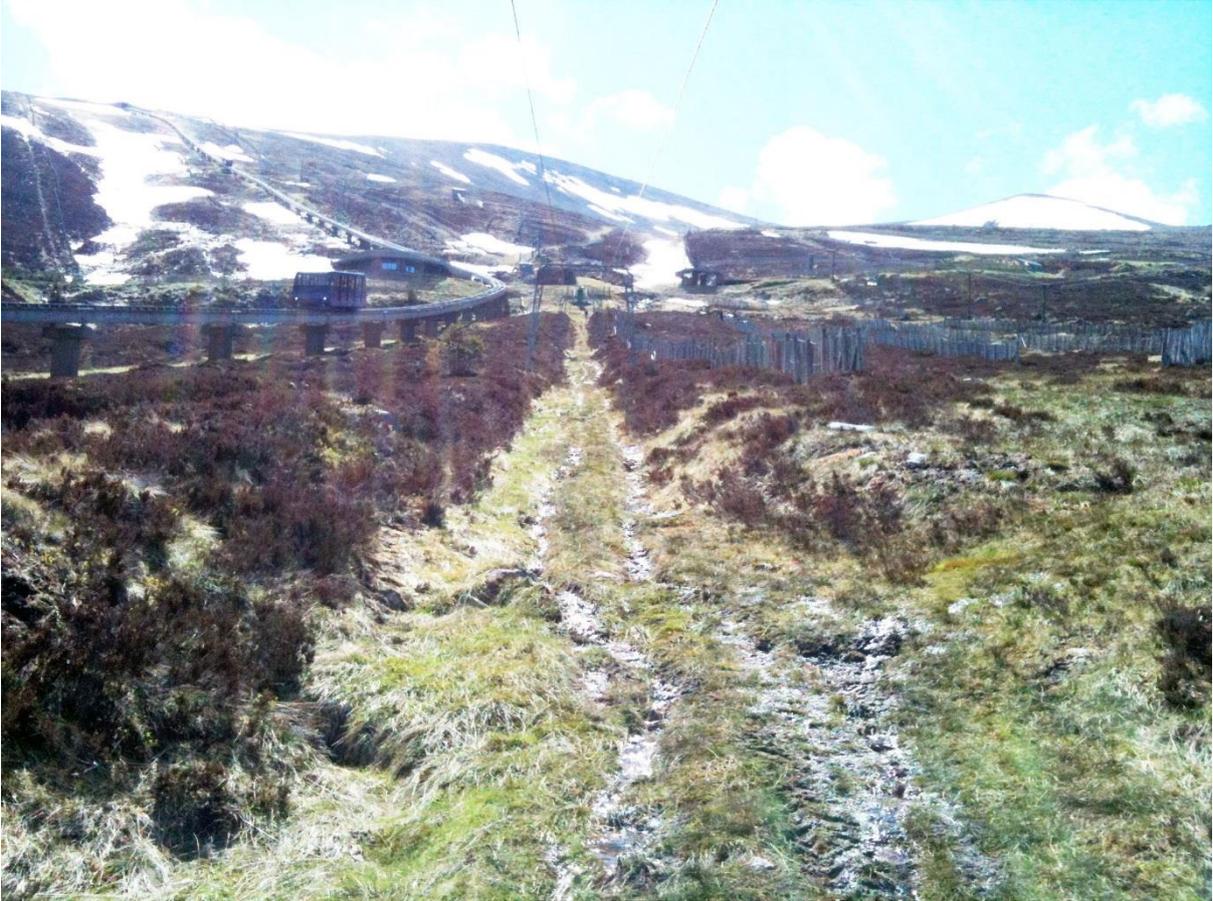
*Image showing old cutting and raised embankments with water draining the length of the previous tow track.*

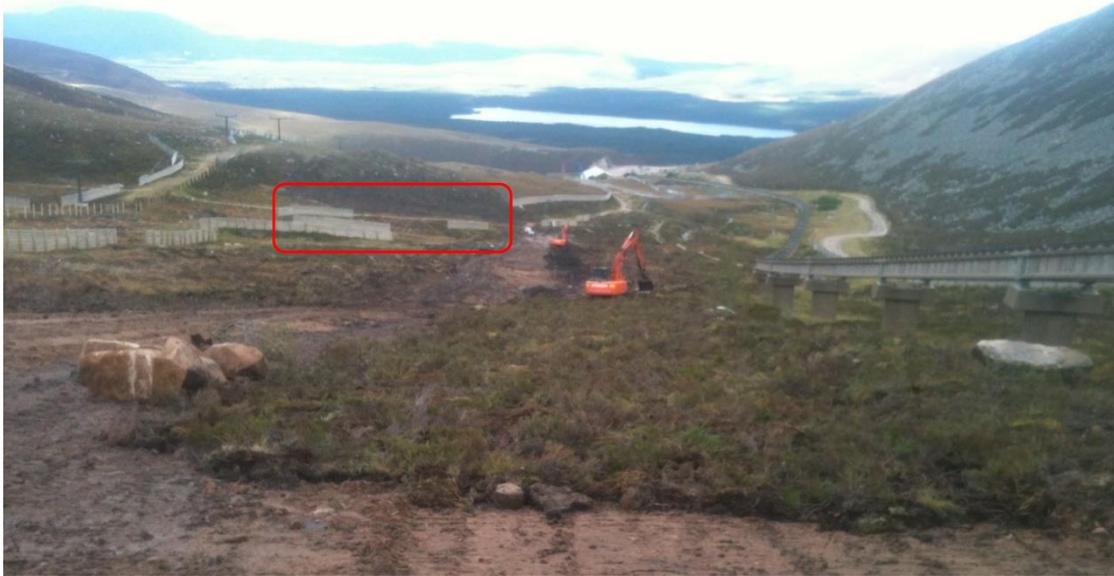
12. The above image is not misleading it shows excellent reinstatement of stored turf on the worksite after the desired ground levels were achieved. The borrow pit had been reinstated at this point and the image shows that this work was also completed to a high standard which makes it difficult to see the difference in the ground changes. The following statement in the representation is incorrect. *“Highlighted on the image are the site of the following features which were not yet present on date photograph was taken: 1. A 3m+ deep borrow pit for materials was dug in the area marked 1 [red], later backfilled with large rocks recovered from October and November’s ground works.”*

**Representation:** *“Misleading information in Application Page 3 of the supporting evidence for the application includes the following photo, dated Oct 2015 which claims to show reinstatement works to restore the site. This photo is misleading as it was taken before additional major groundworks were undertaken later in the project (Late Oct into Nov) to further modify the slope profile to fit the very strict requirement of the new tow.”*

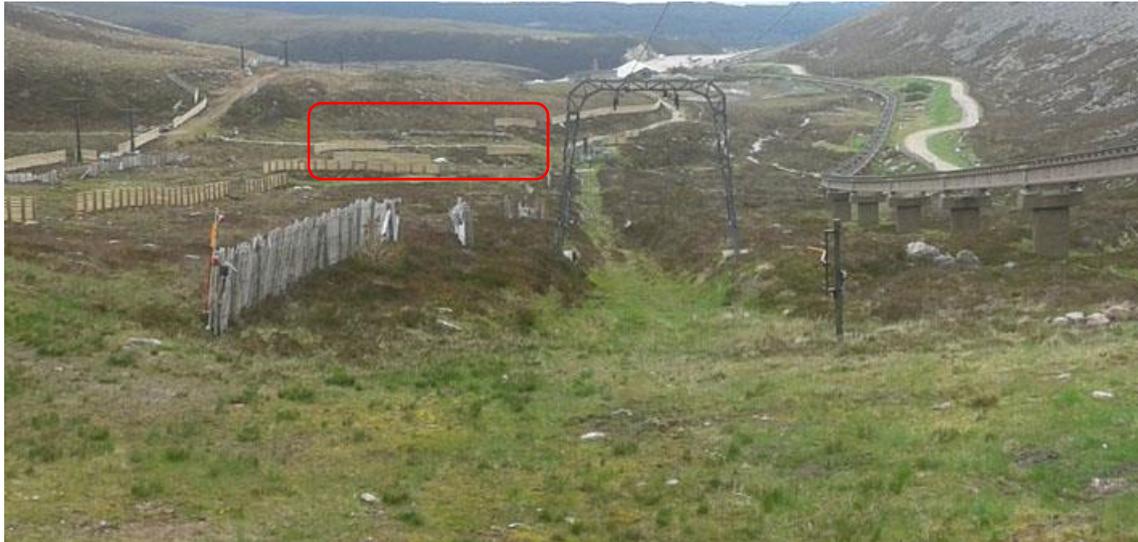
The image below proves that the reinstatement of the borrow pit had been completed at this stage and the fences at the borrow pit were removed.

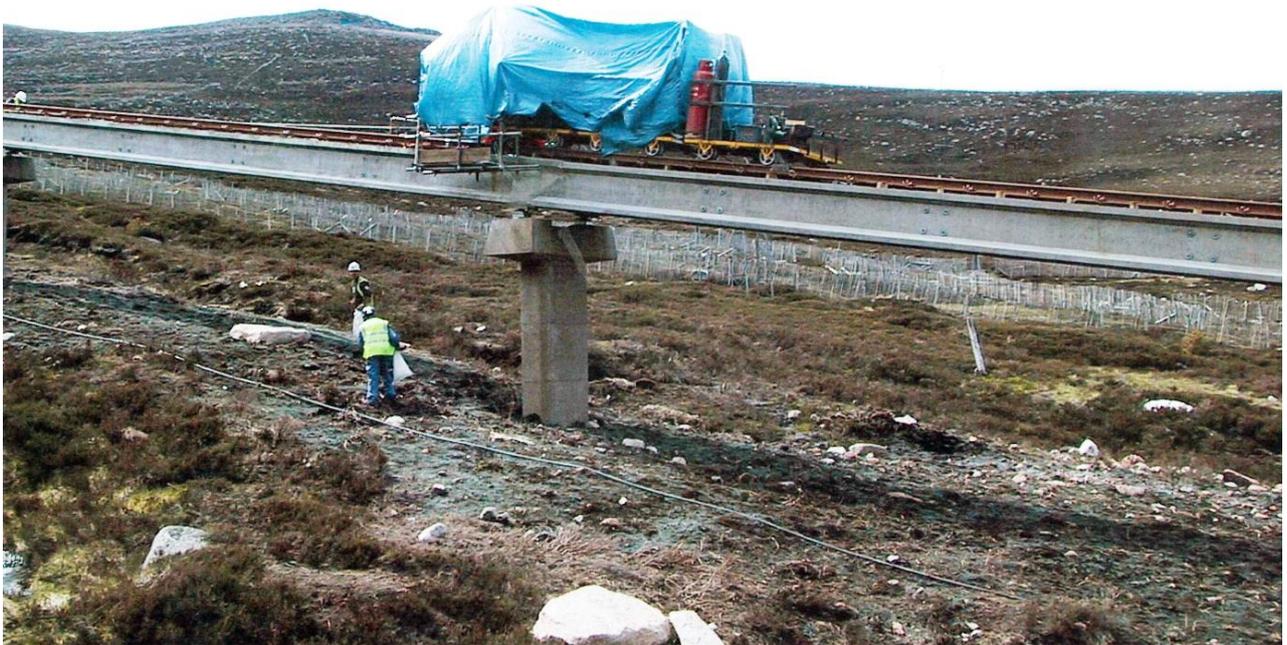
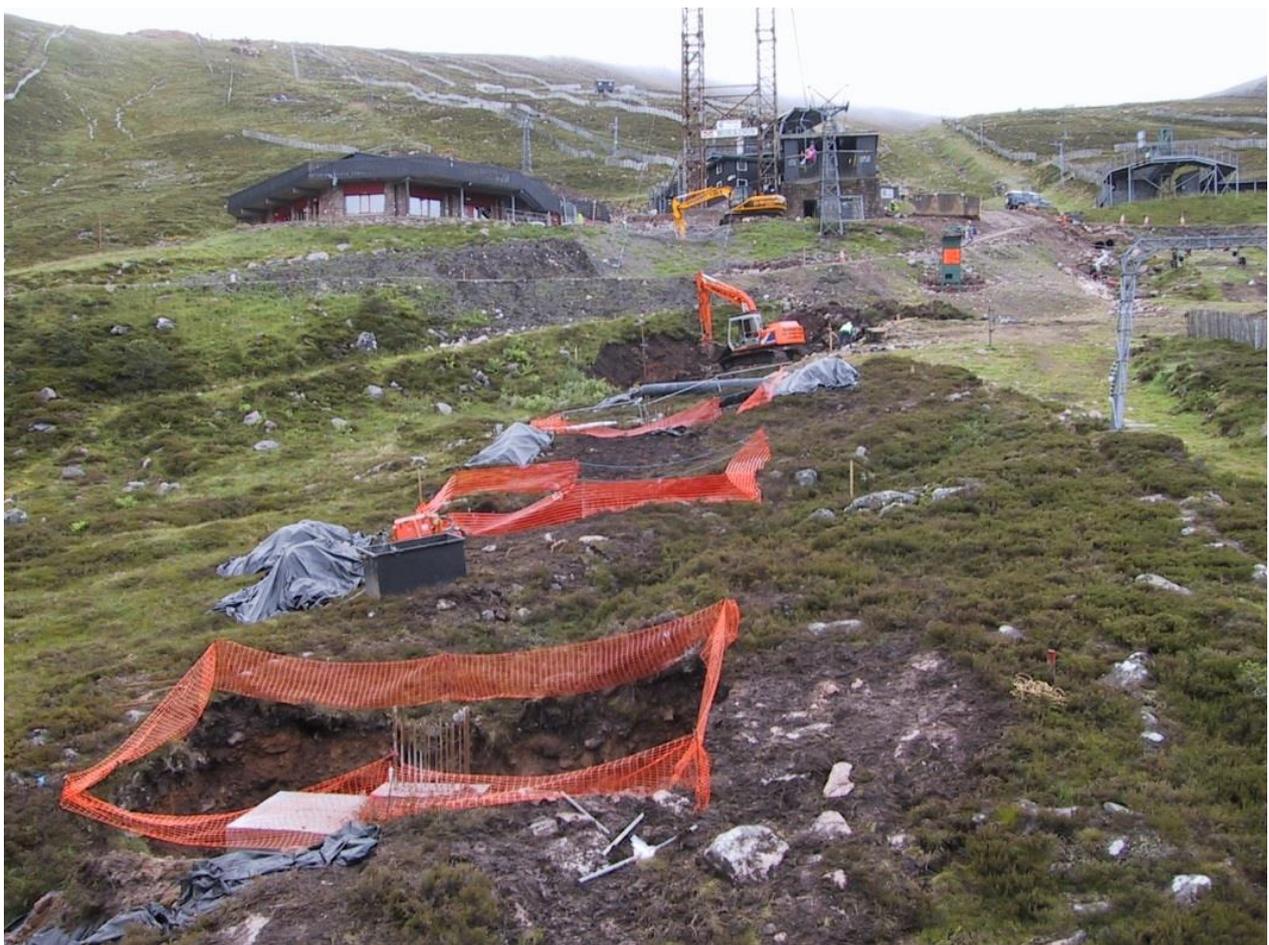
The image below demonstrates Railway re-instatement at the same elevation and within an area of deep peat, re-instated by grass seeding and Seed Aide. The methods used to store turf and re-instate the Shielling were completed to a higher standard using stored turf. It has been stated in various representations that the principals used in the Funicular construction have not been followed, this is misleading. The Funicular re-instatement was conducted at various altitudes and with numerous methods that were adapted to both the habitat, accessibility and ground conditions. Undoubtedly Funicular re-instatement was a success and given that the Shielling works were being commented on before the first growing season had started then conclusions on the success in some representations are unreasonable and premature.

The images above demonstrate different techniques used depending on the location. In some instances, vegetation was stored for two years before replacement and therefore the use of Terram was needed. On the Shielling tow the turf was only stored for six weeks and then replaced. The top image shows

where peat removal was the chosen option and second where moraine is the dominant ground condition and was stored and back filled.

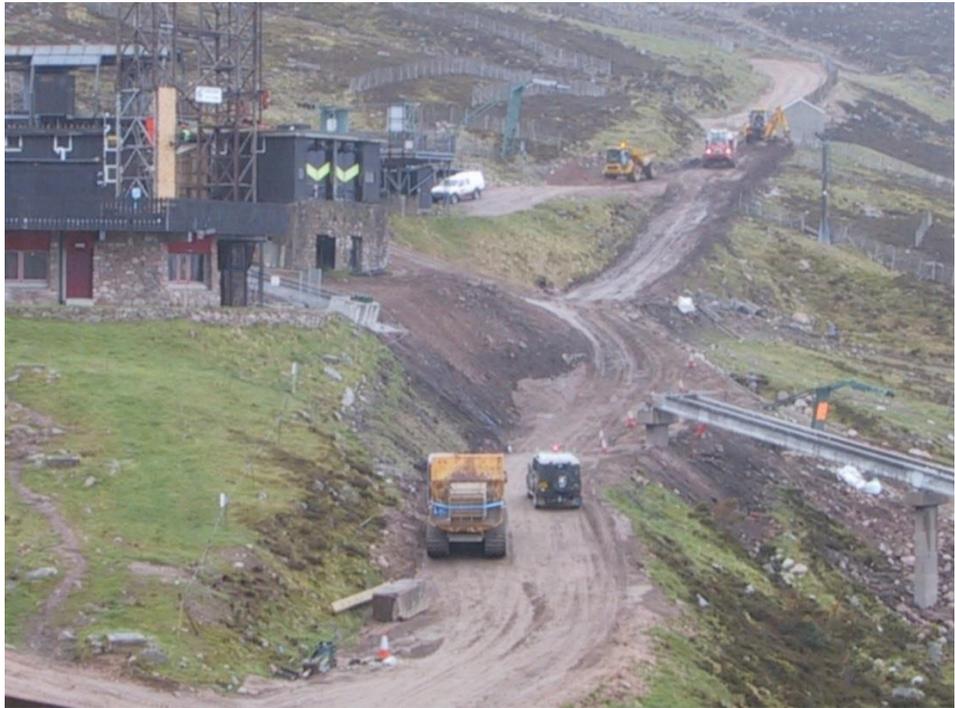
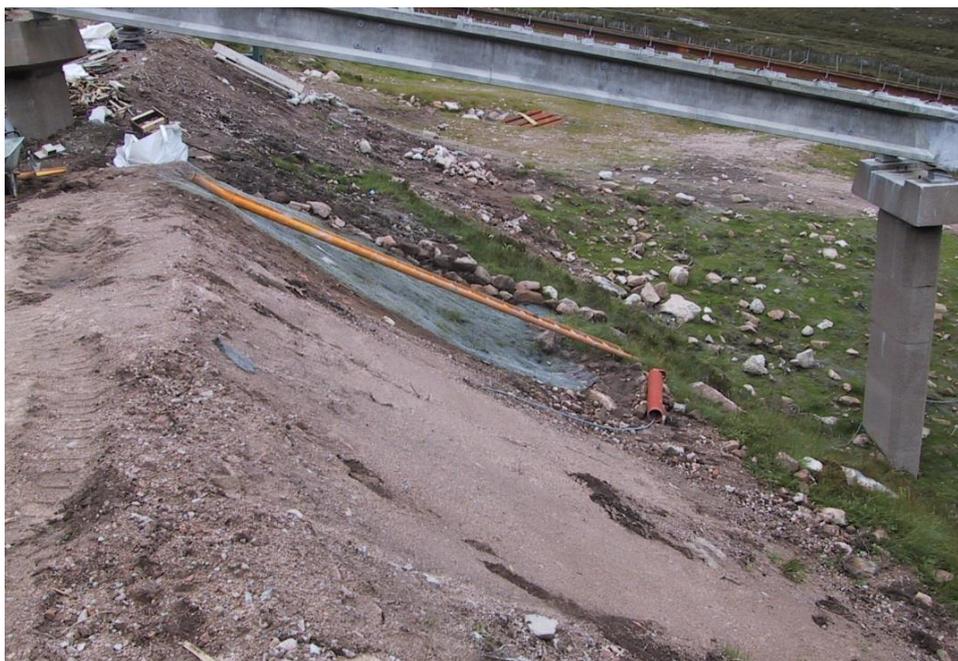
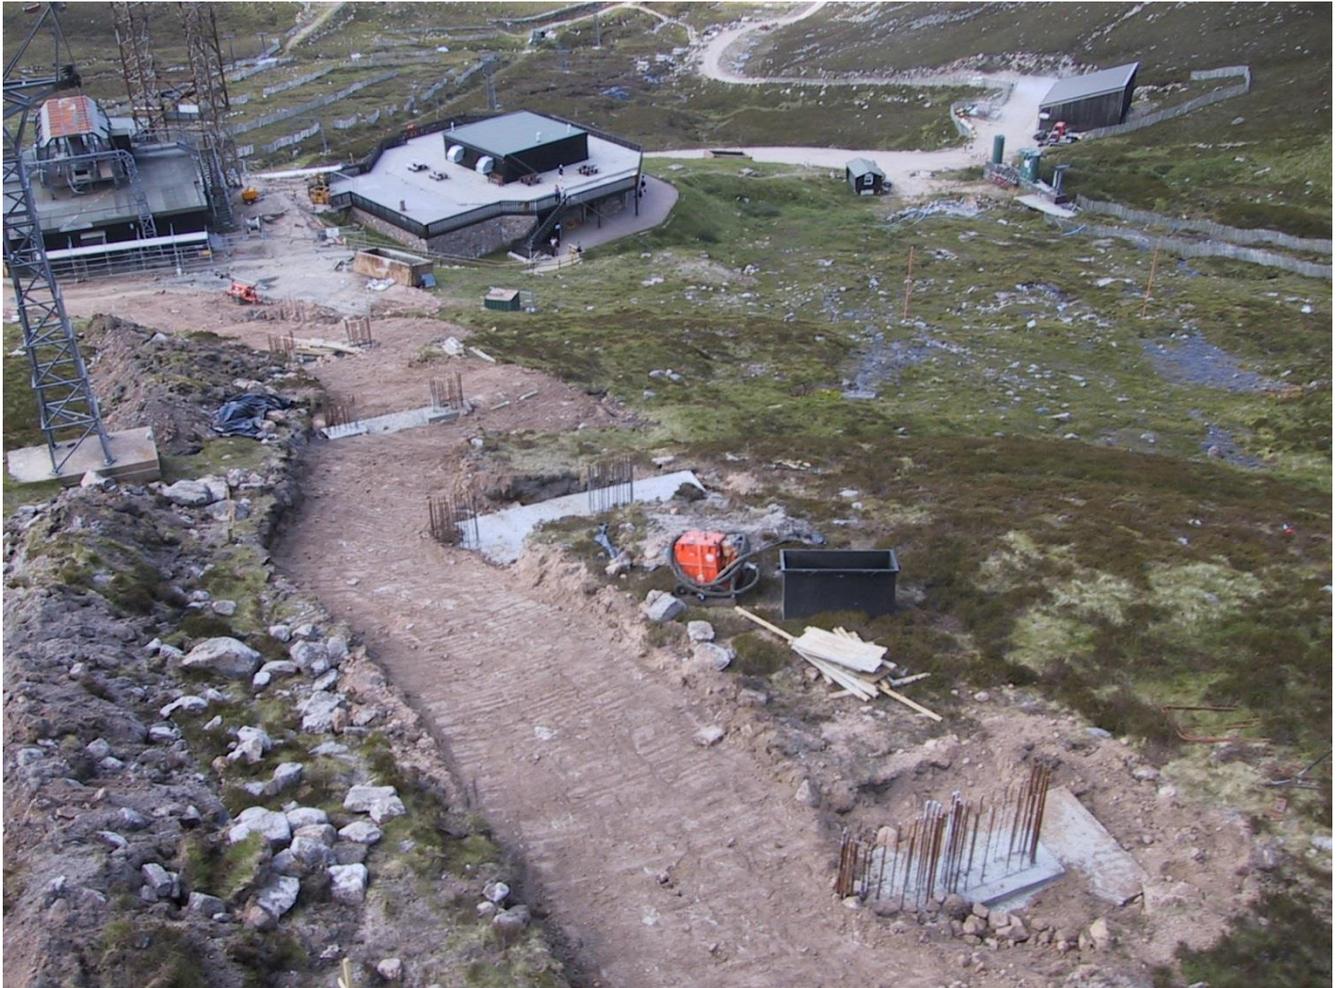
The ground at the top of the Sheiling tow has changed on many occasions, firstly with the construction of the Car Park Chairlift, secondly with the building of the hill road, thirdly with the bulldozed tow track, fourth with the realignment of the hill track, realignment of the Shieling return wheel and tower installation during Funicular construction. The images above and below demonstrate the start of reinstatement on the hill track and re-alignment during Funicular construction.

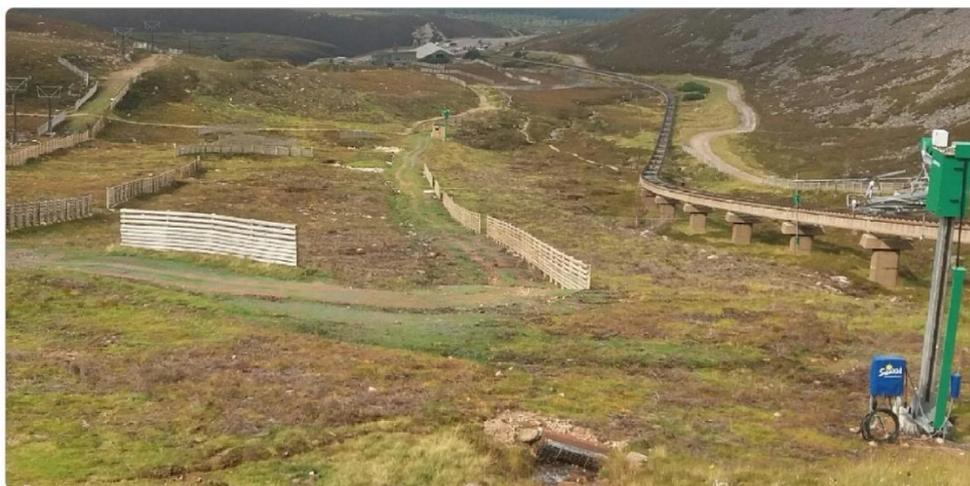
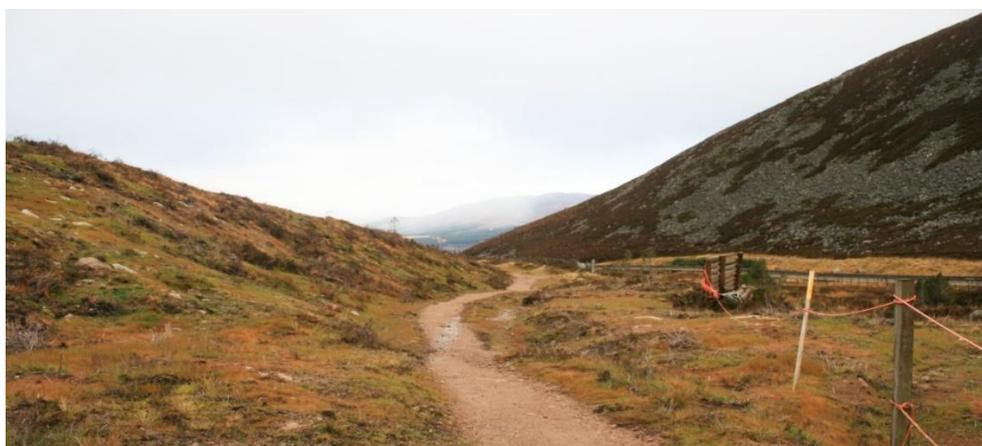
Top image taken in Nov 2016 looking across the site showing the access track after first growing season. Lower image Nov 2016 shows re-graded embankment along the path edge.

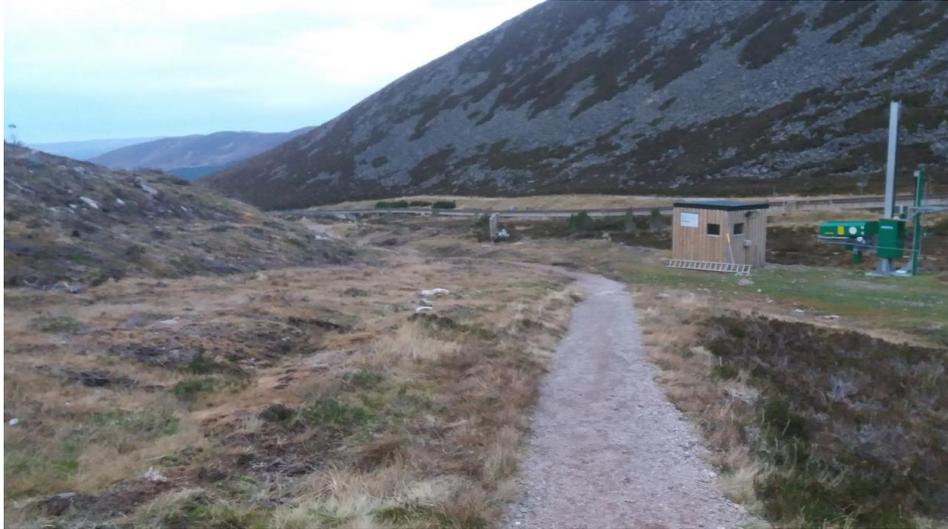
Image December 2016. Looking down AMwood path with re graded embankment and location of borrow pit on the left, existing path drainage and path levels retained.
