2021/0172/DET

Glen Clova Estate

Caddam

Forestry Track Construction –
Drainage Repairs

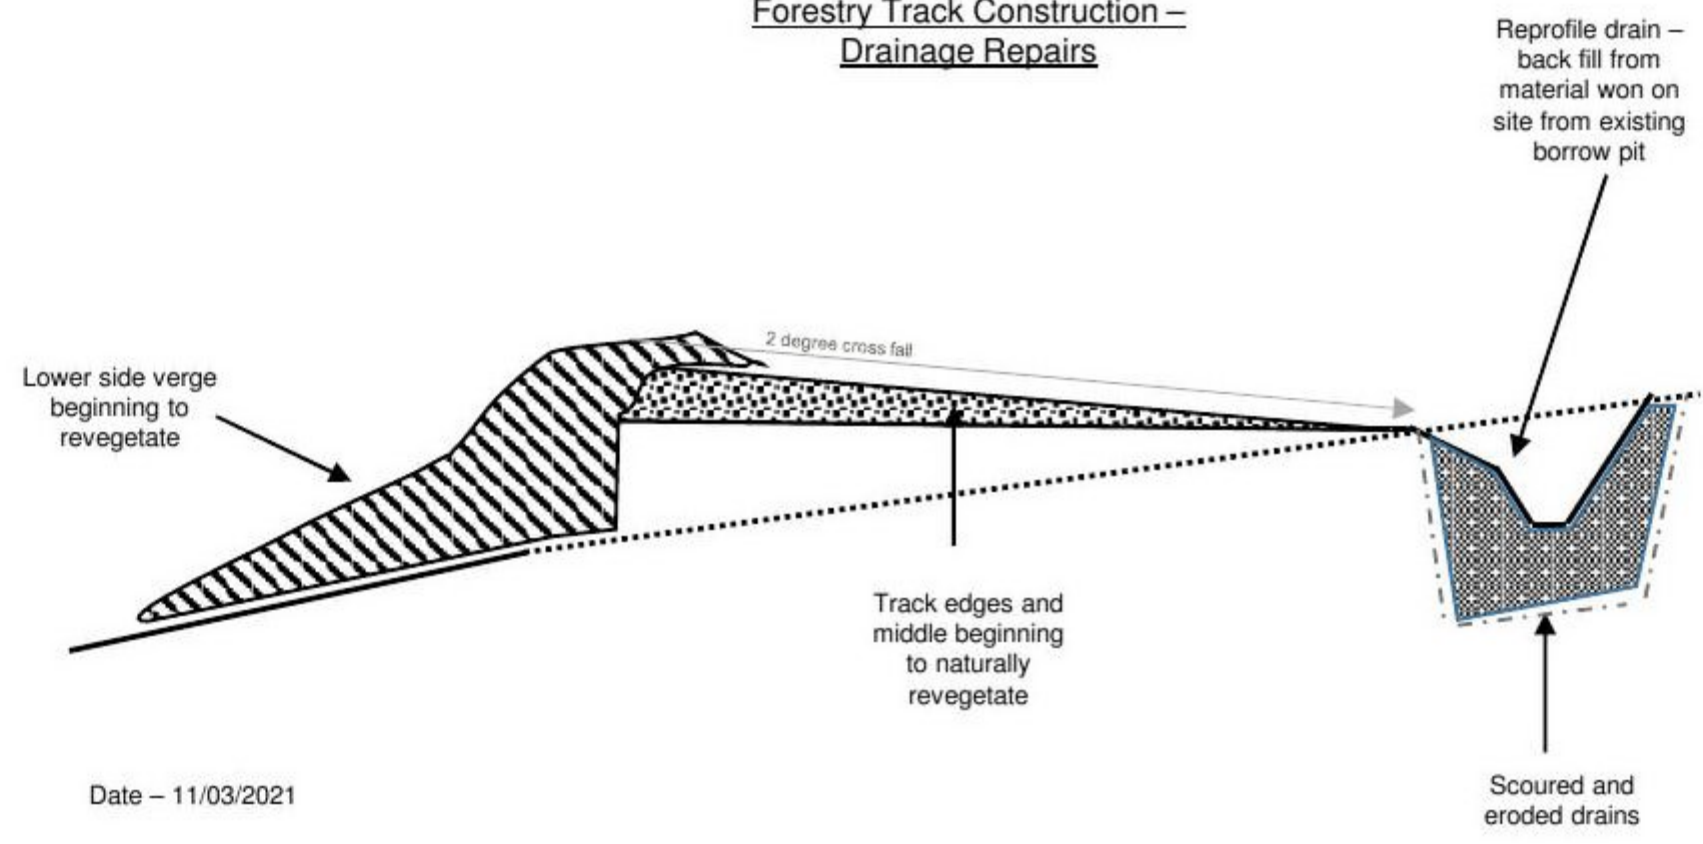
Site – Glen Clova Estate – Caddam Wood
Drain Repair

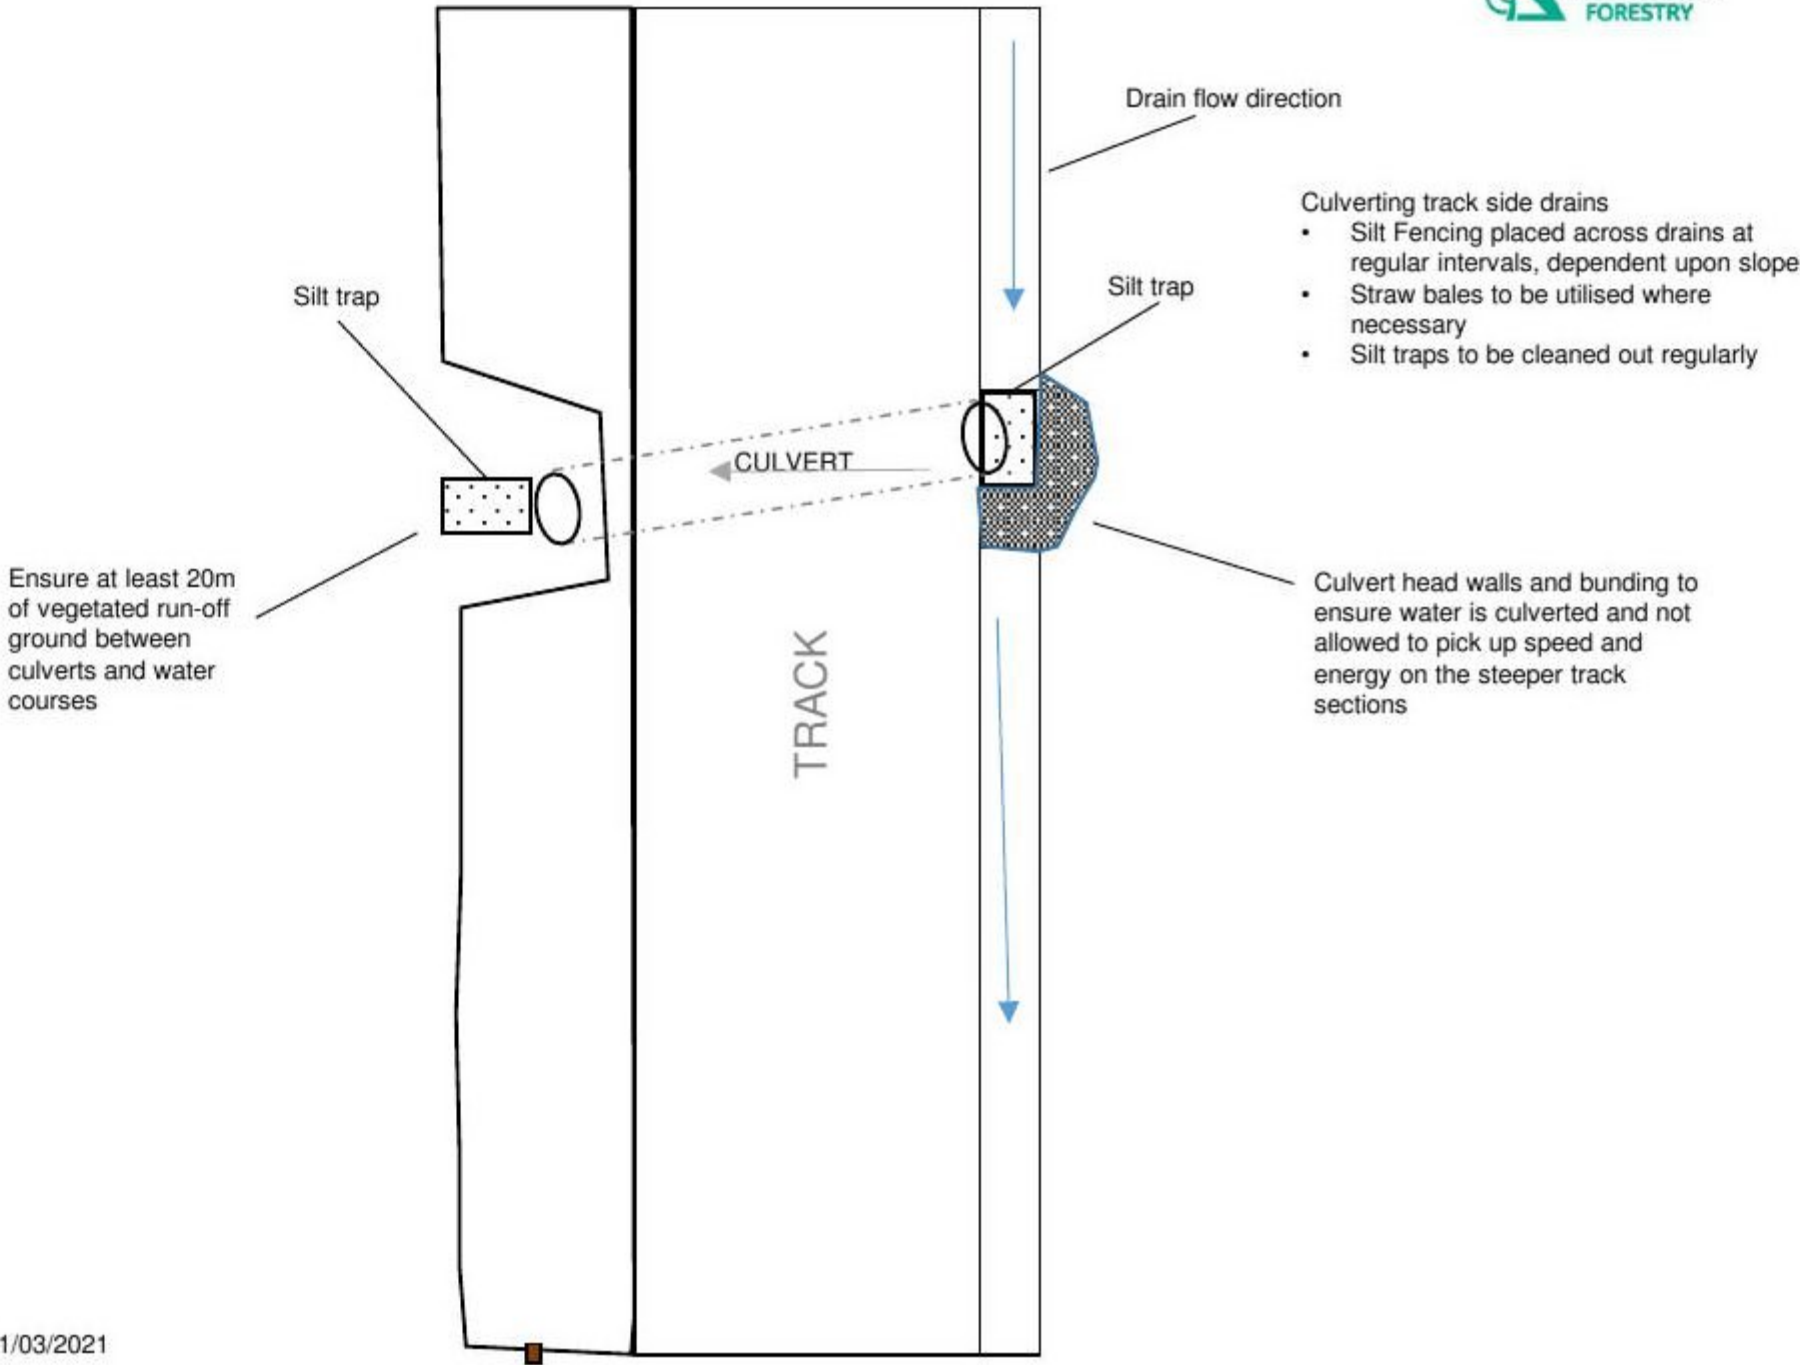
Culvert Installation – Plan

Site – Glen Clova Estate – Caddam Wood
Retro-fitting Culverts

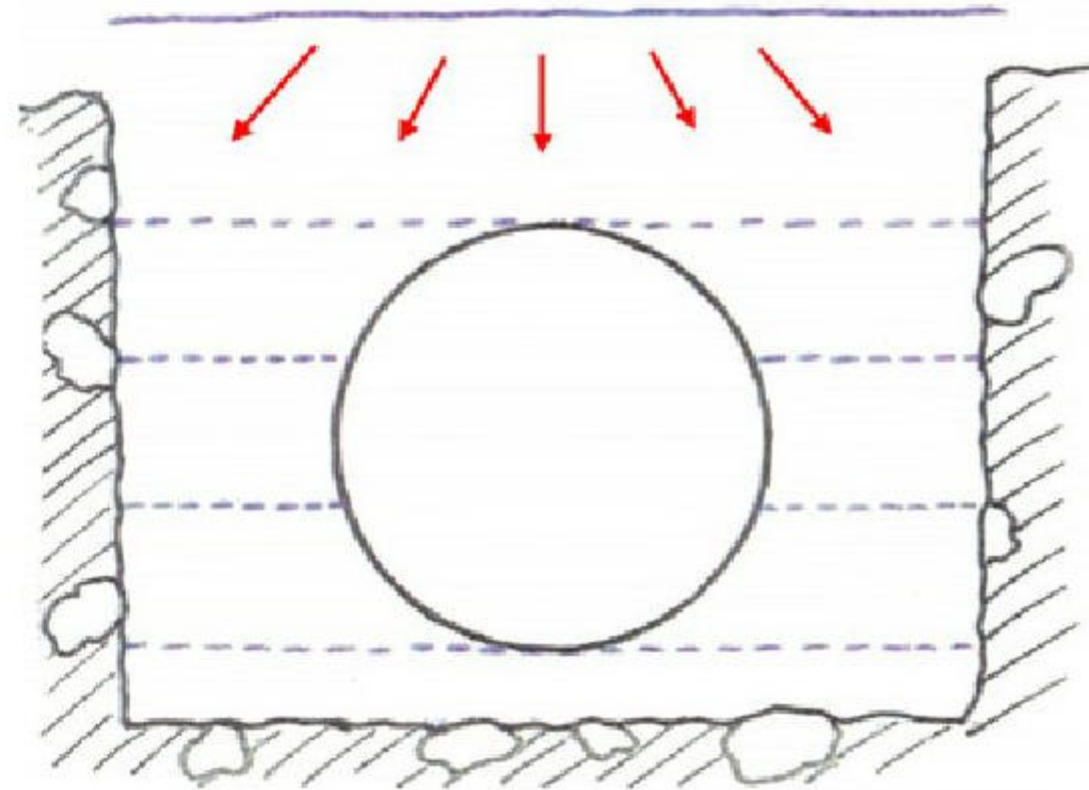
Relief Culvert
Installation

A thick layer of good stone is needed above the pipe to spread the load. Consult manufacturers guidance for installation

Fill trench with good stone. Fill in 150mm layers, firming down between each layer to ensure that it is well packed.

Trench is wide enough to backfill pipe. Cut trench to allow at least 30cm between pipe and side of trench to give enough space to compress stone.

The pipe need to lie on a 100mm firmed bed of good quality material
