Cairngorms National Park
Partnership Plan 2017-2022

**Strategic Environmental Assessment
Scoping Report**

Appendix 2: Environmental Baseline

Topic 3: Water

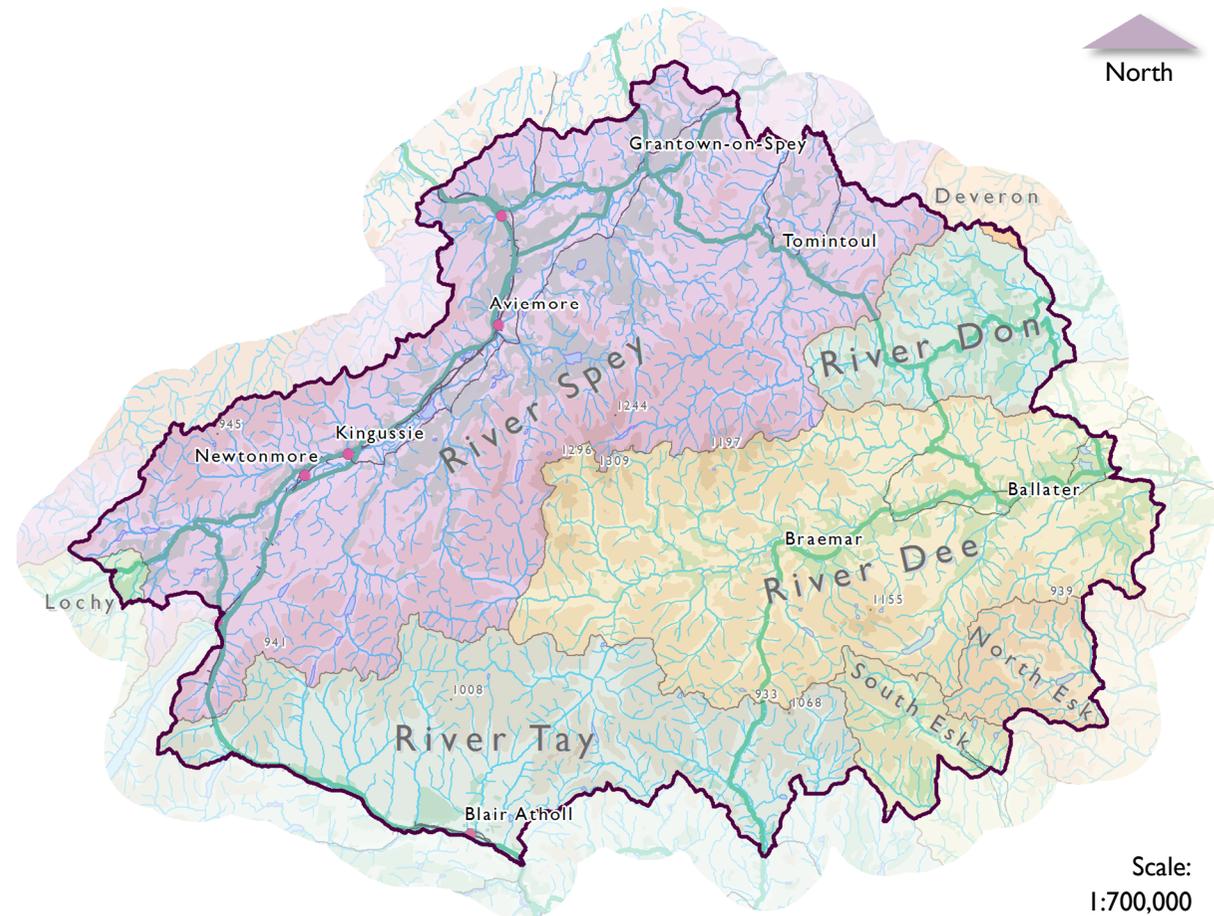
Figure 15 River catchment areas within the Cairngorms National Park.

The Cairngorms National Park encompasses the headwaters of three of Scotland’s major rivers as well as many smaller ones (**Figure 15**). Many of the rivers and their tributaries as well as lochs and wetlands are designated as Natura sites and Sites of Special Scientific Interest (SSSIs). The rivers in particular provide water for society in the National Park, and for people outside the Park as they flow downstream towards the sea.

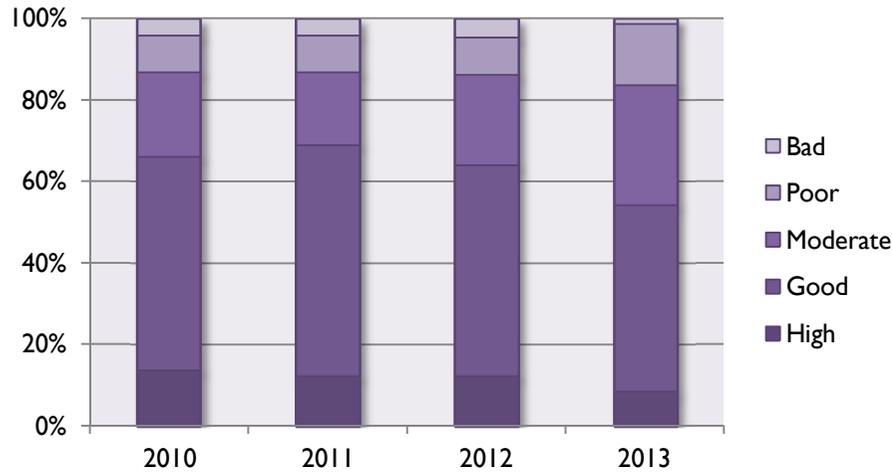
Figure 16 Overall status of waterbodies within and overlapping the Cairngorms National Park.

The overall status and water quality classification of waterbodies within the Cairngorms National Park for years 2010-2013 is presented in **Figure 16**, **Figure 17**, **Figure 18** and **Figure 19**. The main reasons for waterbodies not achieving overall good status is the presence of a large number of barriers to fish and poor morphology (this covers catchment/landuse matters such inputs of fine sediments or impacts to hydrology and direct impacts such as through engineering or condition of riparian corridor).

As can be seen, the current situation is mixed, and only a minority of waterbodies are in bad or poor condition, there has been an increase in the number of waterbodies changing to a worse status or classification.

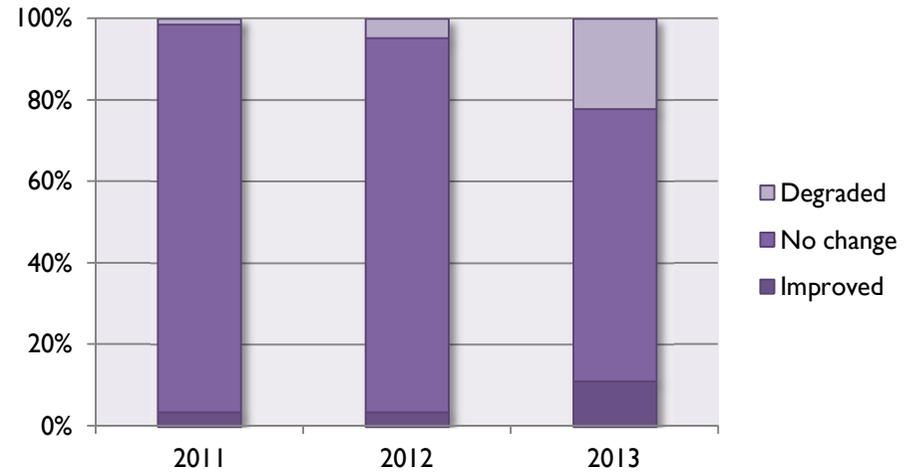
Figure 17 Change from previous year in the overall status of waterbodies within or overlapping the Cairngorms National Park

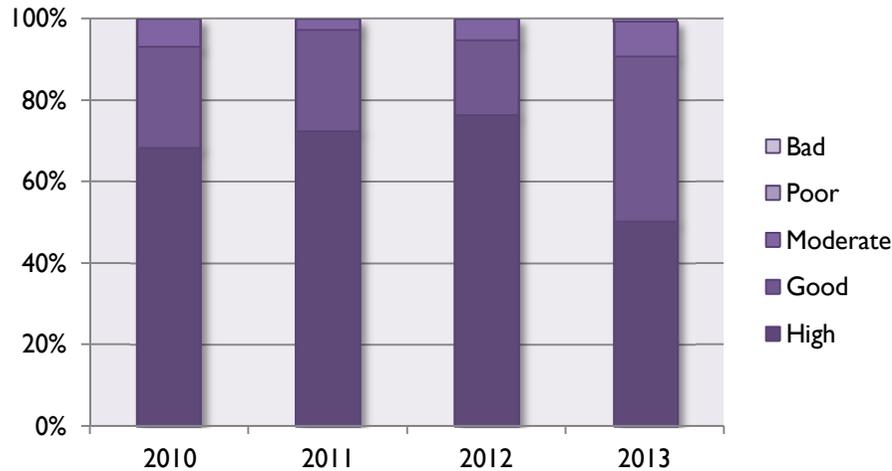
Figure 18 Water quality classification of waterbodies within and overlapping the Cairngorms National Park.

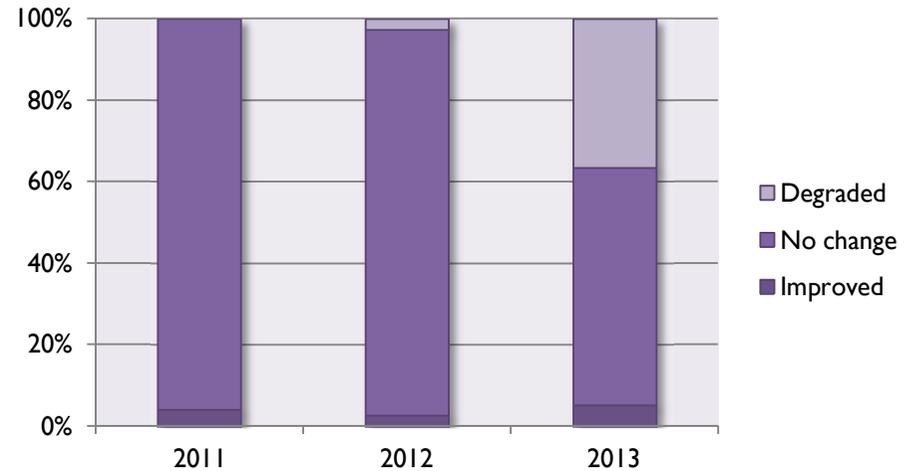
Figure 19 Change from previous year in the water quality of waterbodies within or overlapping the Cairngorms National Park

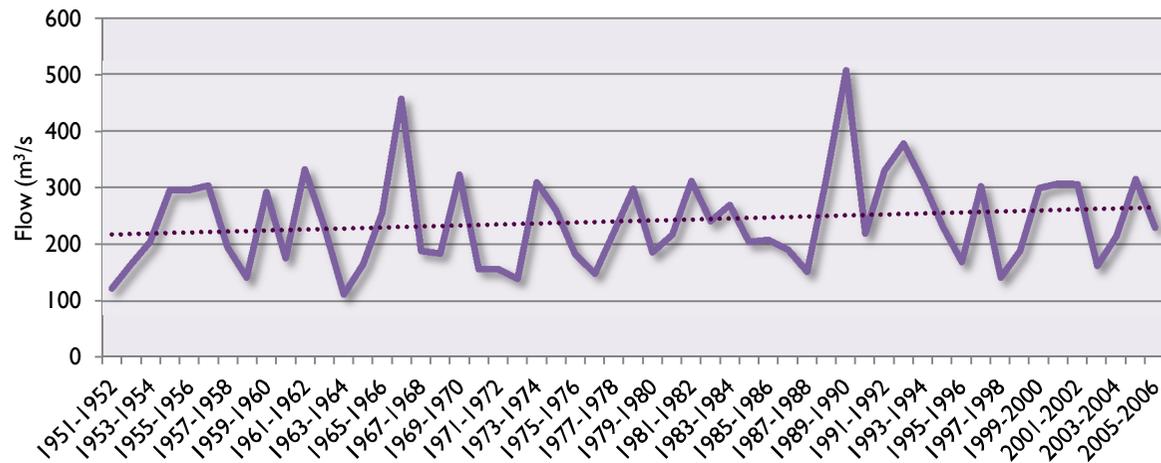
Figure 20 Annual maximum (AMAX) data for the River Spey at Granttown-on-Spey (Station 8010). Contains SEPA data © Scottish Environment Protection Agency and database right 2015. All rights reserved.

Figure 20 and **Figure 21** represent the series of maximum instantaneous peak flows within a given water year (October to September) for monitoring stations on the River Spey and River Dee. The data from both stations shows a general trend for higher annual maximums over the time they were monitored. The causes of this are uncertain; however, it highlights the importance of taking into account the potential for an increase in the number and severity of flood events over the lifetime of the NPPP and beyond.

AMAX data from the Spey and Dee indicates a general trend for higher annual maximum instantaneous peak flows over the time they were monitored, indicating an increase in floodrisk in these catchments.

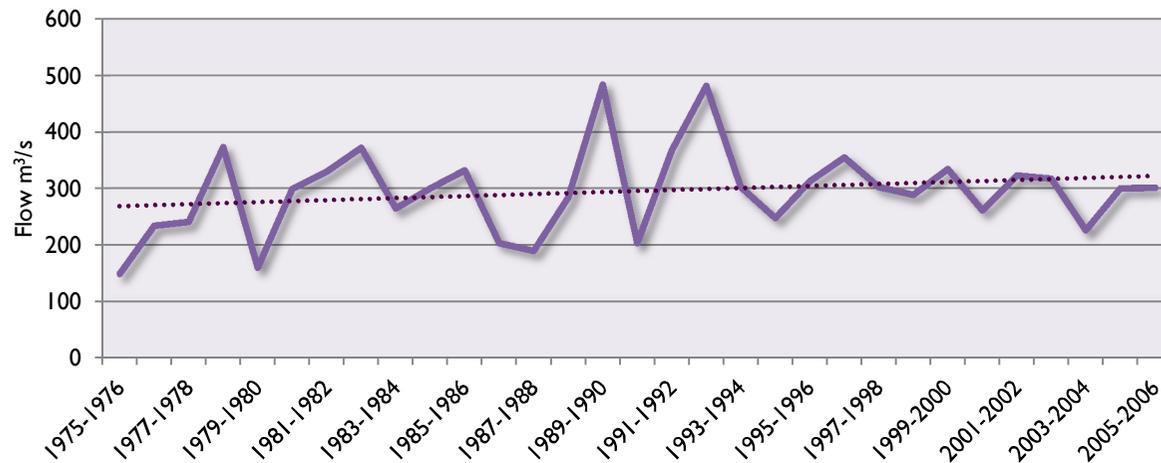
Figure 21 Annual maximum (AMAX) data for the River Dee at Polhollick, near Ballater (Station 12003). Contains SEPA data © Scottish Environment Protection Agency and database right 2015. All rights reserved.

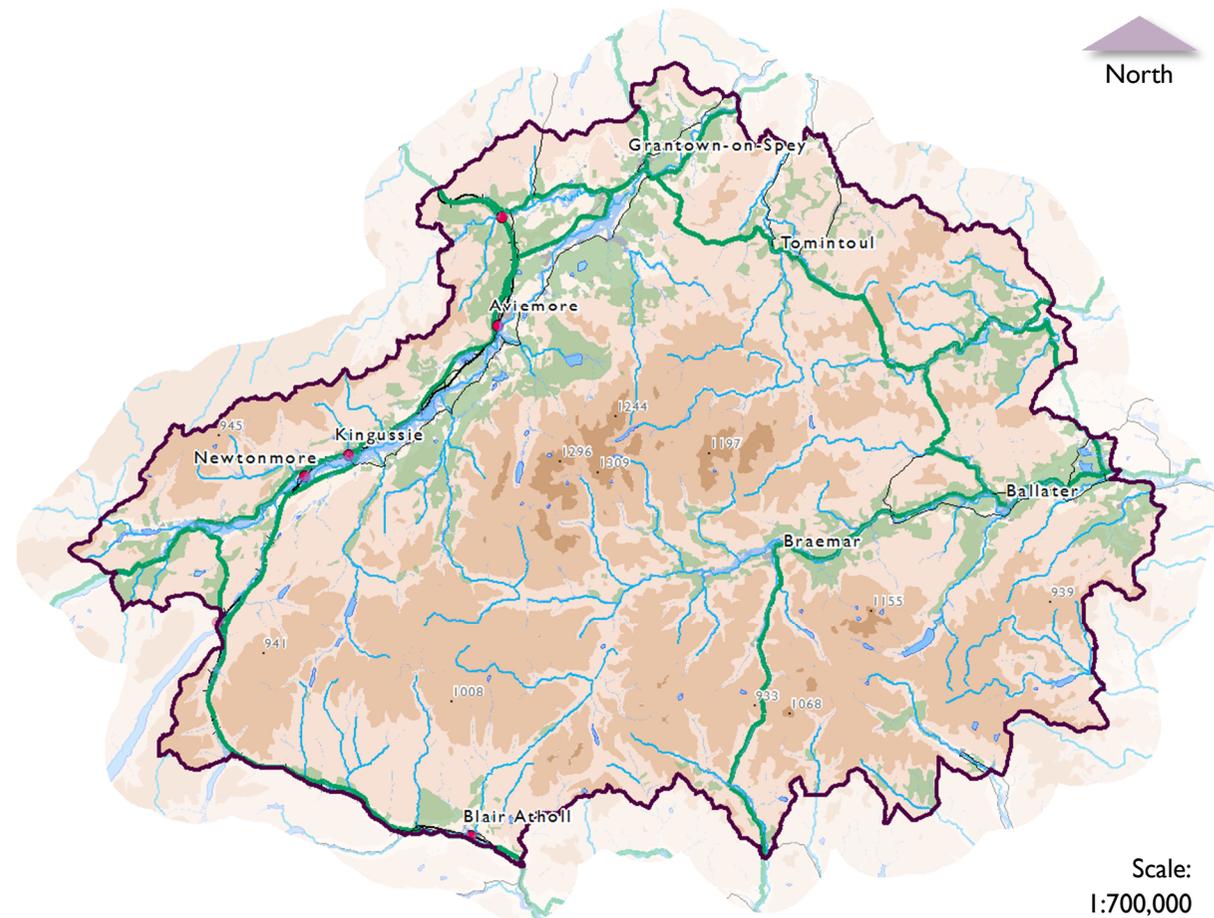
Figure 22 Indicative river flooding extent (medium probability 1 in 200 years) in Cairngorms National Park.

While all of the National Park's rivers and watercourses have the potential to flood to some degree (**Figure 22**), most do not cause great concern, as they are in areas or of a magnitude that is unlikely to cause significant damage to property or risk to life. However, the pattern of settlement in the National Park is now along the main straths and glens and so when the rivers and tributaries that flow along these, namely the Spey, Dee and Don, break their banks, they often result in economic, and occasionally human, cost. Furthermore, in some areas surface water flooding, which can arise for a number of reasons, is a significant risk.
