AGENDA ITEM 7

2019/0289/DET

PLANS

Craggan House, Granttown-on-spey

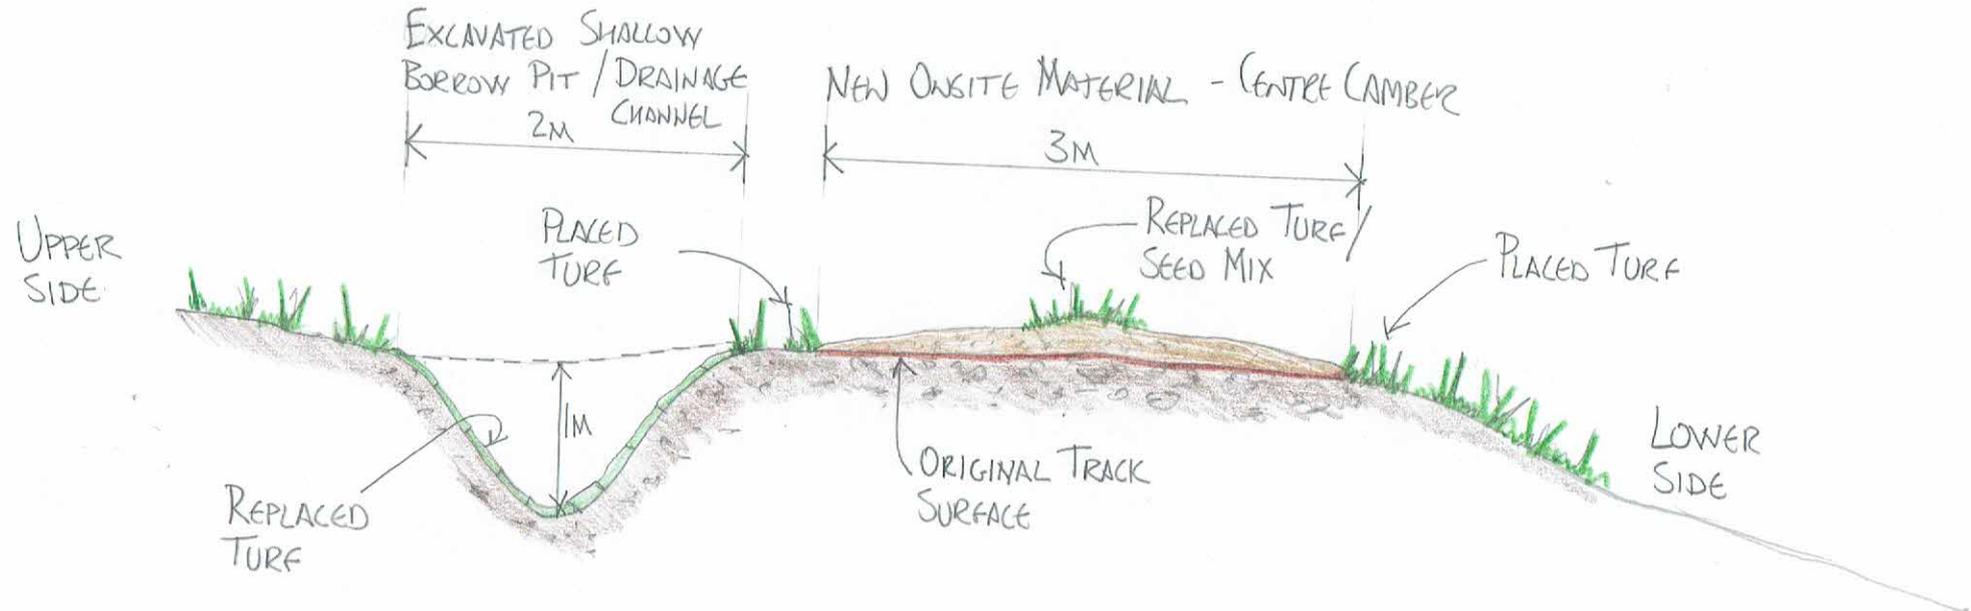
Typical Profile for Repairing
 an Existing Track with
 Shallow Borrow

TYPICAL CONSTRUCTION LAYOUT
FOR REPAIRING TRACKS INC.
SHALLOW BORROW PITS.

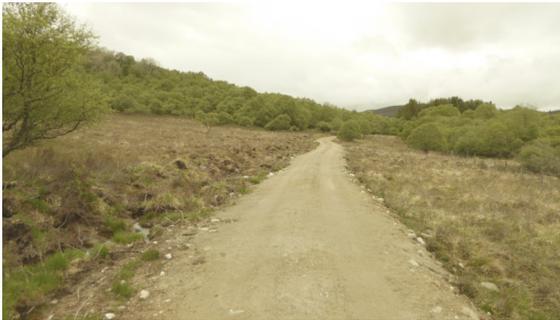
South end of track

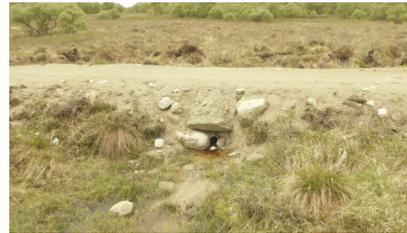
Typical cross drain inflow

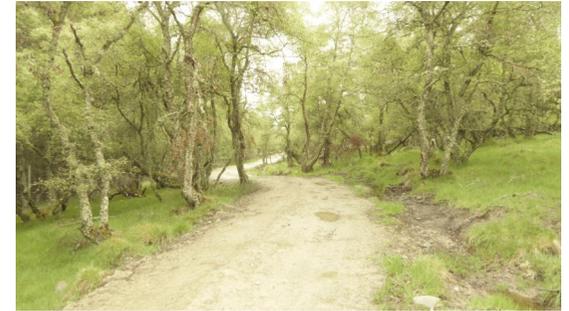
North end of track

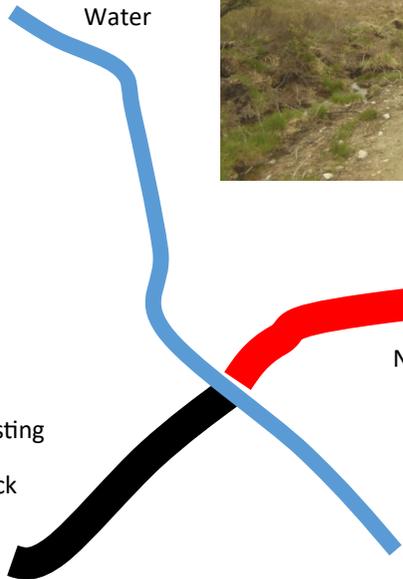
Ditch with cross drains approximately every 20 meters.

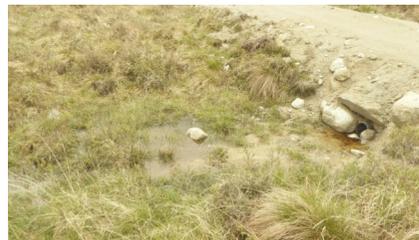
Typical cross
Drain outflow

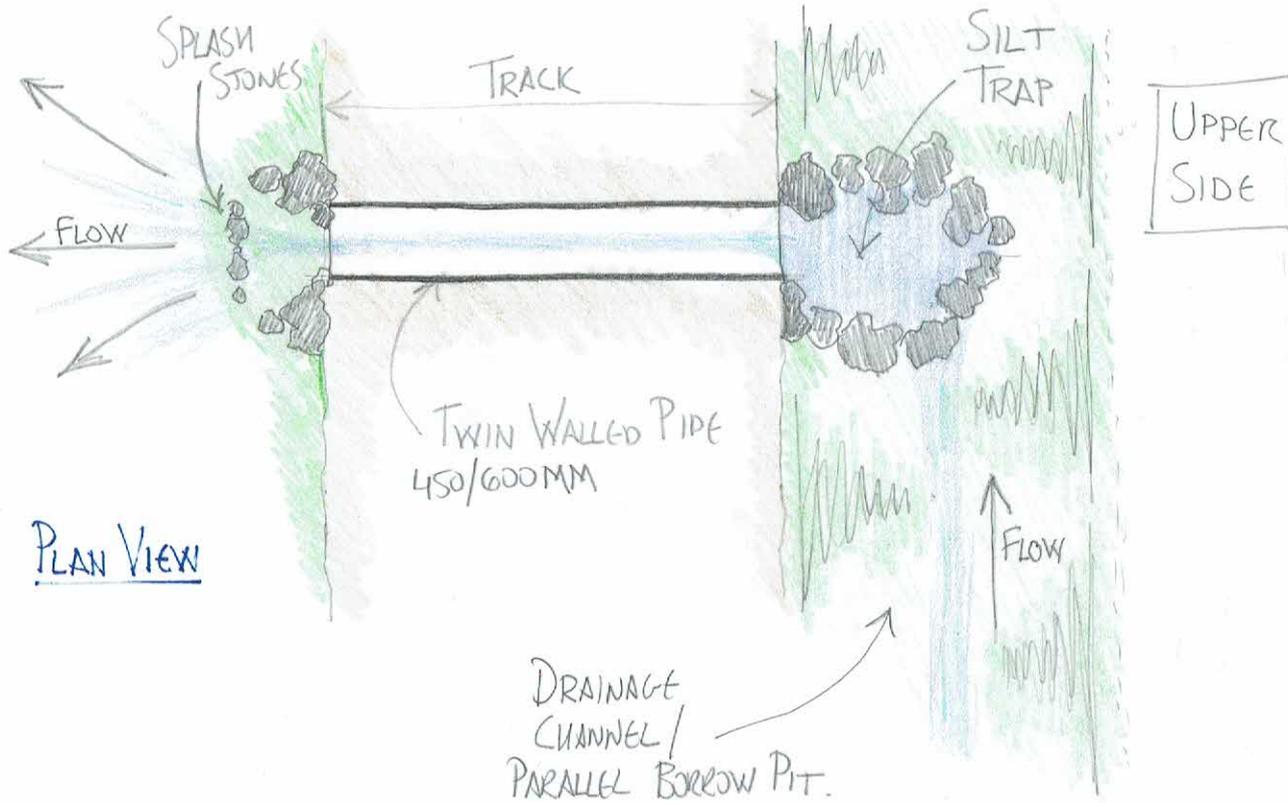
PLAN VIEW

ROAD CROSSING CULVERT
FROM PARALLEL BORROW PIT/
DRAINAGE CHANNEL
